REPORT TURBINE INSPECTION

SN 15401267, WINDPARK SLUFTER WEST 1

Report No. GE15002015001

REPORT GEARBOX INSPECTION
SN 15401267, WINDPARK SLUFTER WEST 1

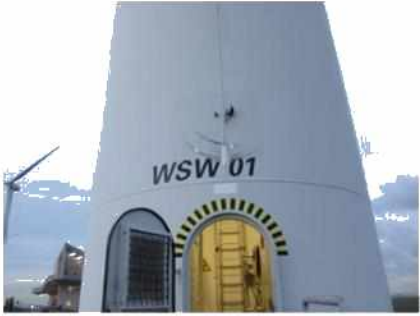
Item	Remark		
1	Tower outside	<p>Light at the outside is broken and has damaged the paint of the tower.</p>

Low</p>
2	Controller overview

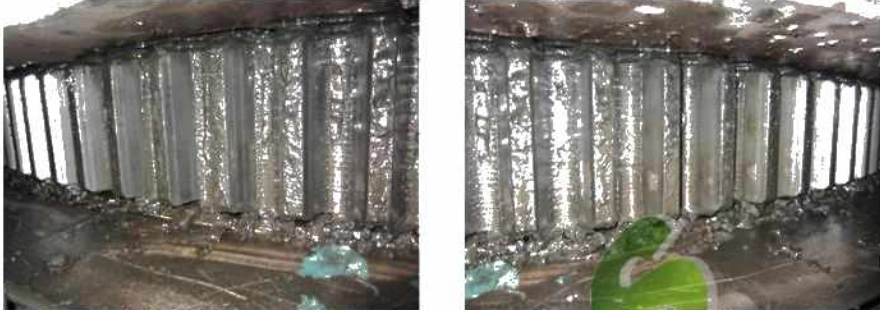
Item	Remark	
1	Yaw section		ok
2	Yaw ring teeth	Yaw ring shows no irregularities.

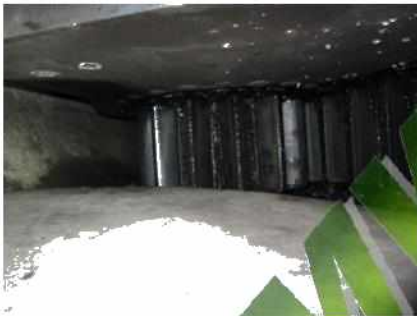
ok
3	Yaw pinions	Yaw pinions show no irregularities.

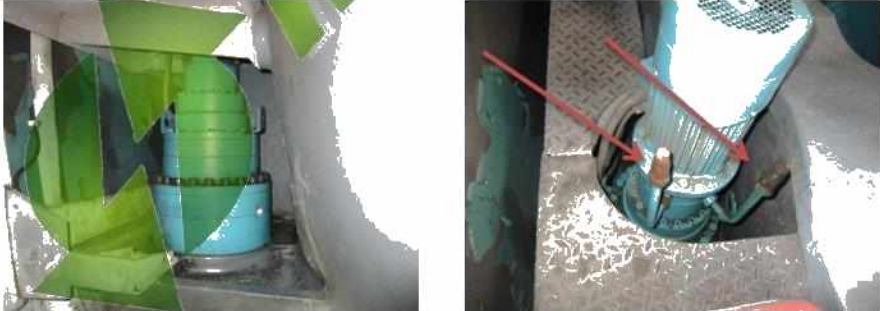
ok
4	Yaw gears	Air outlets of the oil reservoirs are corroded.

<div style="text-align: right;"> COR Low </div>

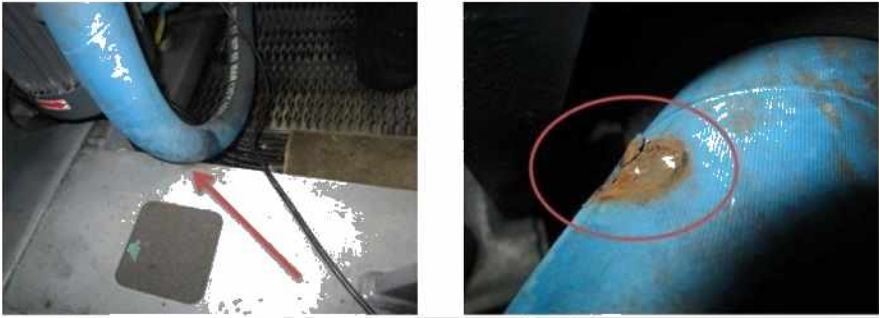
5	Hoses and pipes	<p>Hose between the gearbox and the oil pump is in contact with the sharp edge of the frame. The steel webbing of the hose is visible.</p>

<p>NO High</p>
6	Paint / Corrosion		ok
7	General leakage	<p>Drop of oil visible at the plug of the radiator. Main shaft of the gearbox is leaking some oil.</p>

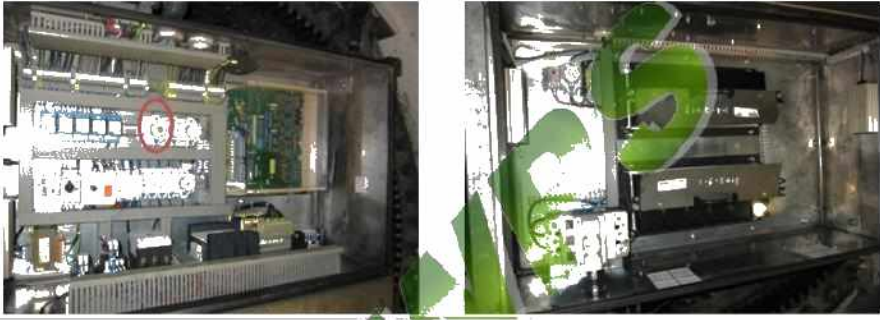
ok
6	Boxes blade 3	<p>Sand is leaking at one fuse of the control box.</p>

Low </div>
7	Mounting of the electrical boxes	<p>The mounting of the boxes shows no irregularities.</p>

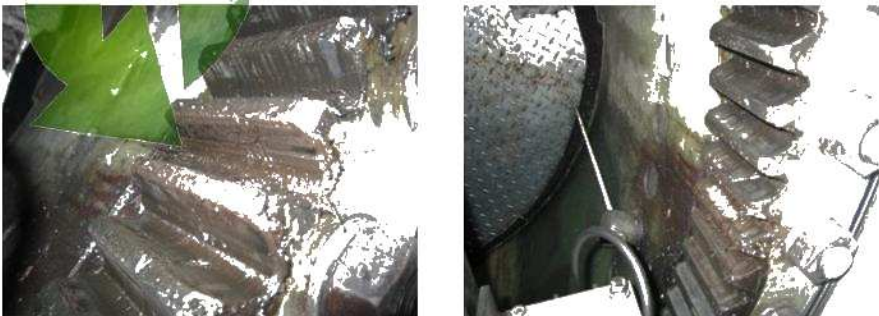
High
10	Pitch teeth at zero of blade 2	<p>The tooth at zero shows wear.</p>

High

The wear of the zero-tooth of the pitch ring is serious, but it is possible to solve this problem by assigning another tooth to be the zero-tooth. Dismounting and remounting of the blades is necessary to achieve this. The same thing can be done with the pinions, although replacing the pitch gears (with the pinions) is also an option.

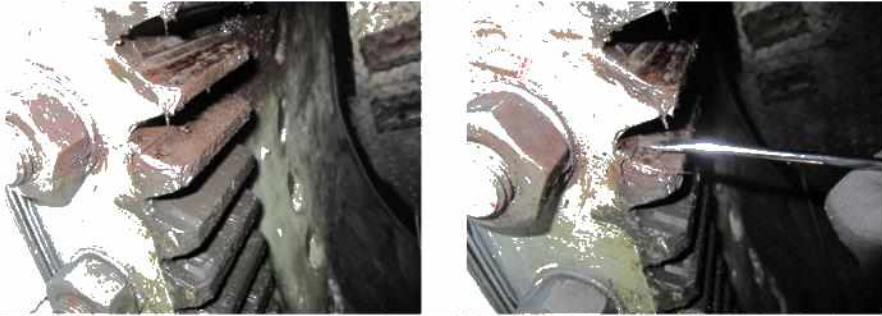
11	Pitch teeth at zero of blade 3	The tooth at zero shows wear.

High </div>
12	Grease system pitch teeth	There is an automatic grease system present in the hub. The system is not operational.	 	<div style="text-align: center;">   High </div>
13	Pitch gears			ok
14	Miscellaneous			ok

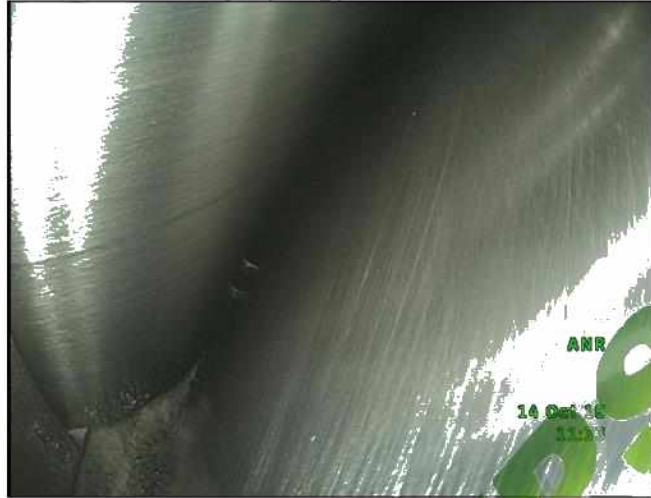
Picture 1 shows bearing position no. 1, the bearing of the planet carrier at rotor side. No irregularities.

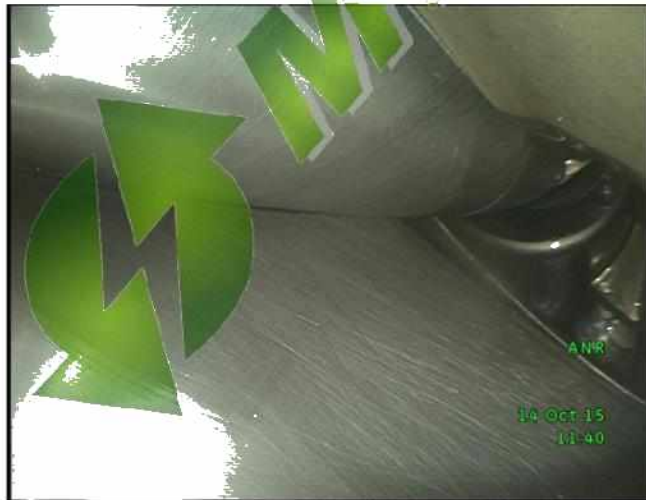
Picture 2 shows the bearing of the first planet wheel. No irregularities.

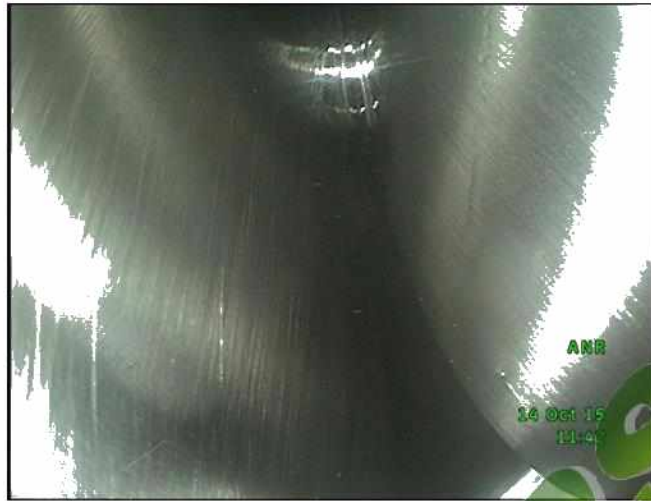
Picture 3 shows the bearing of the second planet wheel. No irregularities.

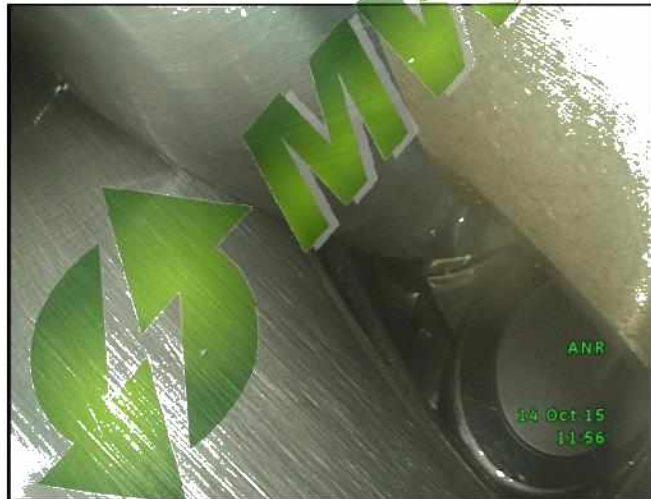
Picture 4 shows the bearing of the third planet wheel. No irregularities.

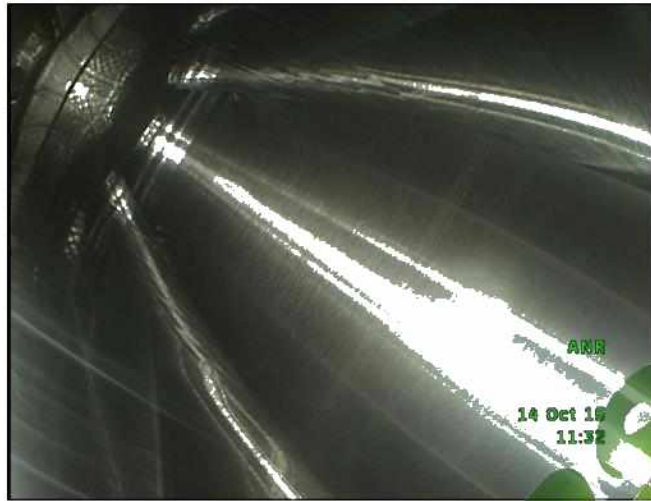
Picture 5 shows bearing position no. 5, the bearing of the planet carrier at generator side. The bearing shows no irregularities.

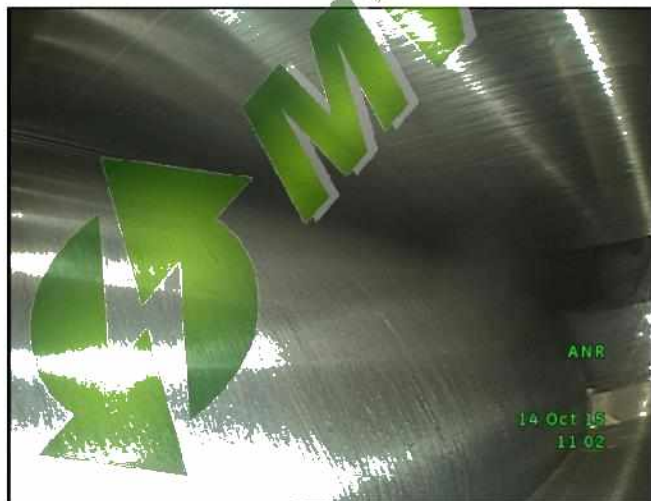
Picture 6 shows bearing position no. 6, the bearing of the low speed shaft at rotor side. The bearing shows no irregularities.

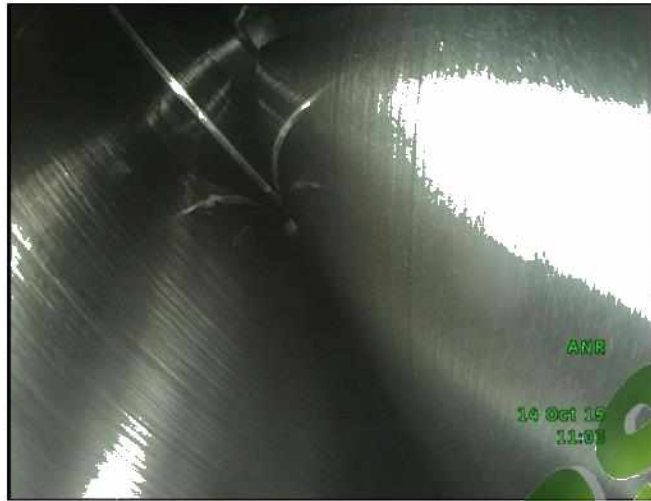
Picture 7 shows bearing position no. 7, the bearing of the low speed shaft at generator side. The bearing shows no irregularities.

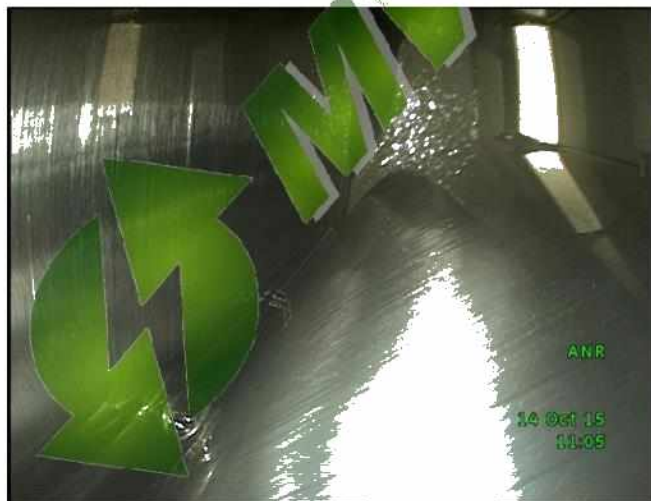
Picture 8 shows bearing position no. 8, the bearing of the intermediate shaft at rotor side. The bearing shows no irregularities.

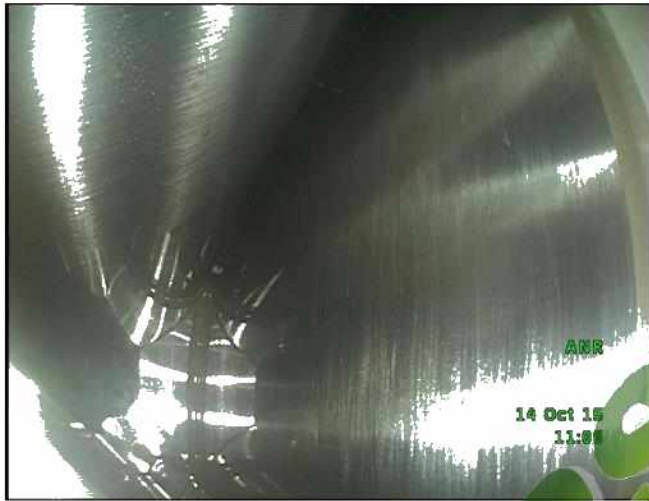
Picture 9 shows bearing position no. 9, the bearing of the intermediate shaft at generator side. The bearing shows no irregularities.

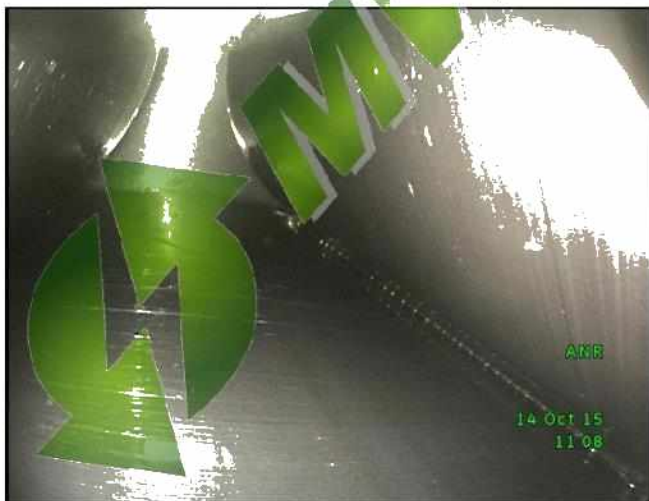
Picture 10 shows bearing position no. 10, the bearing of the high speed shaft at rotor side. The bearing shows no irregularities.

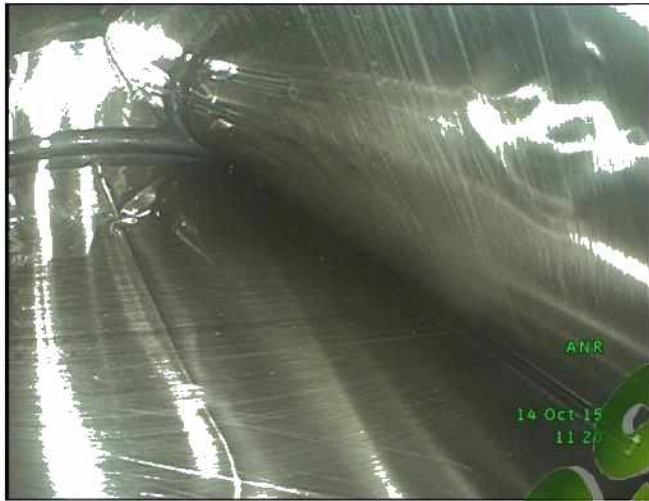
Picture 11 shows bearing position no. 11, the bearing of the high speed shaft at generator side. The bearing shows no irregularities.

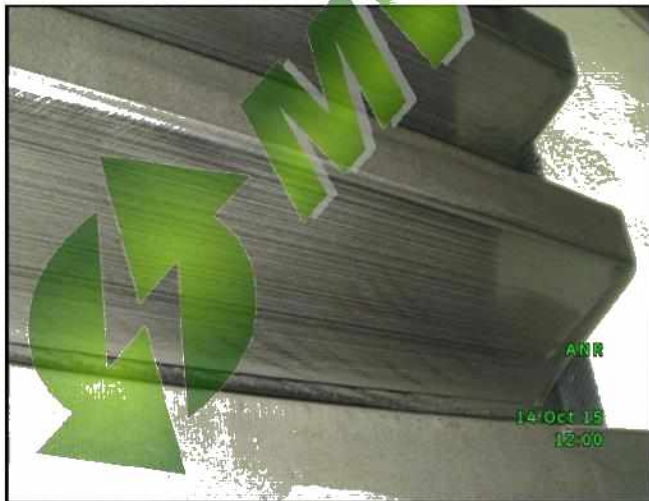
Picture 12 shows the active flank of the ring gear. No irregularities.

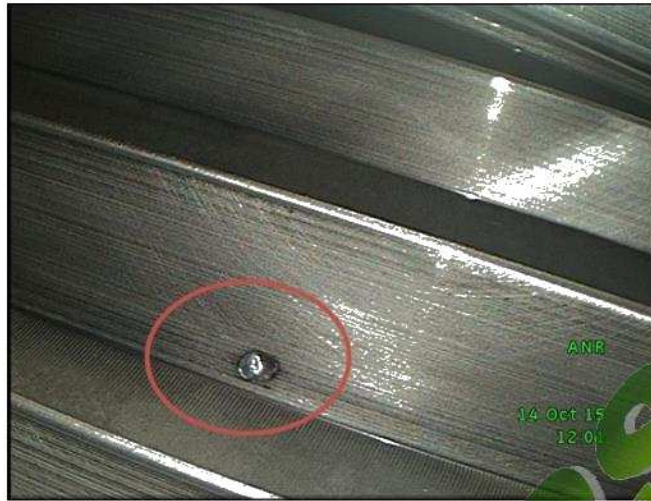
Picture 13 shows the active flank of the ring gear again. Small indentation visible at one of the flanks.

The active flank of the ring gear shows a small indentation at one of the flanks.

The small irregularities in the planetary stage and the small scratches at the pinion of the high speed shaft were probably generated before the gearbox was revised in 2014. It is likely that the gears have been reused. There is no reason to assume that an active defect is present at this moment. The clean magnet supports this conclusion.

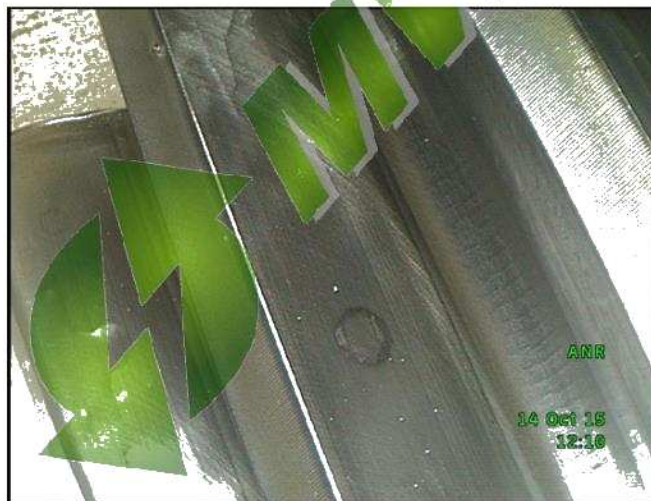
Picture 14 shows one of the planet wheels. One planet wheel shows an irregularity at the flank.

One of the planet wheels shows an irregularity at the flank.

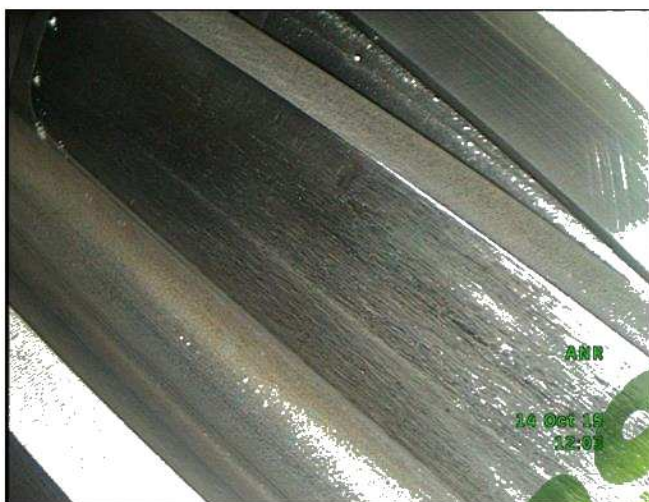
Picture 15 shows the active flanks of the sun pinion. No irregularities.

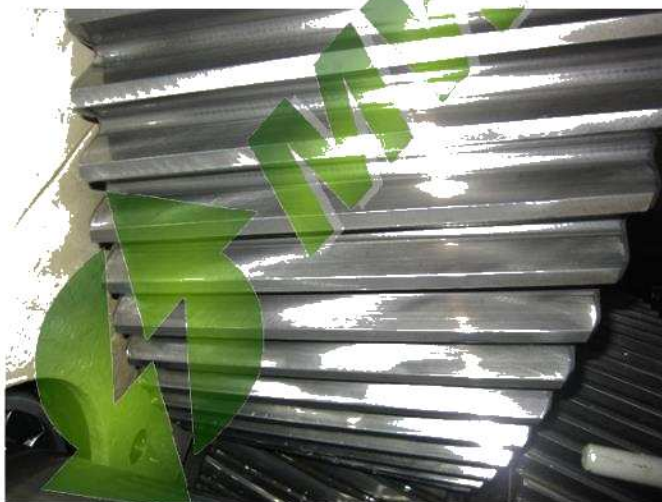
Picture 16 shows the active flanks of the wheel of the low speed shaft in the linear stage. No irregularities.

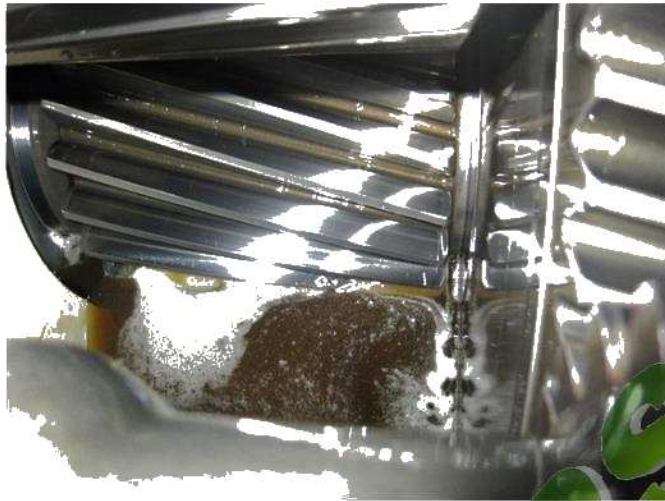
Picture 17 shows the active flanks of the pinion of the intermediate shaft in the linear stage. No irregularities.

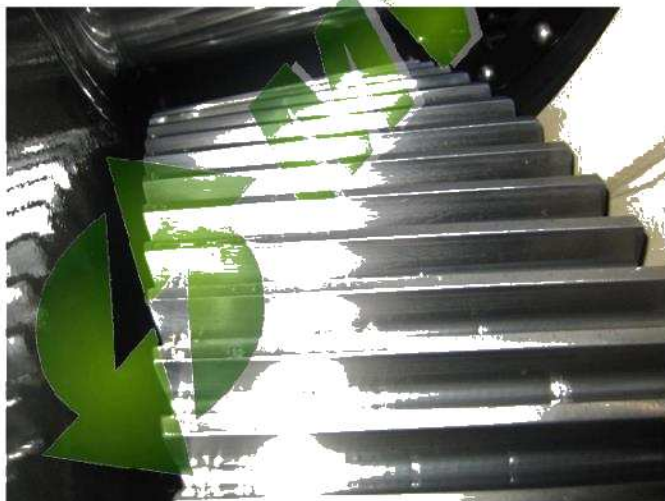
Picture 18 shows the active flanks of the wheel of the intermediate shaft in the linear stage. No irregularities.

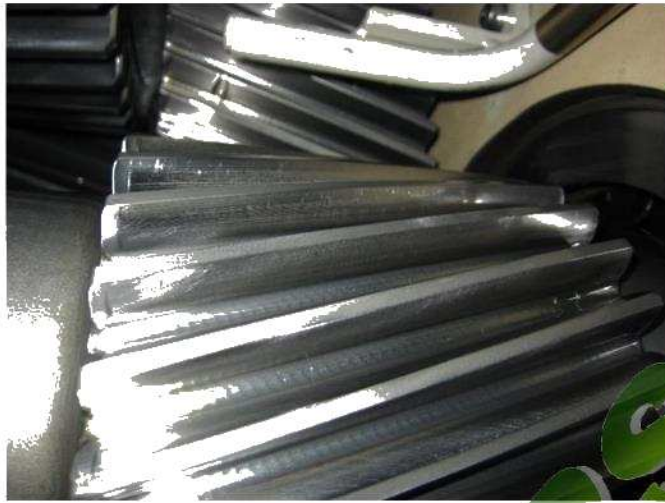
Picture 19 shows the active flanks of the pinion of the high speed shaft in the linear stage. Small scratches visible on the flanks of the pinion.

The active flanks of the pinion of the high speed shaft in the linear stage show small scratches on the pinion.

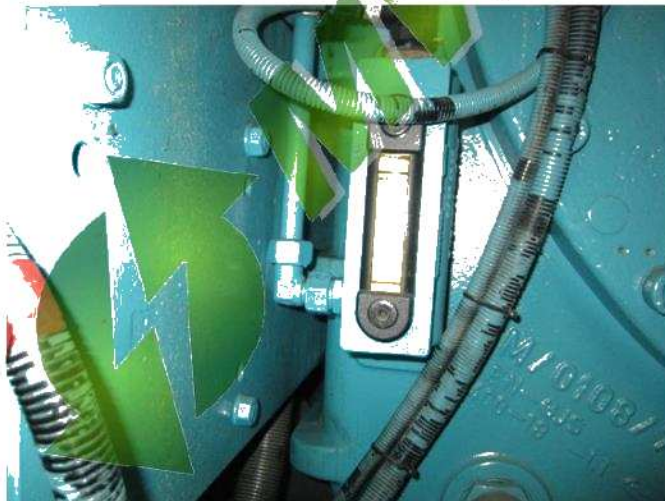
Picture 20 shows the oil level of the gearbox.

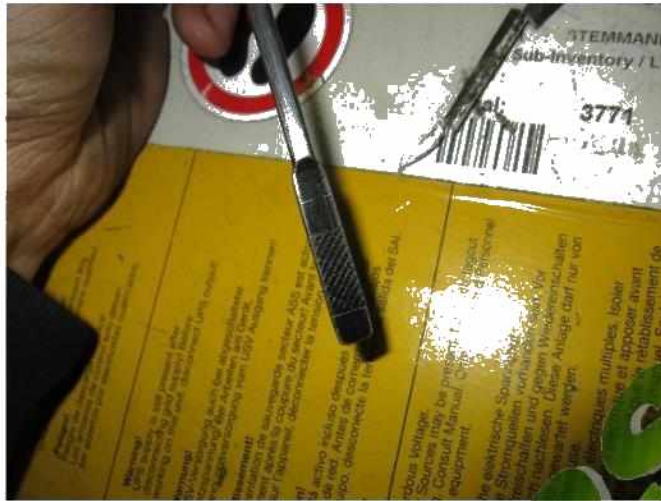
Picture 21 shows the oil dip stick of the gear box. The dip stick is dry.

The oil dip stick of the gearbox is dry.

The oil level is correct according to the glass, but the dip stick is dry. It is recommended to fill up the gearbox.

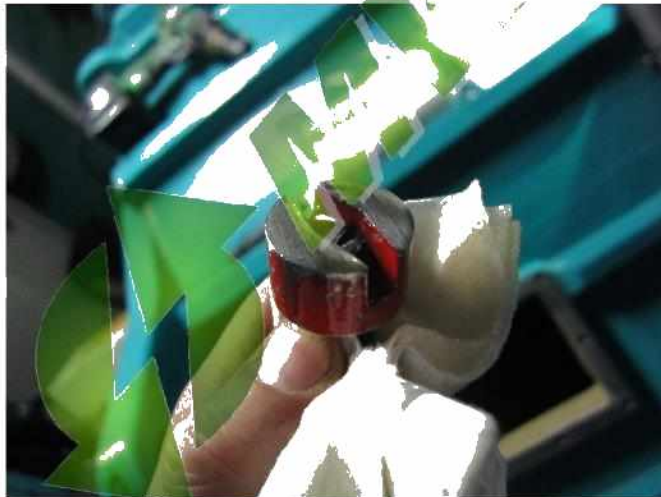
Picture 22

The inside and bottom of the gearbox have been searched with a magnet. The magnet shows no steel particles.

No steel particles were found in the gearbox.
