REPORT TURBINE INSPECTION
SN 15401267, WINDPARK SLUFTER WEST 1

Report No. GE15002015001

REPORT GEARBOX INSPECTION

Report no. GE15002015011

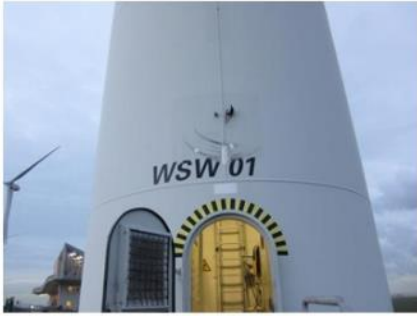
Item	Remark		
1	Tower outside	<p>Light at the outside is broken and has damaged the paint of the tower.</p>

Low</p>
2	Controller overview

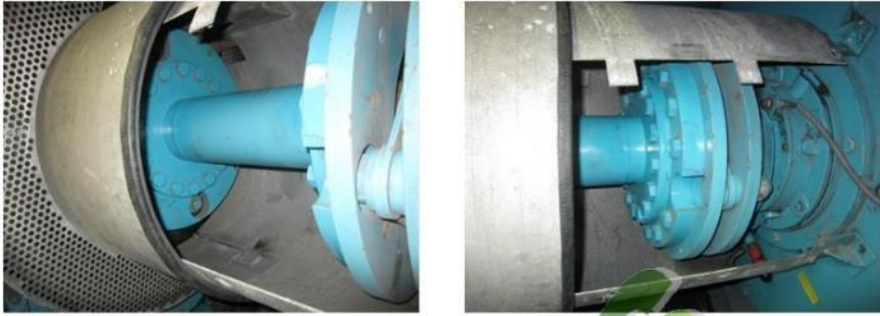
Item	Remark	
1	Coupling	<p>The coupling shows no irregularities.</p>

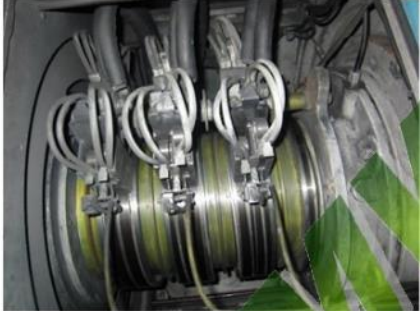
Info
2	Paint / Corrosion		ok
3	Slip ring	<p>The slip ring shows no visual irregularities.</p>

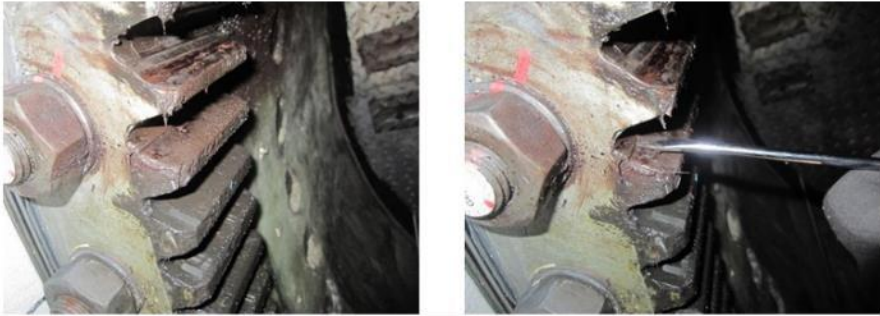
11	Pitch teeth at zero of blade 3	The tooth at zero shows wear.

High
12	Grease system pitch teeth	There is an automatic grease system present in the hub. The system is not operational.

The wear of the zero-tooth of the pitch ring is serious, but it is possible to solve this problem by assigning another tooth to be the zero-tooth. Dismounting and remounting of the blades is necessary to achieve this. The same thing can be done with the pinions, although replacing the pitch gears (with the pinions) is also an option.

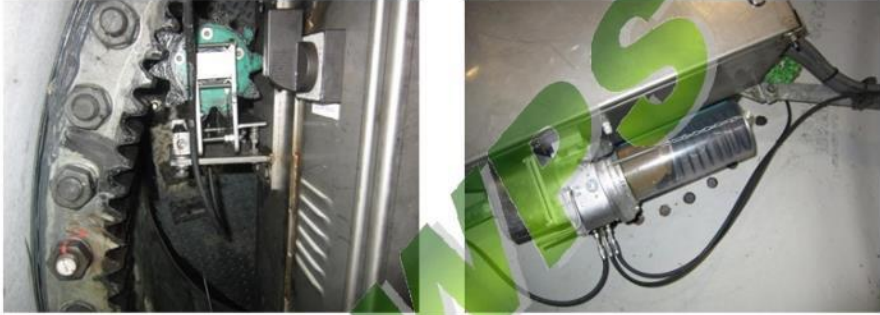
High
13	Pitch gears			ok
14	Miscellaneous			ok

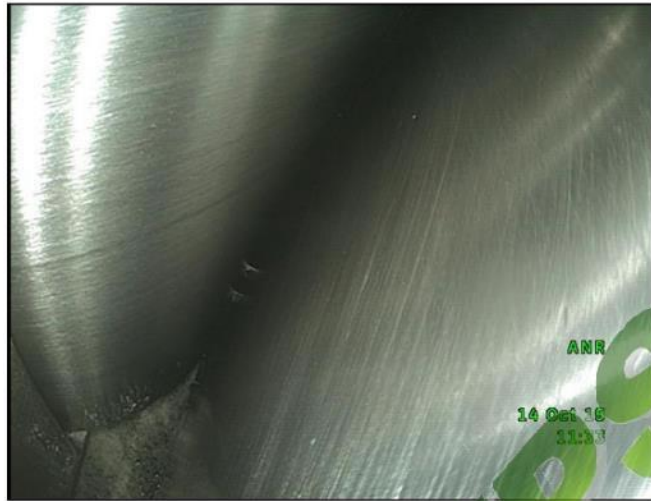
Picture 1 shows bearing position no. 1, the bearing of the planet carrier at rotor side. No irregularities.

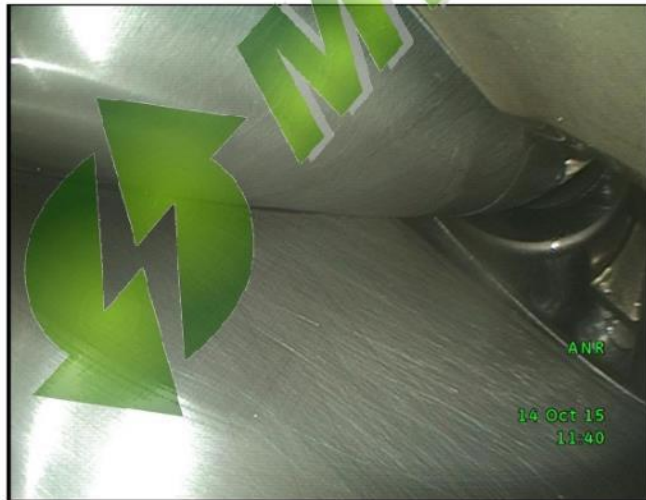
Picture 2 shows the bearing of the first planet wheel. No irregularities.

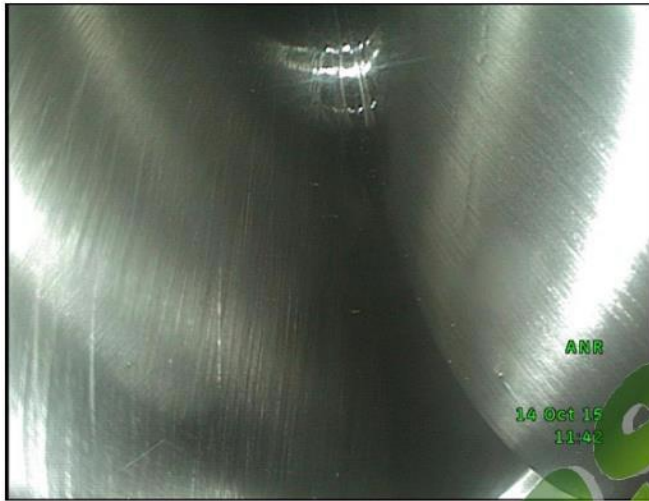
Picture 3 shows the bearing of the second planet wheel. No irregularities.

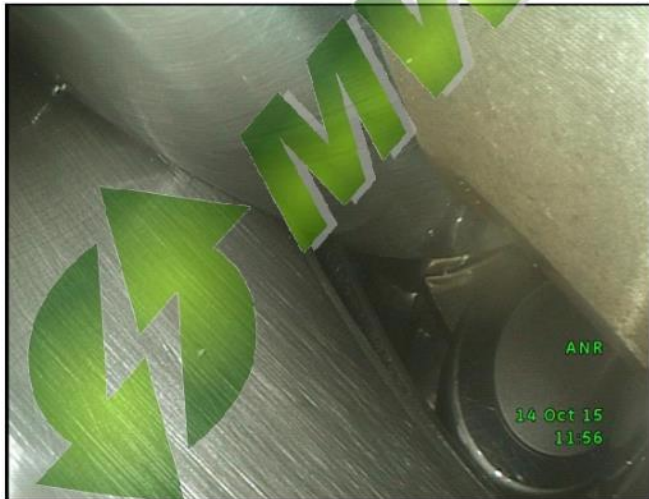
Picture 4 shows the bearing of the third planet wheel. No irregularities.

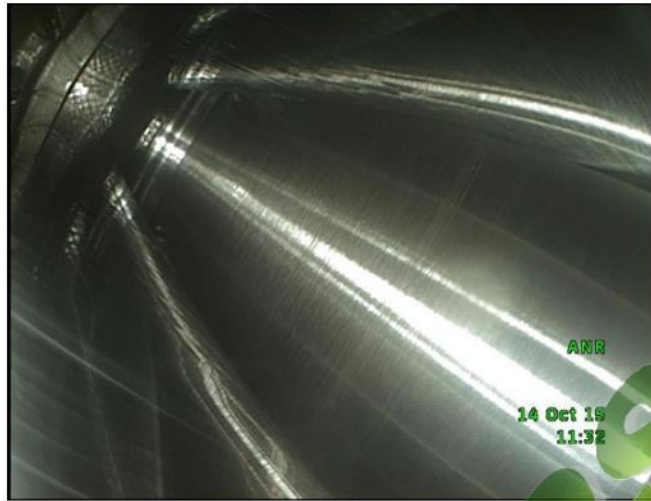
Picture 5 shows bearing position no. 5, the bearing of the planet carrier at generator side. The bearing shows no irregularities.

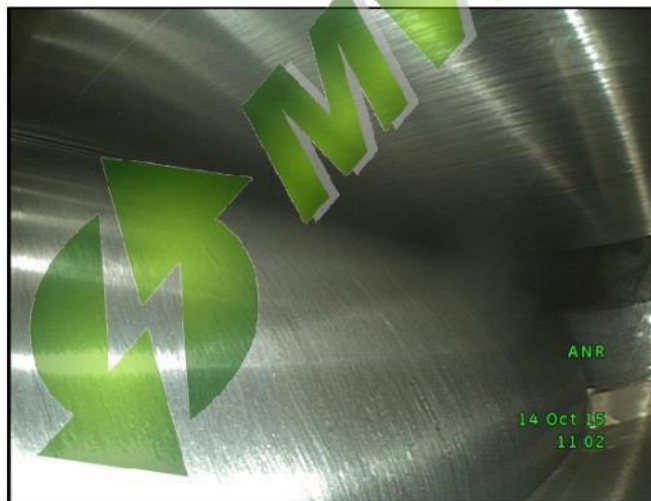
Picture 6 shows bearing position no. 6, the bearing of the low speed shaft at rotor side. The bearing shows no irregularities.

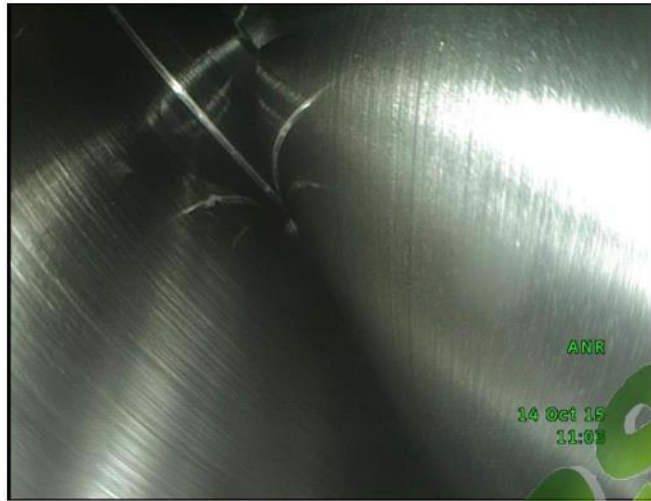
Picture 7 shows bearing position no. 7, the bearing of the low speed shaft at generator side. The bearing shows no irregularities.

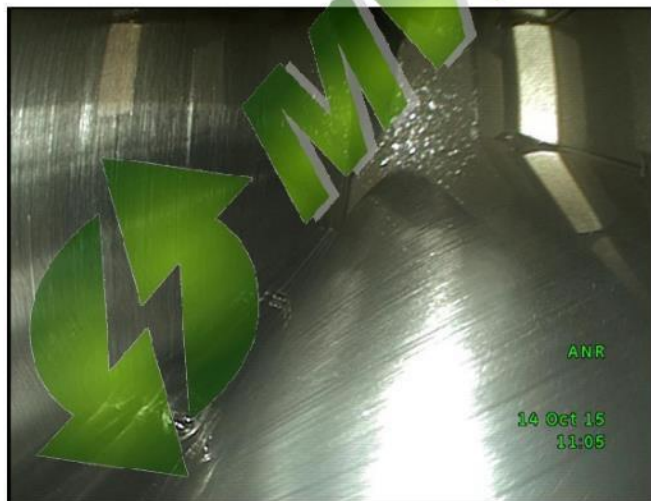
Picture 8 shows bearing position no. 8, the bearing of the intermediate shaft at rotor side. The bearing shows no irregularities.

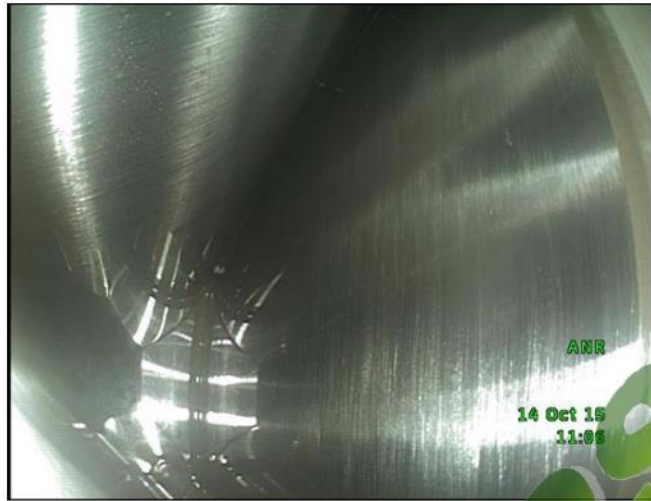
Picture 9 shows bearing position no. 9, the bearing of the intermediate shaft at generator side. The bearing shows no irregularities.

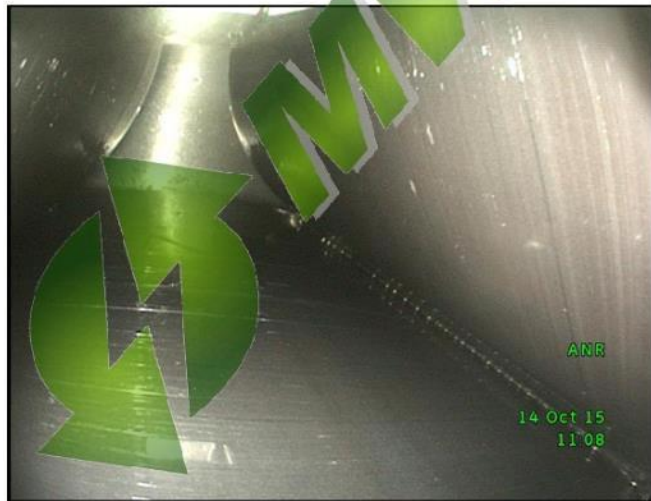
Picture 10 shows bearing position no. 10, the bearing of the high speed shaft at rotor side. The bearing shows no irregularities.

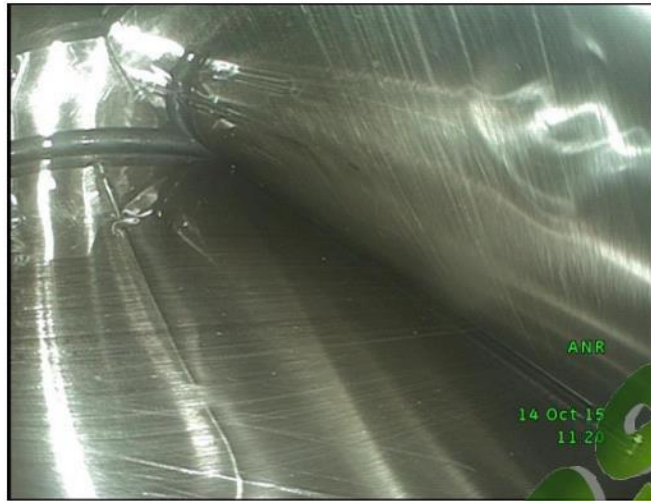
Picture 11 shows bearing position no. 11, the bearing of the high speed shaft at generator side. The bearing shows no irregularities.

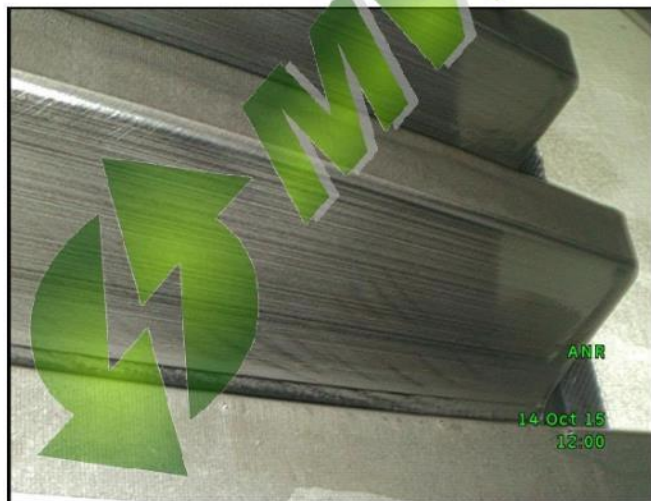
Picture 12 shows the active flank of the ring gear. No irregularities.

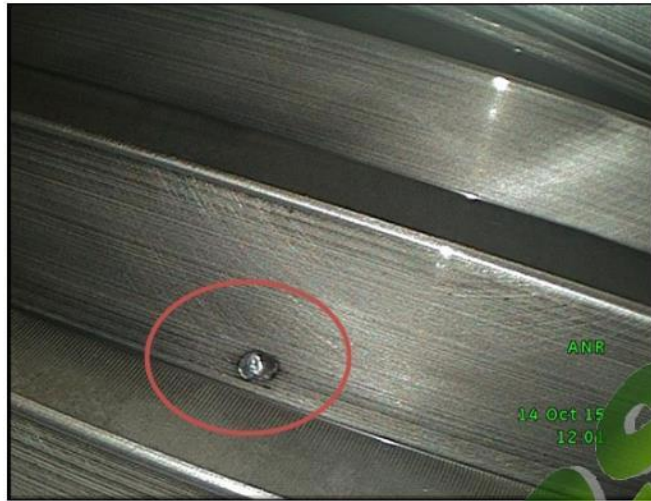
Picture 13 shows the active flank of the ring gear again. Small indentation visible at one of the flanks.

The active flank of the ring gear shows a small indentation at one of the flanks.

The small irregularities in the planetary stage and the small scratches at the pinion of the high speed shaft were probably generated before the gearbox was revised in 2014. It is likely that the gears have been reused. There is no reason to assume that an active defect is present at this moment. The clean magnet supports this conclusion.

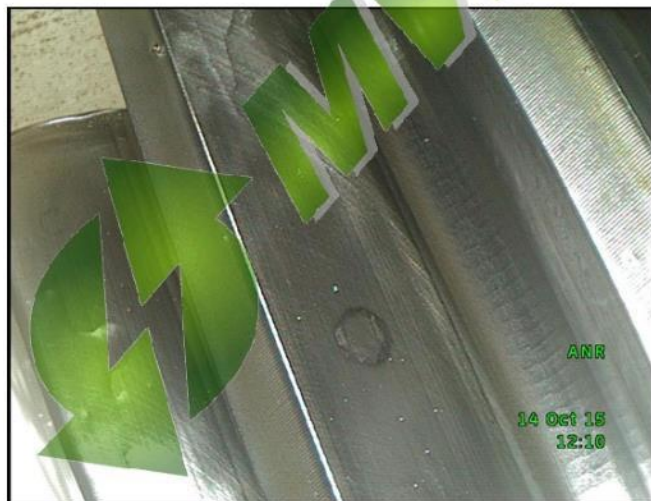
Picture 14 shows one of the planet wheels. One planet wheel shows an irregularity at the flank.

One of the planet wheels shows an irregularity at the flank.

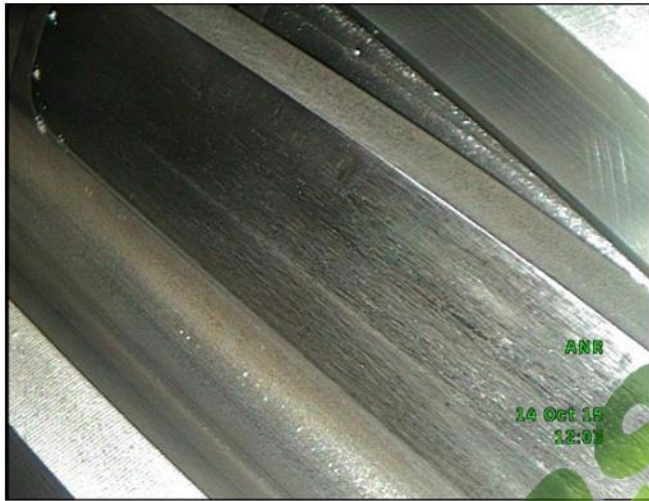
Picture 15 shows the active flanks of the sun pinion. No irregularities.

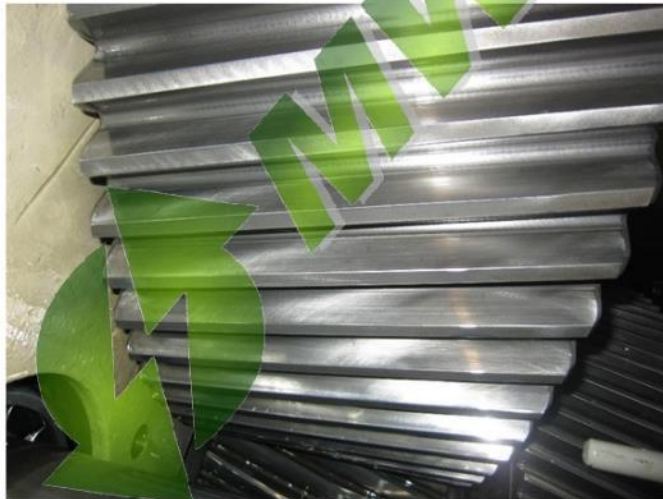
Picture 16 shows the active flanks of the wheel of the low speed shaft in the linear stage. No irregularities.

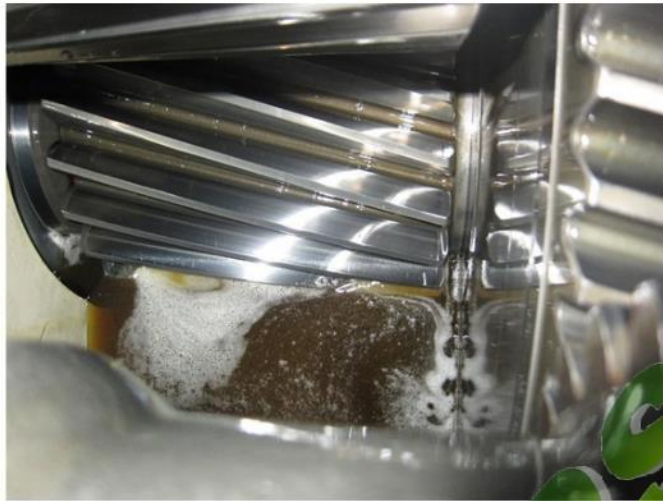
Picture 17 shows the active flanks of the pinion of the intermediate shaft in the linear stage. No irregularities.

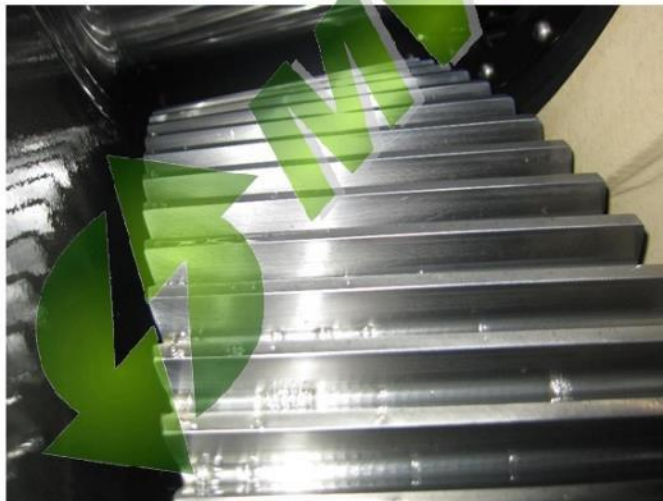
Picture 18 shows the active flanks of the wheel of the intermediate shaft in the linear stage. No irregularities.

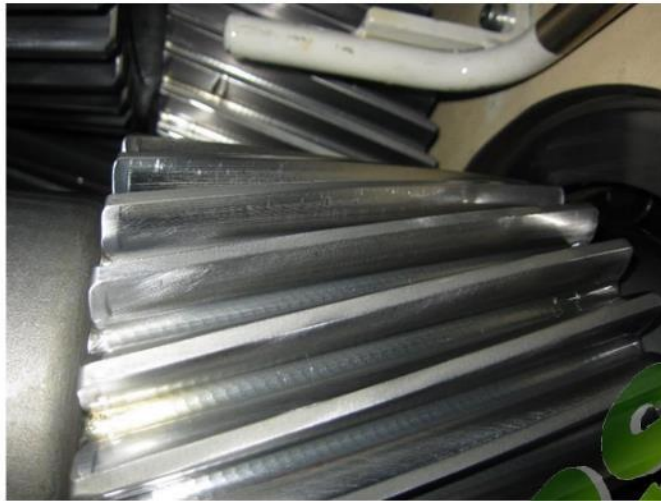
Picture 19 shows the active flanks of the pinion of the high speed shaft in the linear stage. Small scratches visible on the flanks of the pinion.

The active flanks of the pinion of the high speed shaft in the linear stage show small scratches on the pinion.

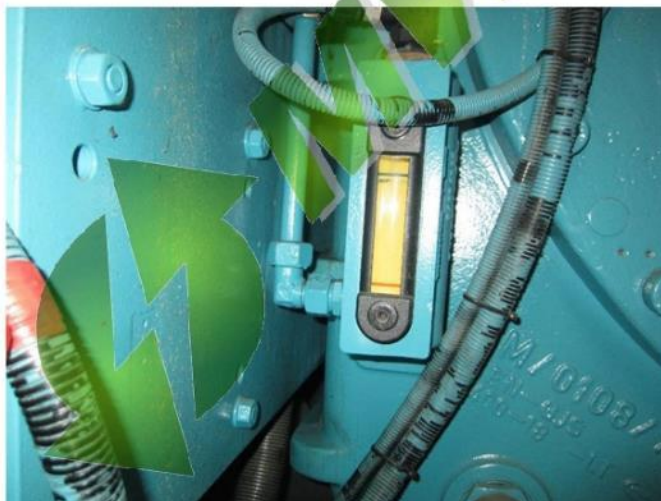
Picture 20 shows the oil level of the gearbox.

The oil level is correct according to the glass, but the dip stick is dry. It is recommended to fill up the gearbox.

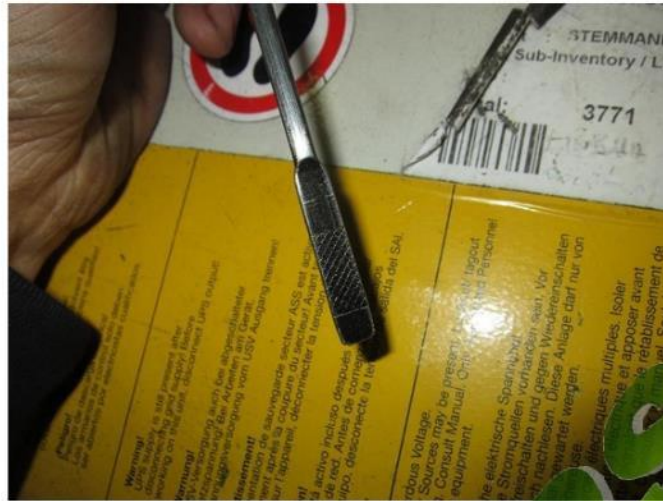
Picture 21 shows the oil dip stick of the gear box. The dip stick is dry.

The oil dip stick of the gearbox is dry.

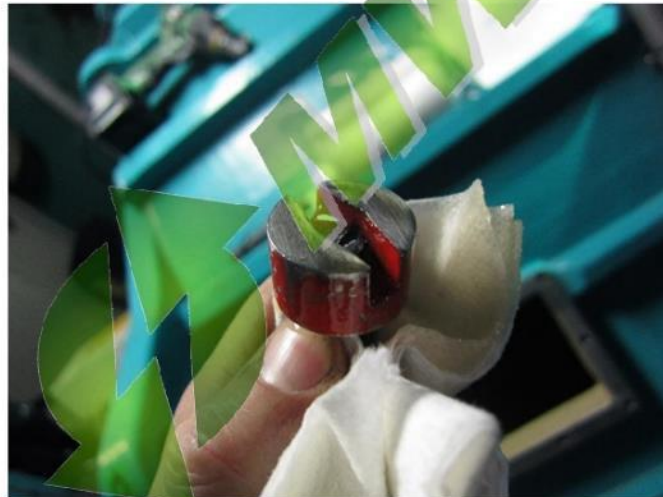
Picture 22

The inside and bottom of the gearbox have been searched with a magnet. The magnet shows no steel particles.

No steel particles were found in the gearbox.
