REPORT TURBINE INSPECTION
SN 15401268, WINDPARK SLUFTER WEST 2

Report No. GE15002015002

REPORT GEARBOX INSPECTION
SN 15401268, WINDPARK SLUFTER WEST 2

Report no. GE15002015012

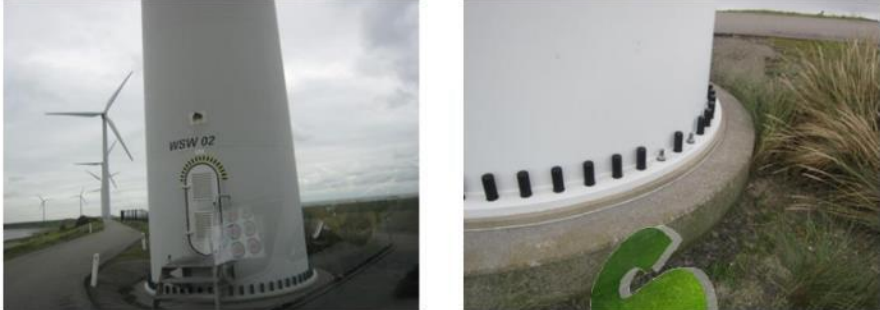
Item	Remark		
1	Tower outside Light at the outside is broken and has damaged the paint of the tower. Caps from a few bolts of the bottom flange are missing.

Low </div>
2	Controller overview

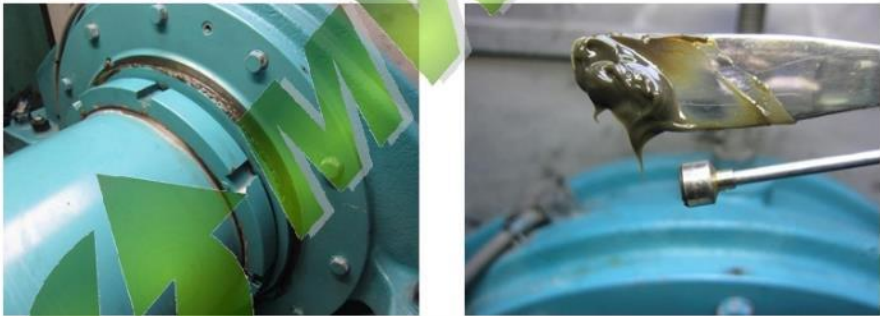
Item	Remark	
1	Main shaft bearings	Grease of the main bearing is not magnetic.

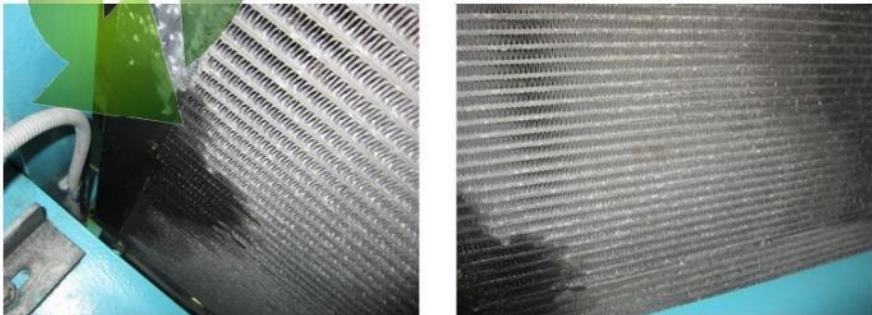
ok
2	Radiators	Leakage at the radiator.

<div style="color: red; font-weight: bold;">nok</div> High
3	CCJ-unit	No CCJ-filter present in the turbine.	Info

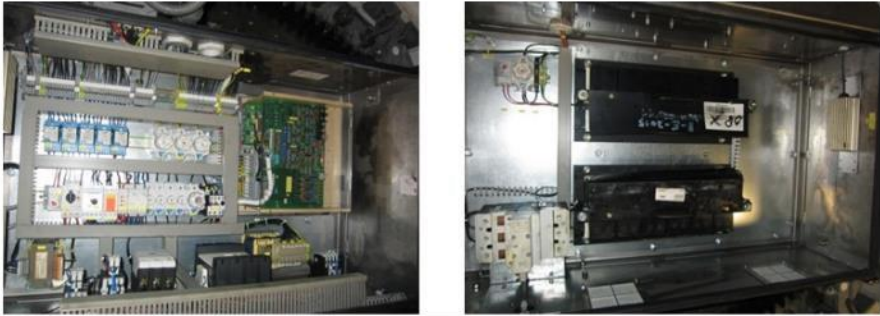
5	Boxes blade 2	<p>Control box and battery box show no irregularities.</p>

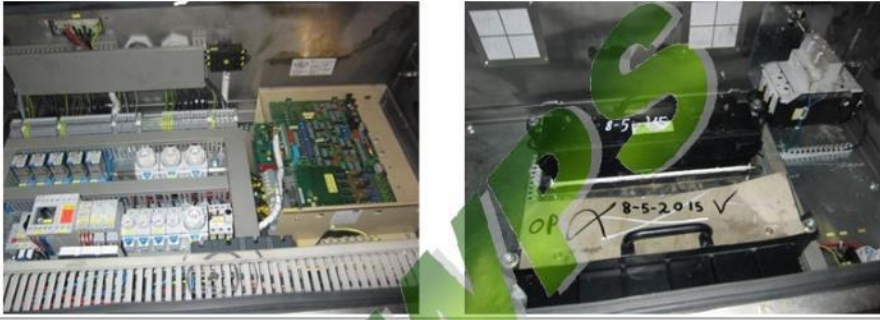
ok
6	Boxes blade 3	<p>Control box and battery box show no irregularities.</p>

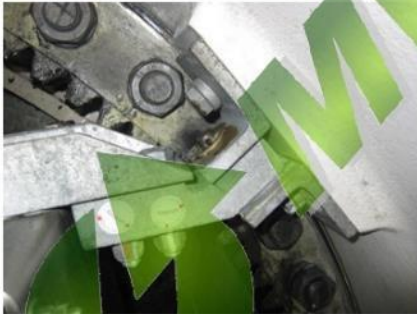
ok
7	Mounting of the electrical boxes	<p>The mounting of the boxes shows no irregularities.</p>

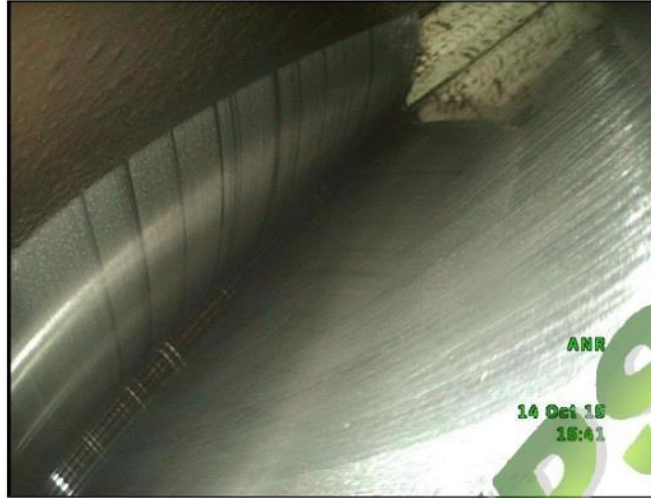
Picture 1 shows bearing position no. 1, the bearing of the planet carrier at rotor side. No irregularities.

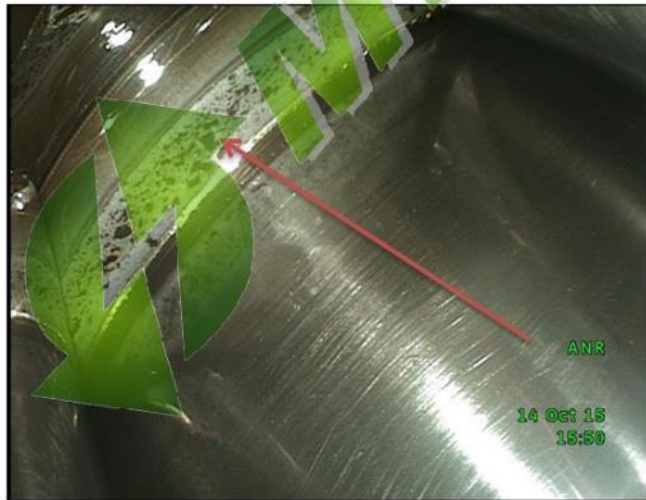
Picture 2 shows the bearing of the first planet wheel. Surface of the inner guide ring is roughened.

The surface of the inner guide ring of the bearing of the first planet wheel is roughened.

The irregularities at the planet bearing and the high speed bearings are remarkable and it is recommended to keep monitoring these bearings closely in the future.

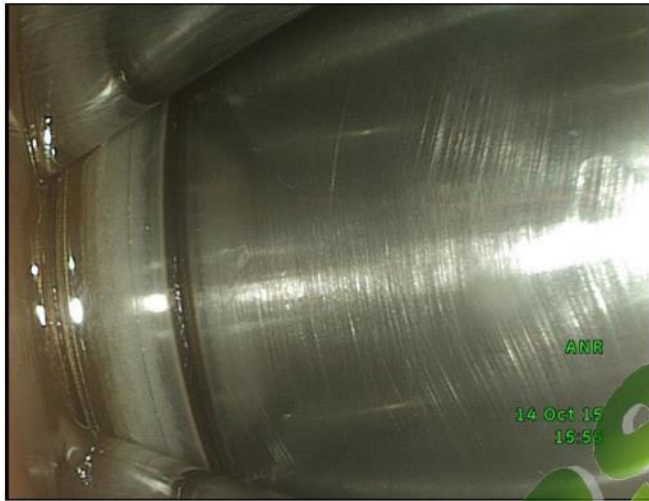
Picture 3 shows the bearing of the second planet wheel. No irregularities.

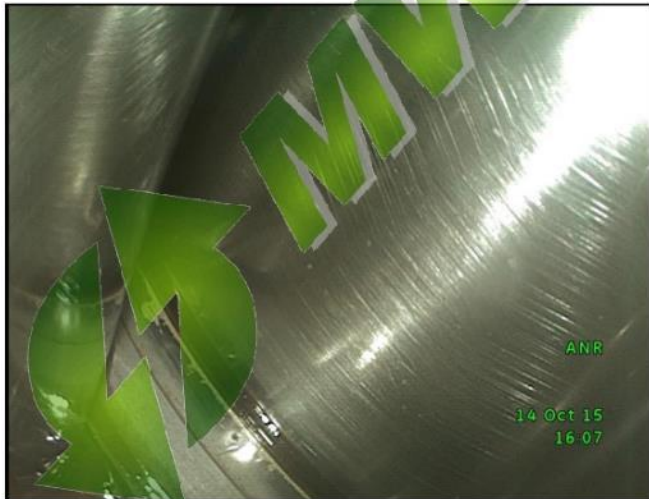
Picture 4 shows the bearing of the third planet wheel. No irregularities.

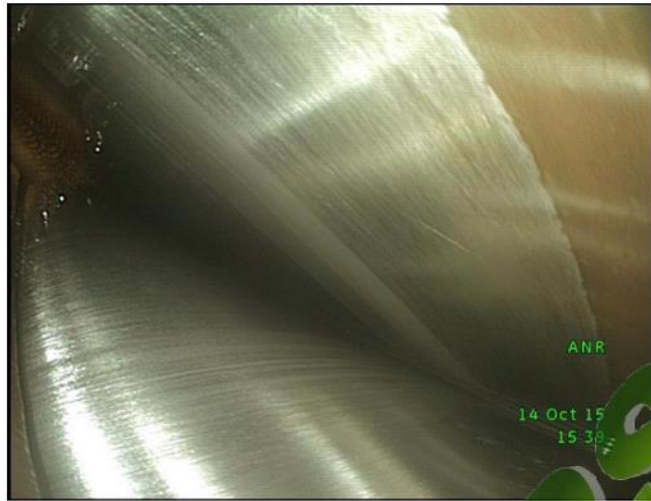
Picture 5 shows bearing position no. 5, the bearing of the planet carrier at generator side. The bearing shows no irregularities.

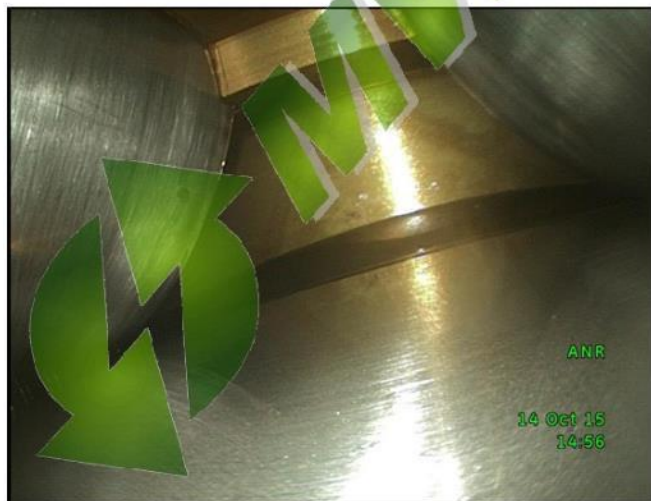
Picture 6 shows bearing position no. 6, the bearing of the low speed shaft at rotor side. The bearing shows no irregularities.

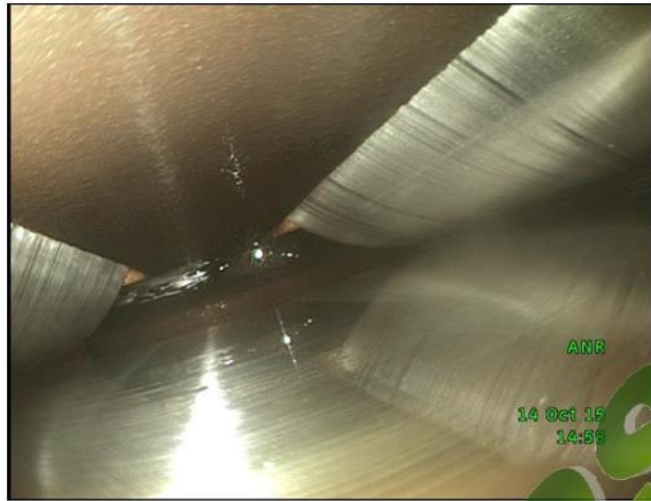
Picture 7 shows bearing position no. 7, the bearing of the low speed shaft at generator side. The bearing shows no irregularities.

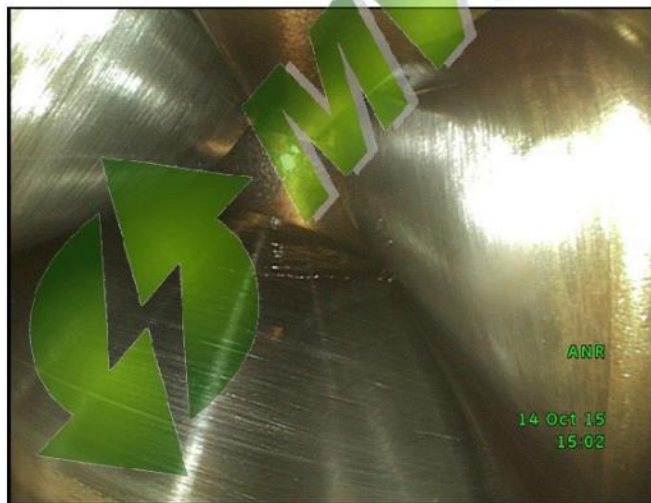
Picture 8 shows bearing position no. 8, the bearing of the intermediate shaft at rotor side. The bearing shows no irregularities.

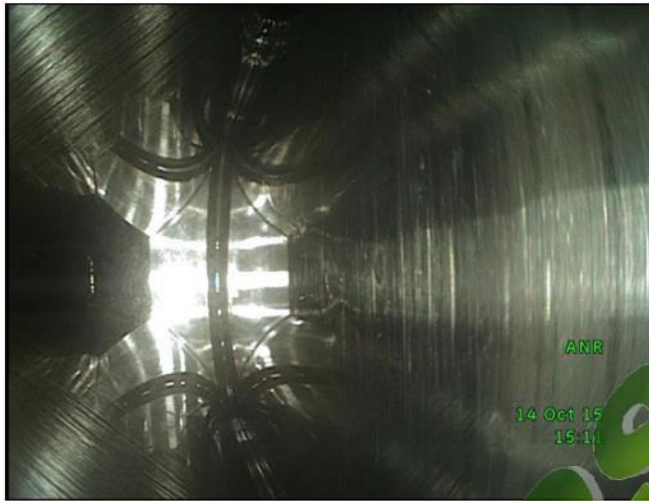
Picture 9 shows bearing position no. 9, the bearing of the intermediate shaft at generator side. The bearing shows no irregularities.

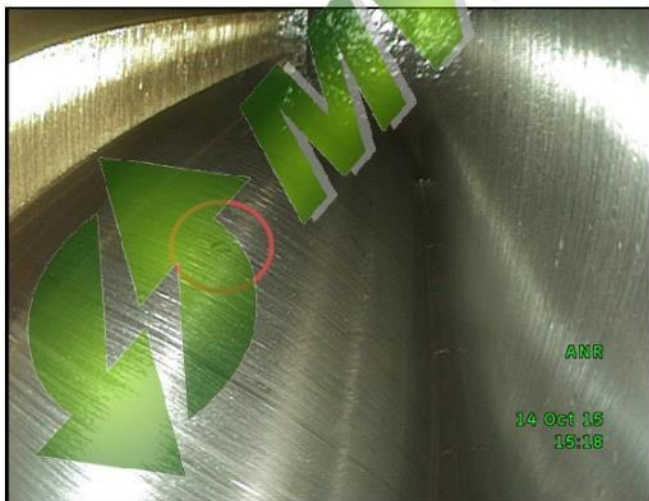
Picture 10 shows bearing position no. 10, the bearing of the high speed shaft at rotor side. Small indentation visible at the rolling element.

The bearing of the high speed shaft at rotor side shows small indentation at the rolling element.

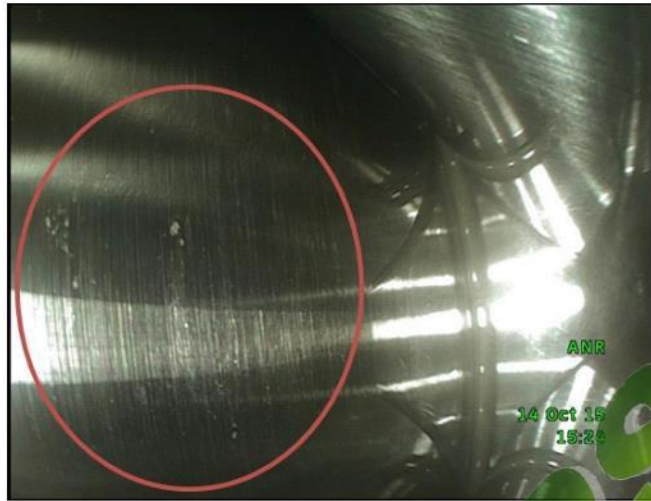
Picture 11 shows bearing position no. 11, the bearing of the high speed shaft at generator side. Several indentations visible at the raceway.

The bearing of the high speed shaft at generator side shows several indentations and a roughened surface at the raceway.

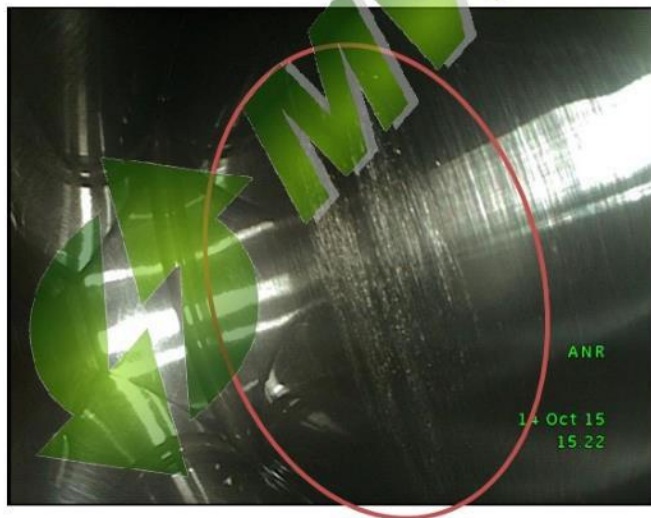
Picture 12 shows bearing position no. 11 again, the bearing of the high speed shaft at generator side. The bearing shows an area on the raceway where the surface is roughened.

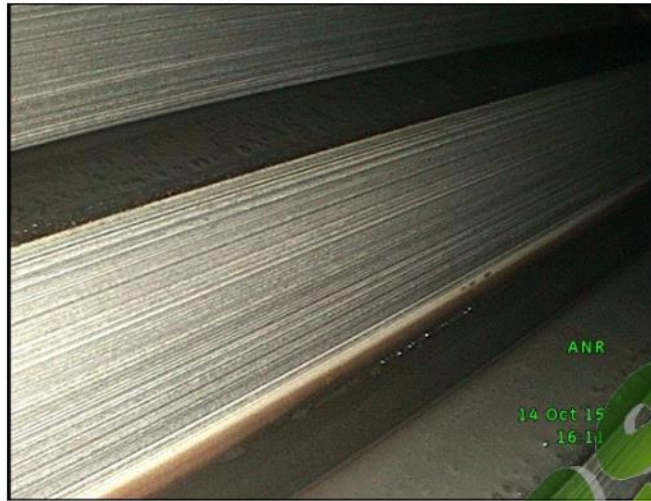
Picture 13 shows the active flank of the ring gear. No irregularities.

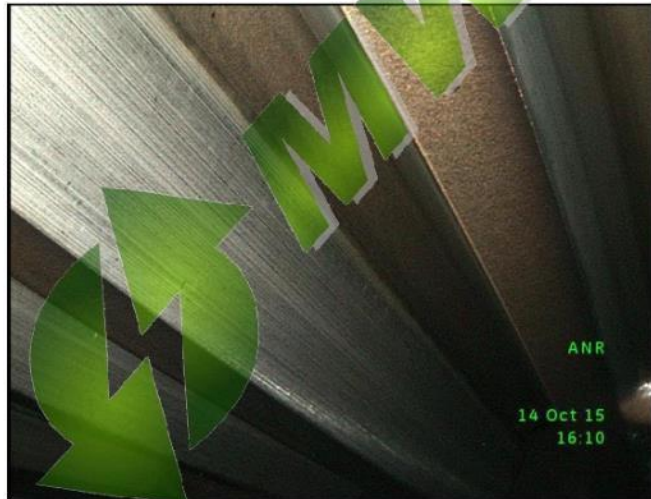
Picture 14 shows one of the planet wheels. None of the planet wheels show irregularities.

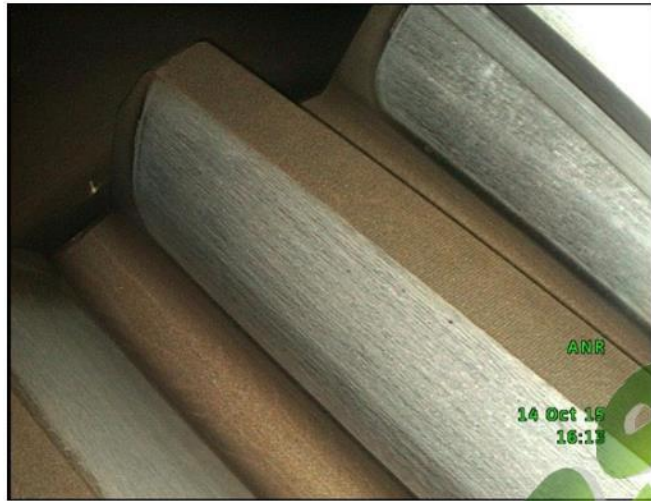
Picture 15 shows the active flanks of the sun pinion. No irregularities.

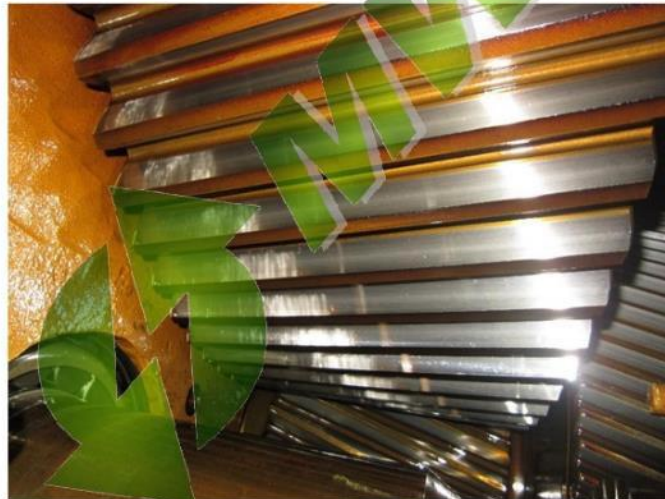
Picture 16 shows the active flanks of the wheel of the low speed shaft in the linear stage. No irregularities.

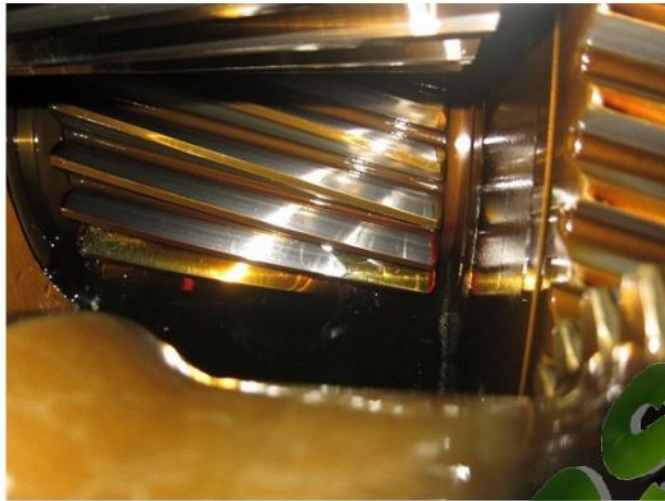
Picture 17 shows the active flanks of the pinion of the intermediate shaft in the linear stage. No irregularities.

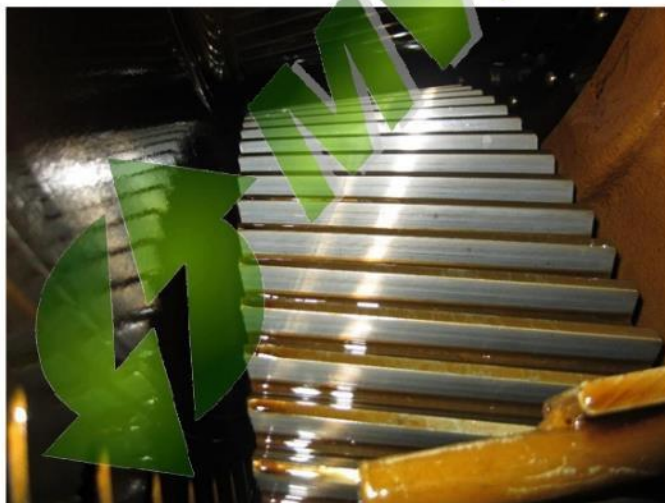
Picture 18 shows the active flanks of the wheel of the intermediate shaft in the linear stage. No irregularities.

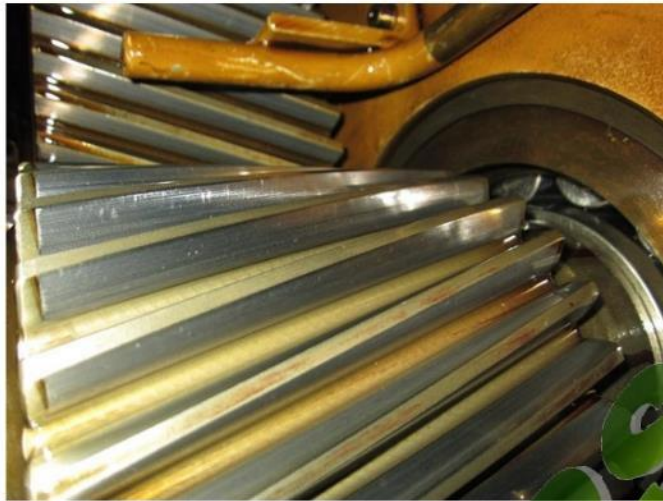
Picture 19 shows the active flanks of the pinion of the high speed shaft in the linear stage. No irregularities.

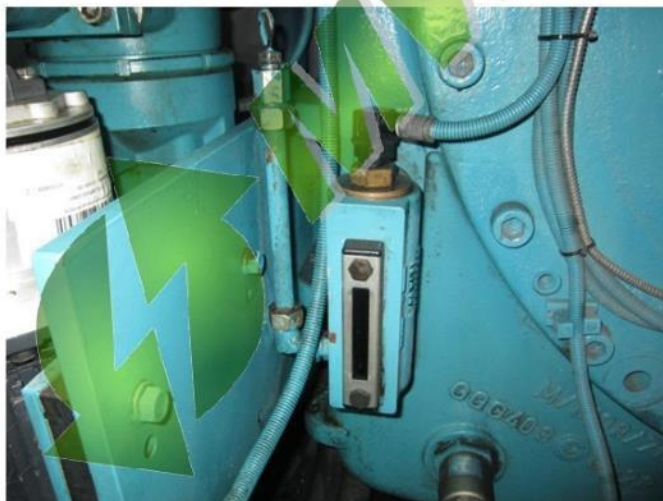
Picture 20 shows the oil level of the gearbox.

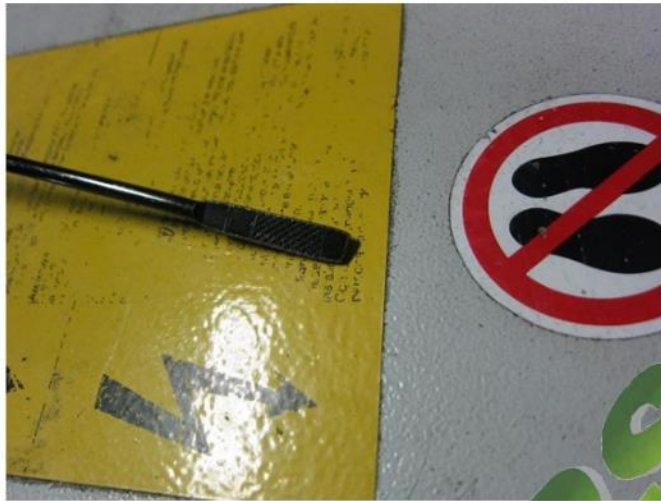
Picture 21 shows the oil dip stick of the gear box. The dip stick is dry.

The oil dip stick of the gearbox is dry.

The oil level is correct according to the glass, but the dip stick is dry. It is recommended to fill up the gearbox.

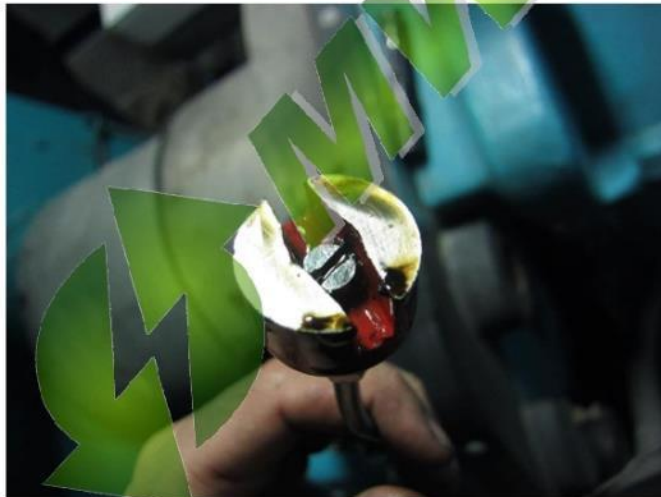
Picture 22

The inside and bottom of the gearbox have been searched with a magnet. The magnet shows no steel particles.

No steel particles were found in the gearbox.
