REPORT TURBINE INSPECTION
SN 15401269, WINDPARK SLUFTER WEST 3

Report No. GE15002015003

REPORT GEARBOX INSPECTION
SN 15401269, WINDPARK SLUFTER WEST 3

Report no. GE15002015013

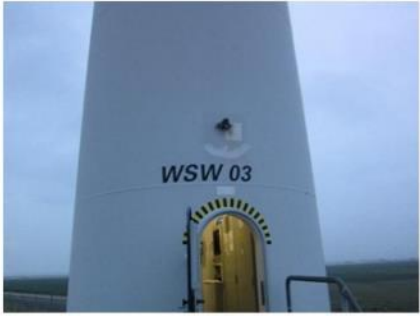
Item	Remark	
1 Tower outside	<p>Light at the outside is broken and has damaged the paint of the tower.</p>

<p>NOK Low</p>
2 Controller overview	<p>Part of the main switch is covered with duct-tape (2nd picture).</p>

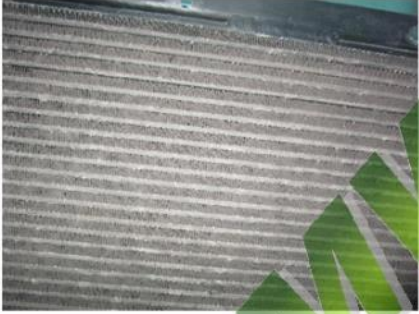
Item	Remark	
1	Main shaft bearings	<p>Grease of the main bearing is not magnetic.</p>  	ok
2	Radiators	<p>The radiator is polluted with dust.</p>

<p>NO Low</p>
3	CCJ-unit	<p>A CCJ-filter is present in the turbine.</p>

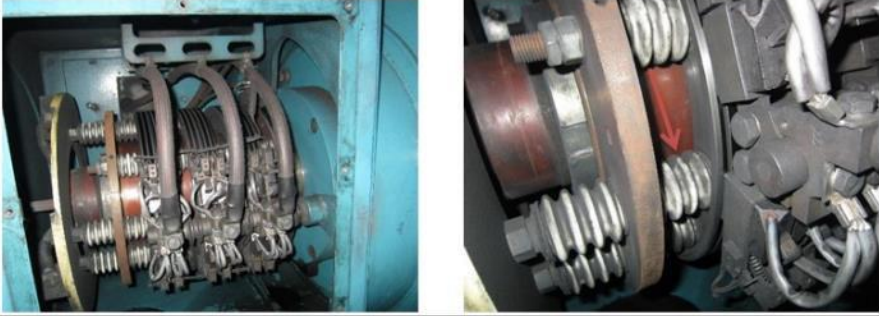
3	Slip ring	<p>The insulating parts between the phases are covered with black carbon dust.</p>

<p>nok High</p>
---	-----------	-----------------------------------------------------------------------------------------------------------------------------------------------------------------------	----------------------------

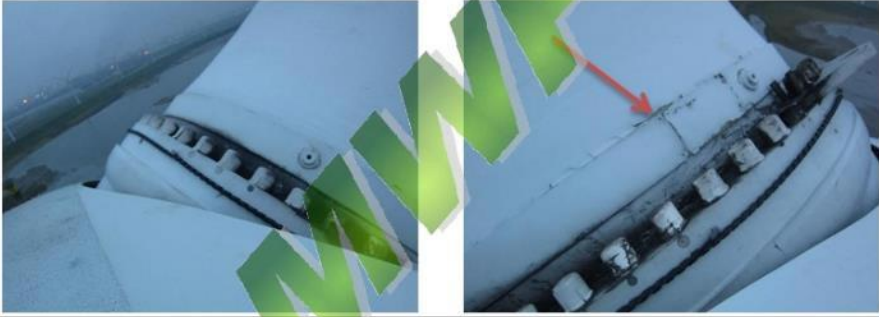
Item	Remark	
1	<p>Blade bearing Several caps of the nuts of the bearing are worn. Cracks visible at the paint at the root of the blade (2nd picture).</p>

<p>nok High</p>
2	<p>Overview inside In general, the hub is clean and there is no excessive corrosion present.</p>

The blades have been maintained recently, but there are some cracks visible at the paint at the root of one of the blades.

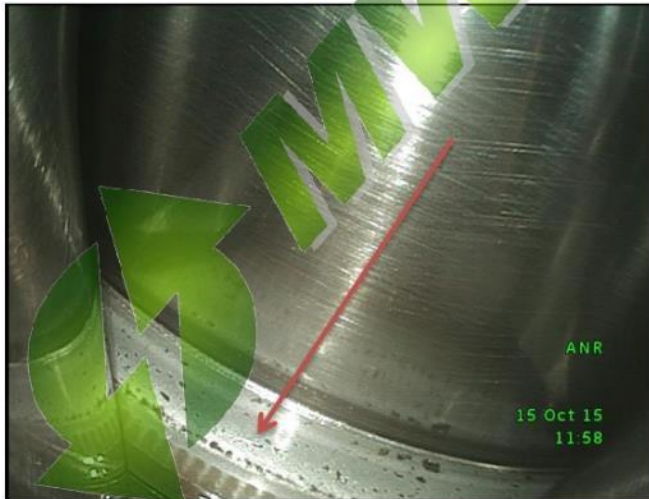
Picture 4 shows the bearing of the third planet wheel. Surface of the inner guide ring is roughened.

The surface of the inner guide ring of the bearing of the first planet wheel is roughened.

The irregularities at the planet bearing are remarkable and it is recommended to keep monitoring this bearing closely in the future.

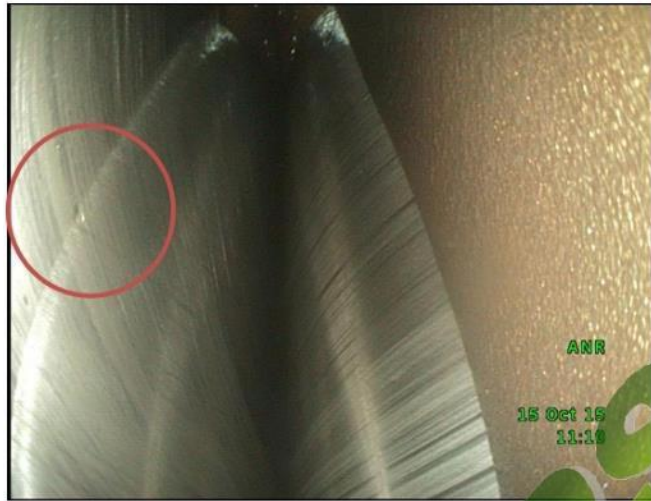
Picture 5 shows bearing position no. 5, the bearing of the planet carrier at generator side. Small indentation visible at the raceway.

The bearing of the planet carrier at generator side shows a small indentation at the raceway.

The small indentations on the other bearings have probably been caused by damaged high speed bearings in 2012.

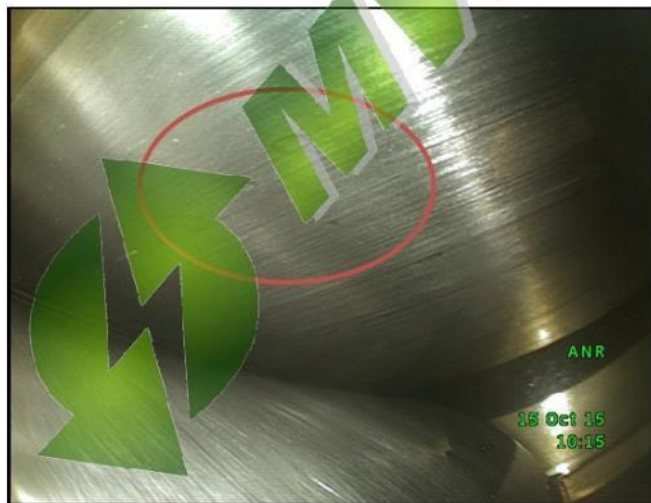
Picture 6 shows bearing position no. 6, the bearing of the low speed shaft at rotor side. Small indentations visible at the raceway.

The bearing of the low speed shaft at rotor side shows small indentations at the raceway.

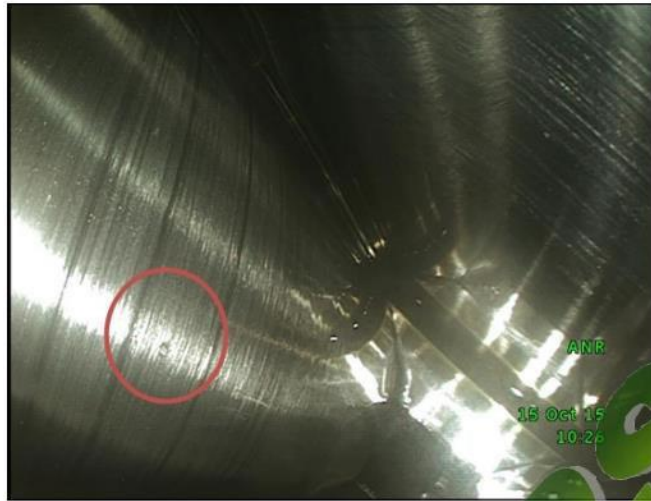
Picture 7 shows bearing position no. 7, the bearing of the low speed shaft at generator side. Small indentation visible at the raceway.

The bearing of the low speed shaft at generator side shows a small indentation at the raceway.

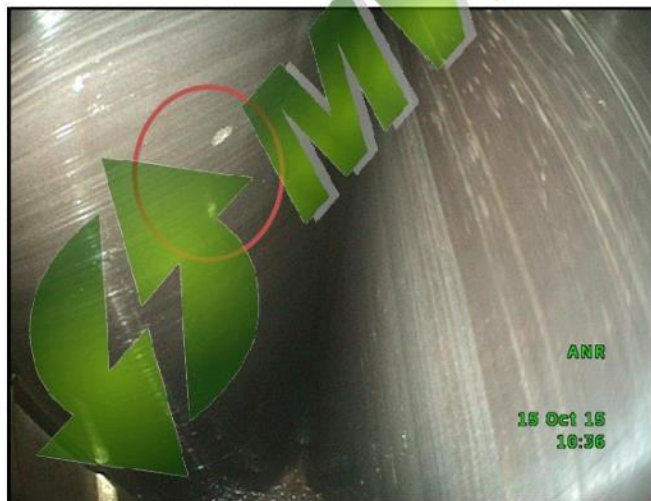
Picture 10 shows bearing position no. 10, the bearing of the high speed shaft at rotor side. Small indentations visible at the rolling element.

The bearing of the high speed shaft at rotor side shows small indentations at the rolling element.

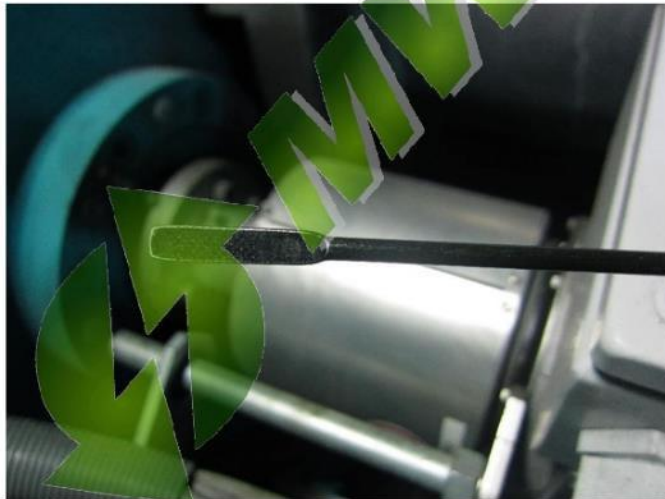
Picture 20 shows the oil dip stick of the gear box. The dip stick is dry.

The oil dip stick of the gearbox is dry.

The oil level is correct according to the glass, but the dip stick is dry. It is recommended to fill up the gearbox.

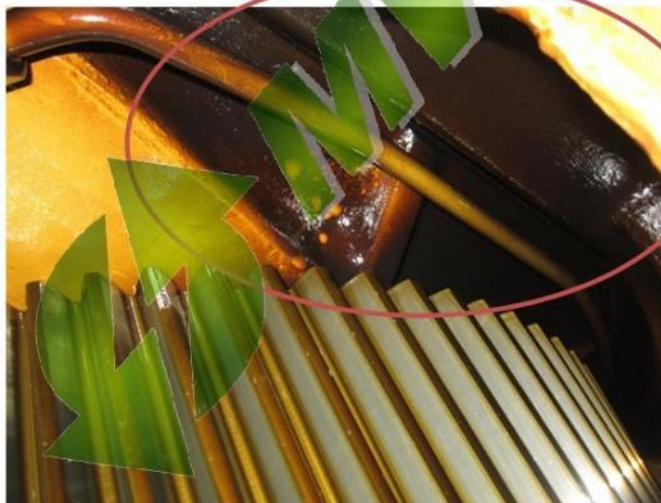
Picture 22

The inside of the gearbox is covered with black sludge.

The gear oil filter has been replaced quite often this year, which is probably caused by sludge in the gearbox.
