REPORT TURBINE INSPECTION
SN 15401270, WINDPARK SLUFTER WEST 4

Report No. GE15002015004

REPORT GEARBOX INSPECTION
SN 15401270, WINDPARK SLUFTER WEST 4

Report no. GE15002015014

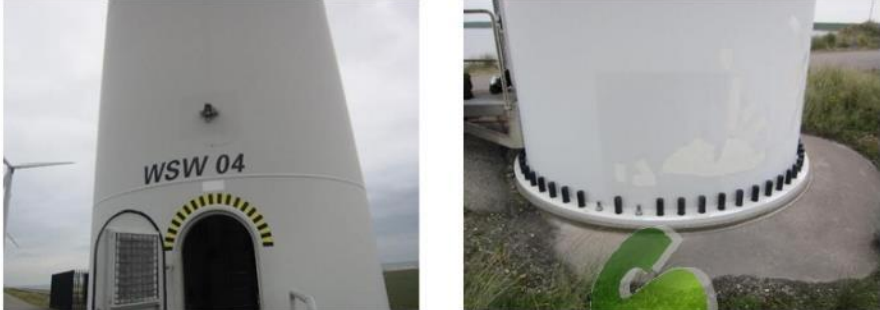
Item	Remark	
1	<p>Light at the outside is broken and has damaged the paint of the tower. Caps from a few bolts of the bottom flange are missing.</p>

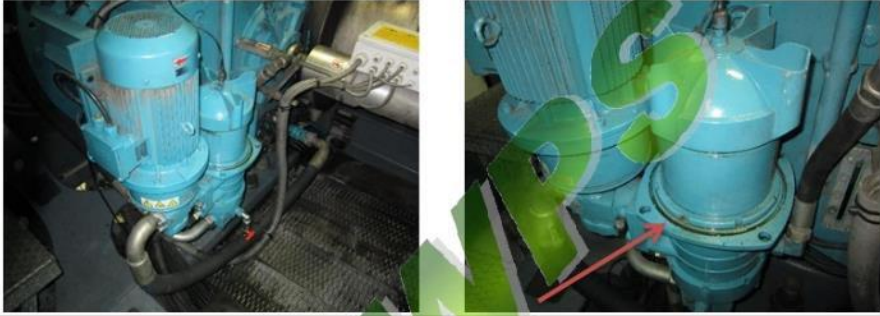
<i>Info</i>
3	CCJ-unit	No CCJ-filter present in the turbine.	<i>Info</i>
4	Gear oil system	Leakage present at the gear oil system.

noK <i>High</i>
5	Hoses and pipes		ok
6	Paint / Corrosion		ok
7	General leakage	A lot of pollution visible around the brake disk at the back of the gearbox.

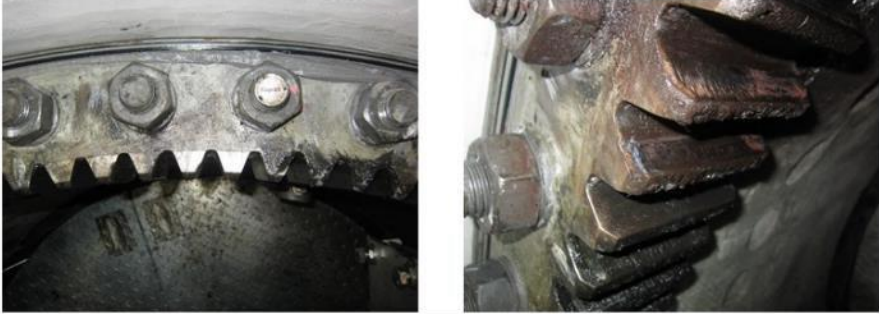
11	Pitch teeth at zero of blade 3	The tooth at zero shows wear.

High </div>
12	Grease system pitch teeth	There is an automatic grease system present in the hub. The system is not operational.

The wear of the zero-tooth of the pitch ring is serious, but it is possible to solve this problem by assigning another tooth to be the zero-tooth (this has already been done in 2008). Dismounting and remounting of the blade is necessary to achieve this. The wear of the pinions is quite severe, so it is probably necessary to replace them.

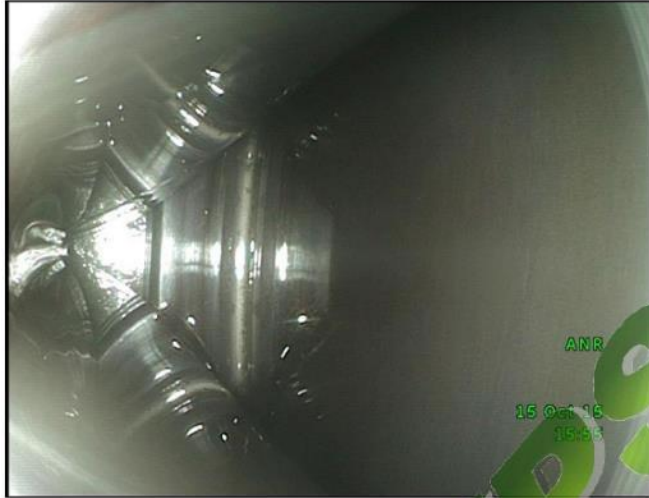
Picture 1 shows bearing position no. 1, the bearing of the planet carrier at rotor side. No irregularities.

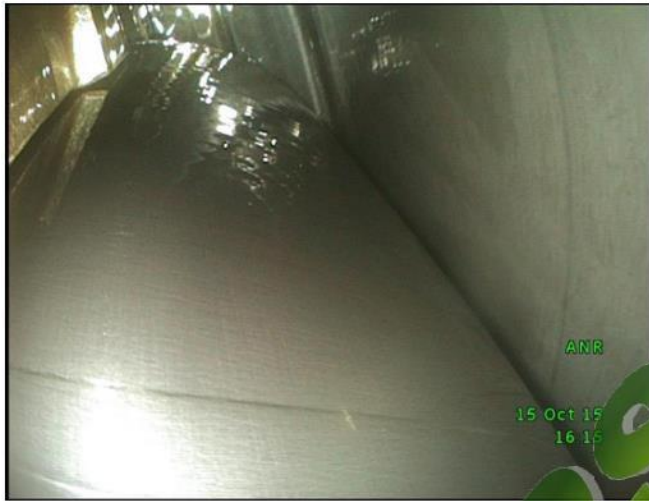
Picture 3 shows the bearing of the second planet wheel. No irregularities.

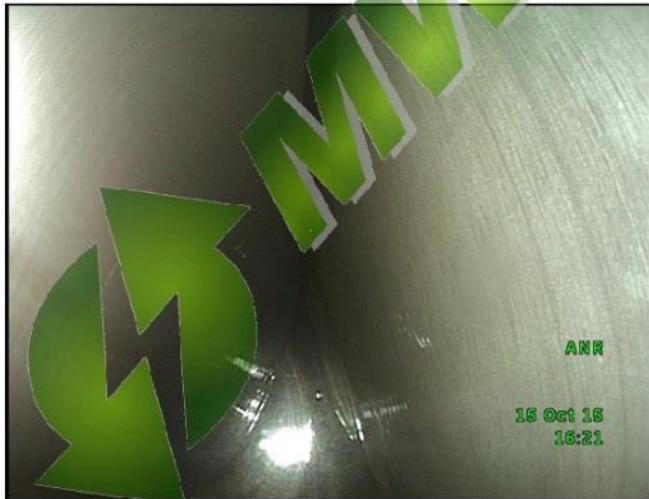
Picture 4 shows the bearing of the third planet wheel. No irregularities.

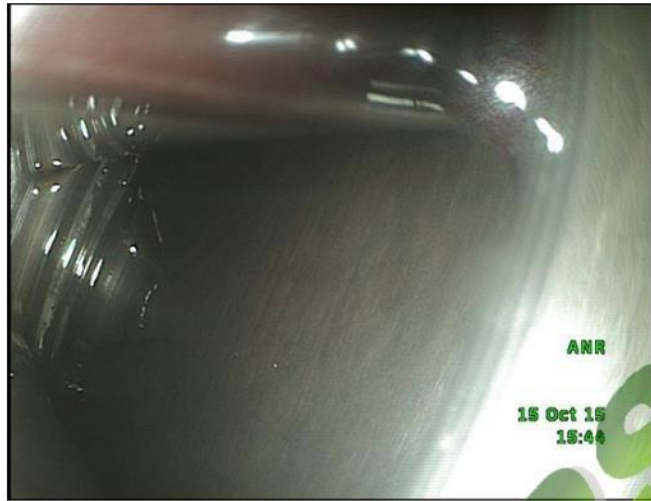
Picture 5 shows bearing position no. 5, the bearing of the planet carrier at generator side. The bearing shows no irregularities.

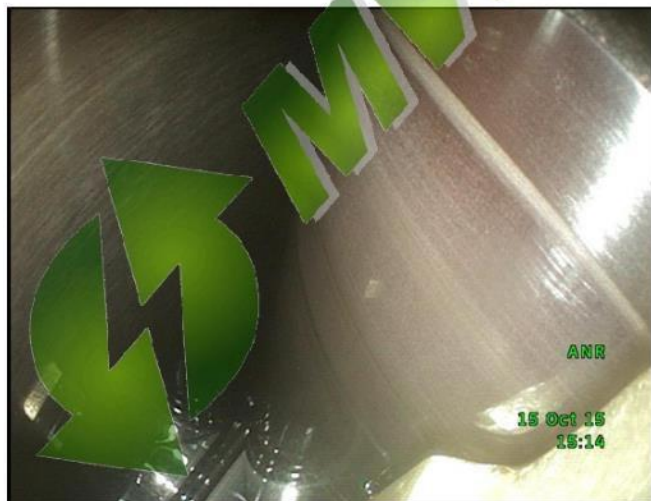
Picture 6 shows bearing position no. 6, the bearing of the low speed shaft at rotor side. The bearing shows no irregularities.

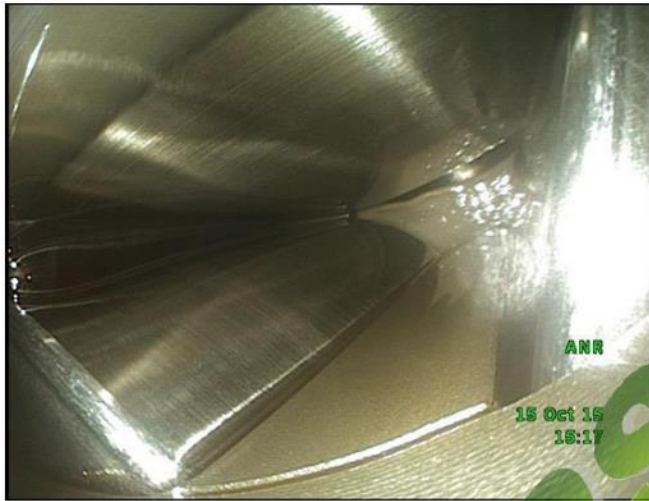
Picture 7 shows bearing position no. 8, the bearing of the intermediate shaft at rotor side. The bearing shows no irregularities.

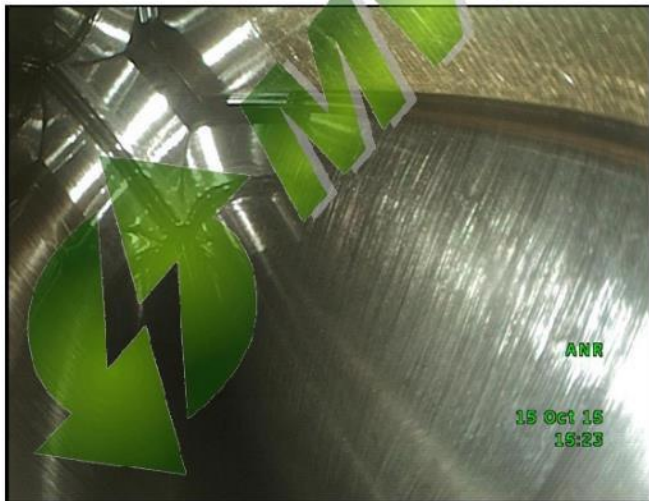
Picture 8 shows bearing position no. 9, the bearing of the intermediate shaft at generator side. The bearing shows no irregularities.

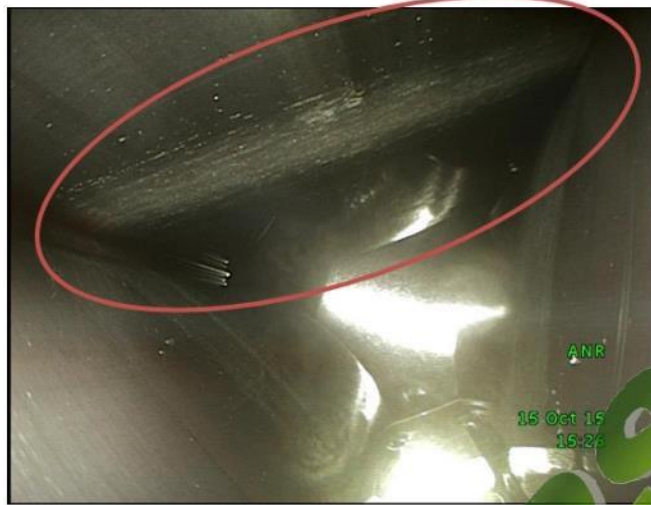
Picture 9 shows bearing position no. 10, the bearing of the high speed shaft at rotor side. The bearing shows an area on the raceway where the surface is roughened.

The bearing of the high speed shaft at rotor side shows rough areas on the raceway and the rolling elements.

The irregularities at the high speed bearing at rotor side are remarkable and it is recommended to keep monitoring this bearing closely in the future.

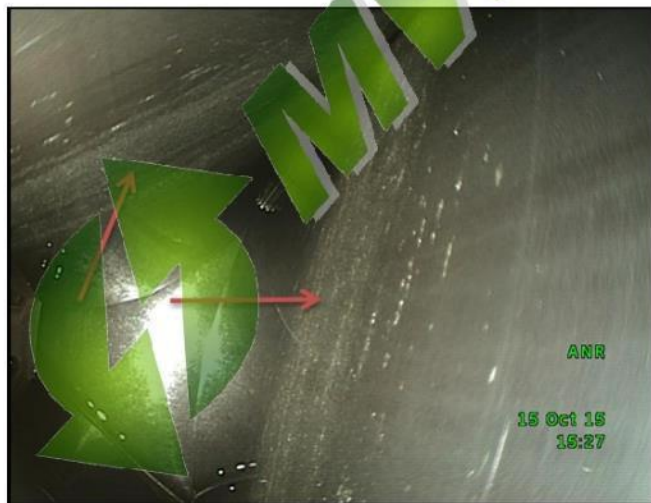
Picture 10 shows bearing position no. 10 again. This picture also shows a rough area at the rolling element of the bearing.

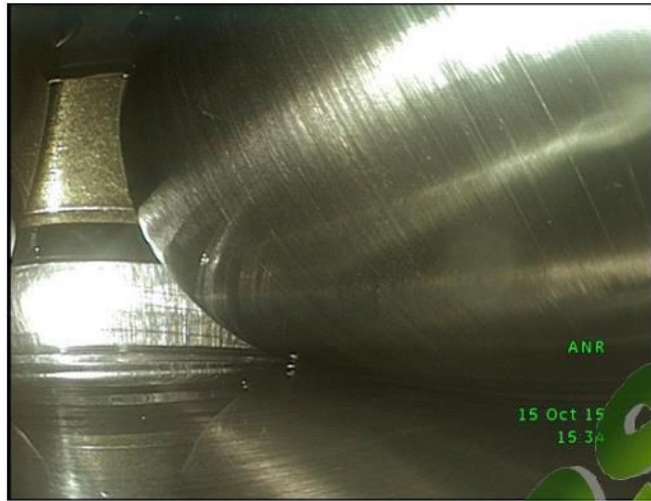
Picture 11 shows bearing position no. 11, the radial bearing of the high speed shaft at generator side. The bearing shows no irregularities.

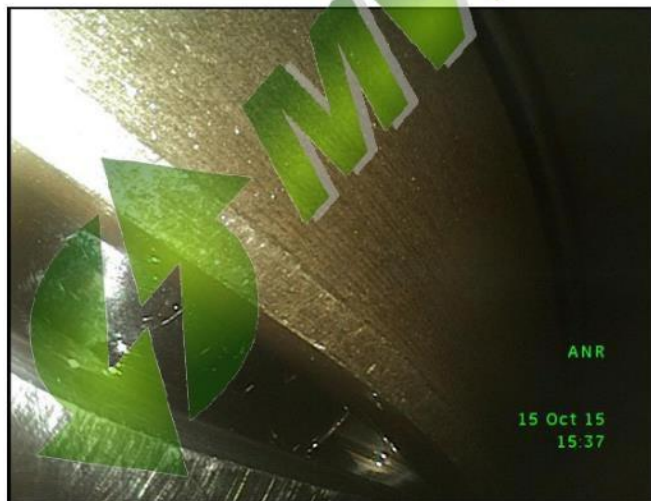
Picture 12 shows bearing position no. 11 again, the axial bearing of the high speed shaft at generator side. The bearing shows no irregularities.

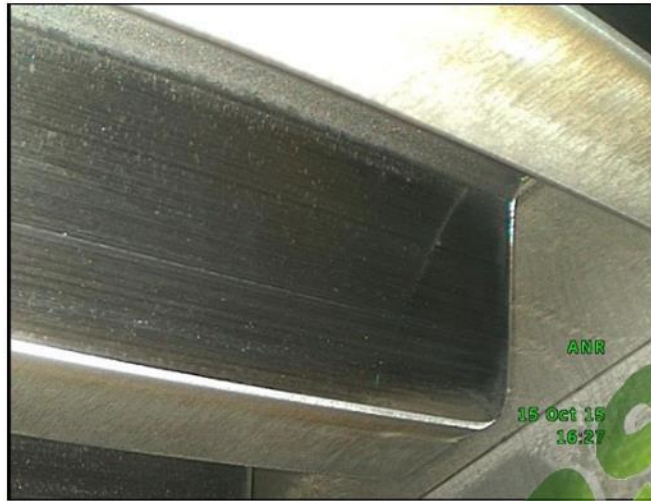
Picture 13 shows the active flank of the ring gear. No irregularities.

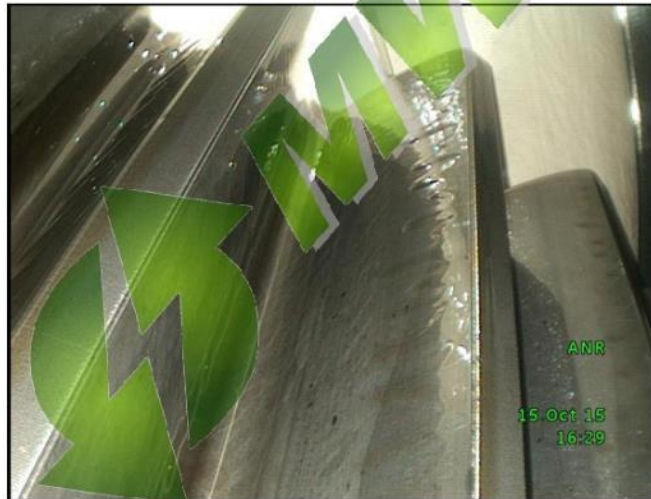
Picture 14 shows one of the planet wheels. None of the planet wheels show irregularities.

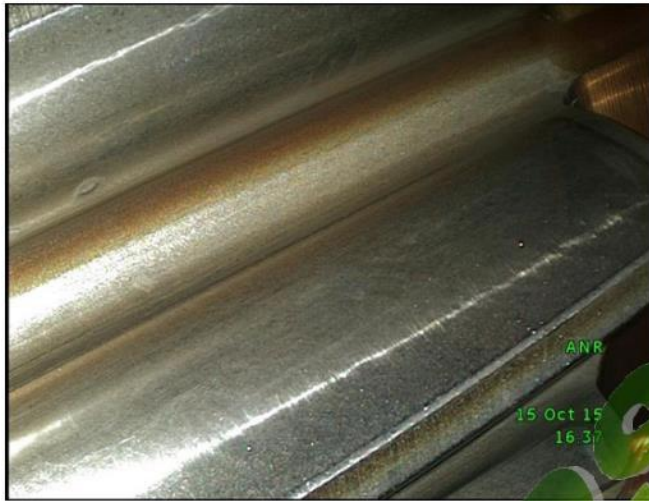
Picture 15 shows the active flanks of the sun pinion. No irregularities.

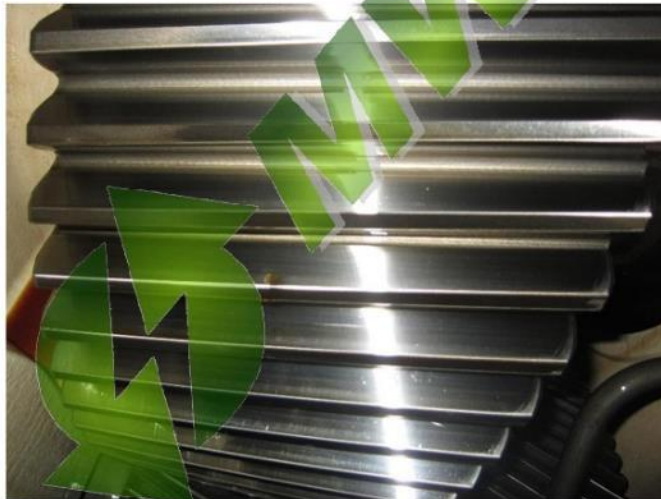
Picture 16 shows the active flanks of the wheel of the low speed shaft in the linear stage. No irregularities.

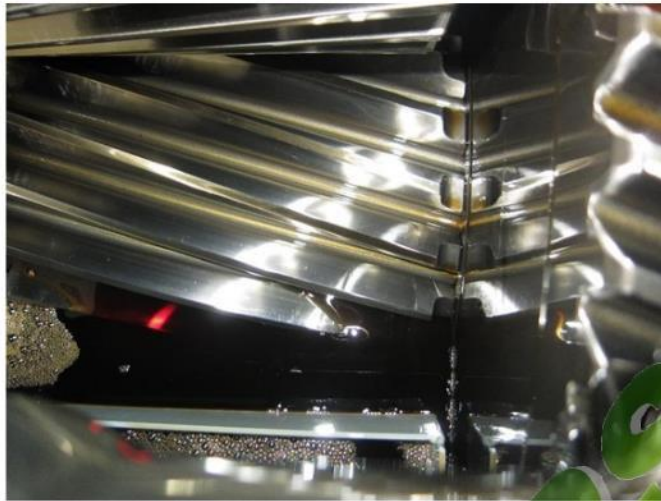
Picture 17 shows the active flanks of the pinion of the intermediate shaft in the linear stage. No irregularities.

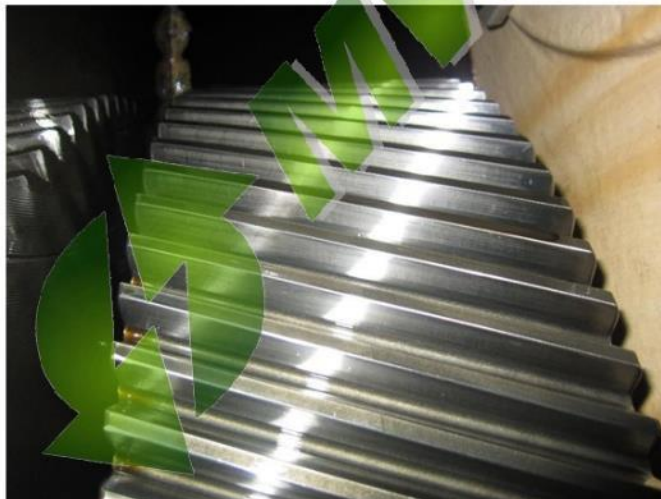
Picture 18 shows the active flanks of the wheel of the intermediate shaft in the linear stage. No irregularities.

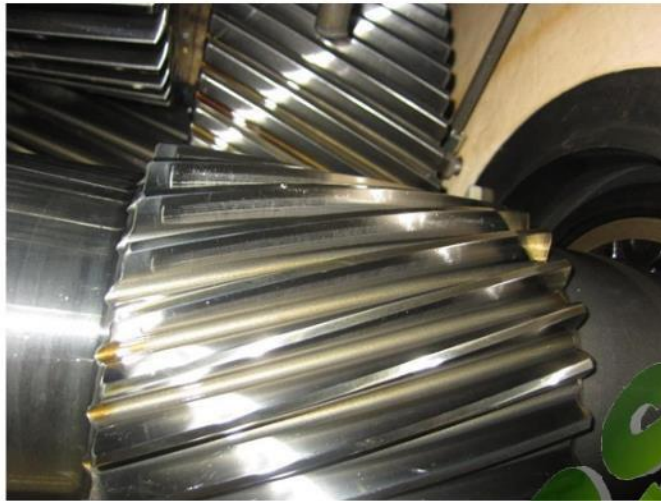
Picture 19 shows the active flanks of the pinion of the high speed shaft in the linear stage. No irregularities.

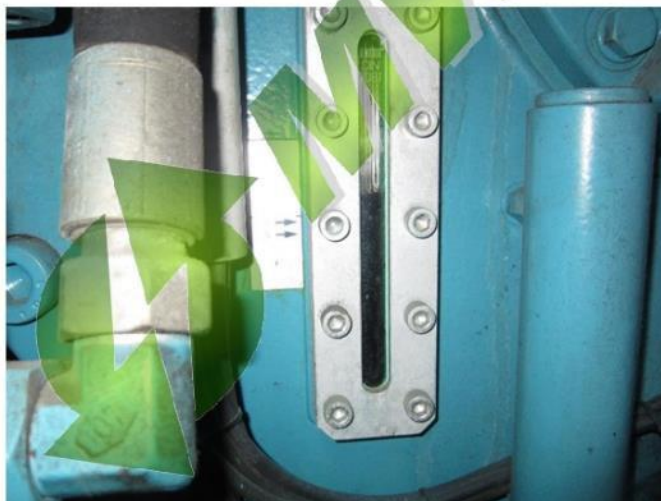
Picture 20 shows the oil level of the gearbox.

The oil level is correct and no steel particles were found in the gearbox.

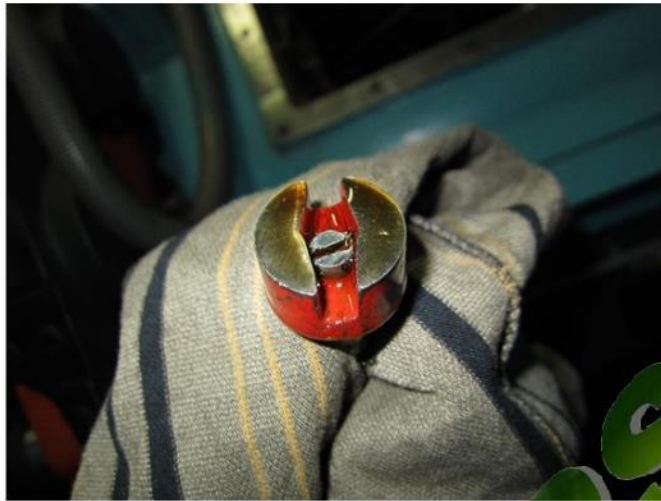
Picture 21

The inside and bottom of the gearbox have been searched with a magnet. The magnet shows no steel particles.
