REPORT TURBINE INSPECTION
SN 15401271, WINDPARK SLUFTER WEST 5

Report No. GE15002015005

REPORT GEARBOX INSPECTION
SN 15401271, WINDPARK SLUFTER WEST 5

Report no. GE15002015015

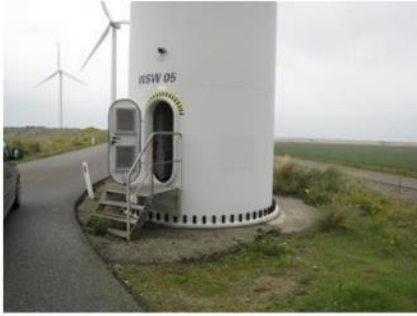
Item	Remark		
1	Tower outside	<p>Light at the outside is broken and has damaged the paint of the tower.</p>

Low</p>
2	Controller overview

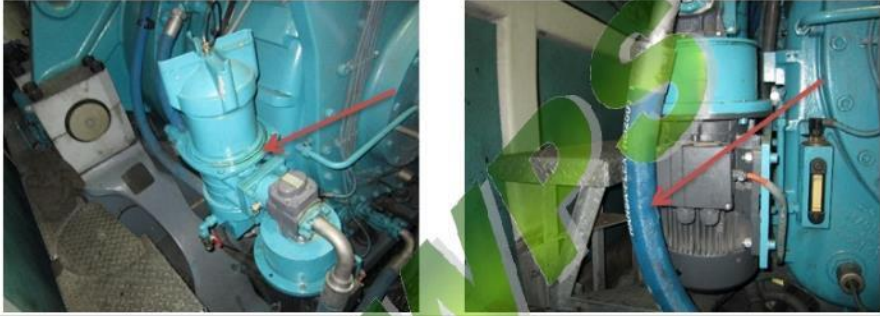
<i>Info</i>
3	CCJ-unit	No CCJ-filter present in the turbine.	<i>Info</i>
4	Gear oil system	Leakage present at the gear oil system.

Not <i>High</i>
5	Hoses and pipes		ok
6	Paint / Corrosion		ok
7	General leakage		ok
8	Slip ring for hub	 	<i>Info</i>

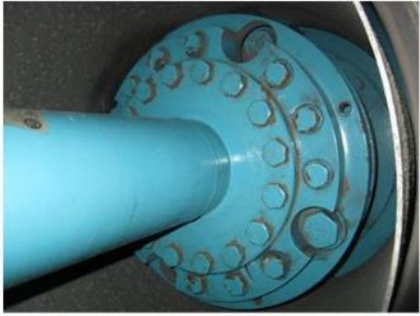
Item	Remark	
1	Coupling	The coupling shows no irregularities.

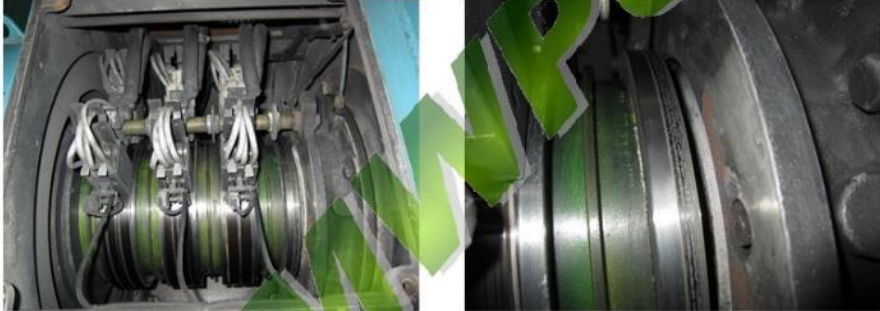
Info
2	Paint / Corrosion		ok
3	Slip ring	Raceway of the earth connection is not completely smooth (2 th picture).

<div style="text-align: center;"> Not High </div>

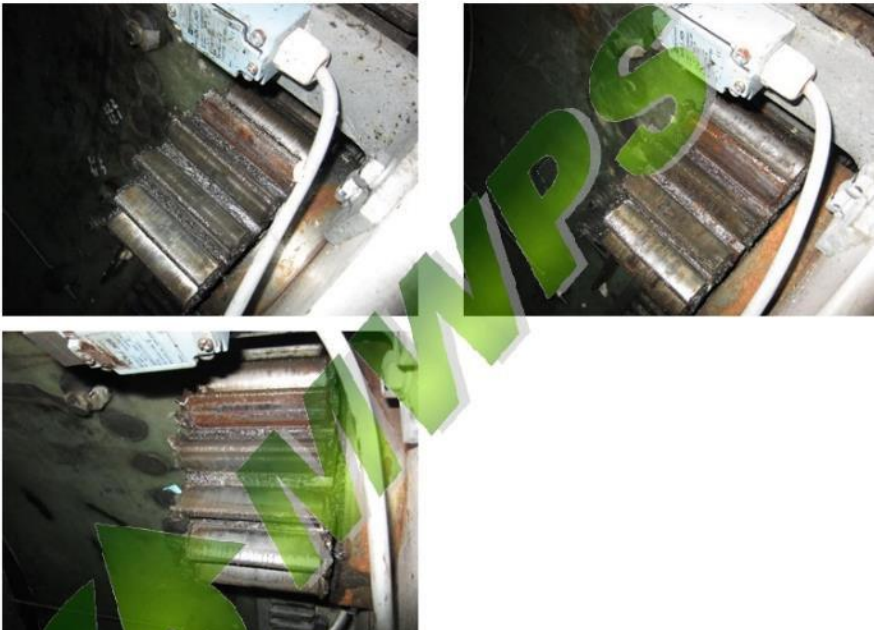
7	Mounting of the electrical boxes	<p>The mounting of the boxes shows no irregularities.</p>  	ok
8	Pinions of pitch gears	<p>Wear on one tooth of the pinions of the pitch gears.</p>

<p>nok High</p>
9	Pitch teeth at zero of blade 1	<p>The tooth at zero shows wear, but the condition is acceptable.</p>  	<p>nok High</p>

Although the pitch rings have been turned in 2015 (and one was replaced), there is already some wear visible at the zero-tooth of the pitch rings. The pinions of the pitch gears are also showing wear. The reason for the wear is the absent of a functioning grease system for the pitch gear and pitch ring.

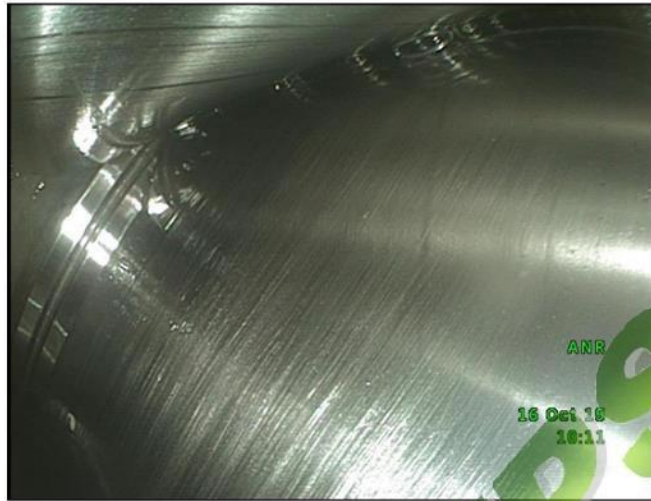
Picture 1 shows bearing position no. 1, the bearing of the planet carrier at rotor side. No irregularities.

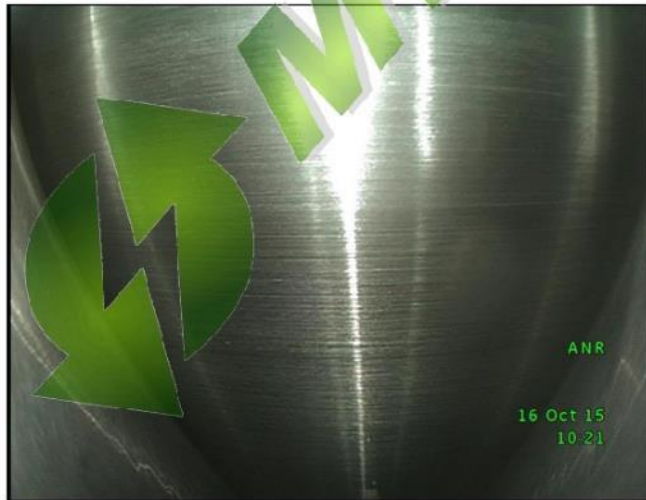
Picture 2 shows the bearing of the first planet wheel. No irregularities.

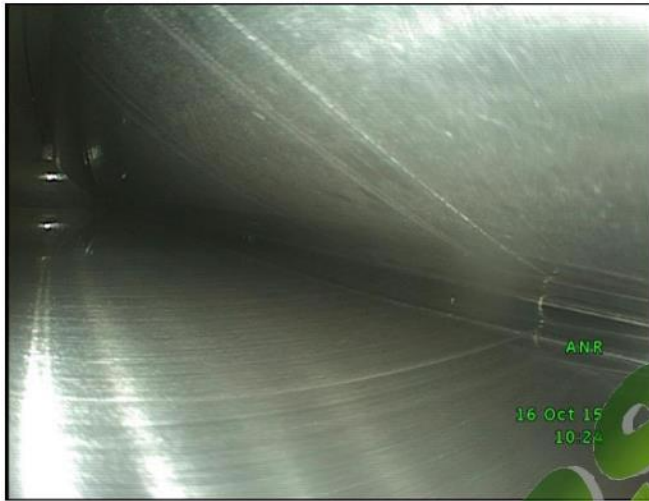
Picture 3 shows the bearing of the second planet wheel. No irregularities.

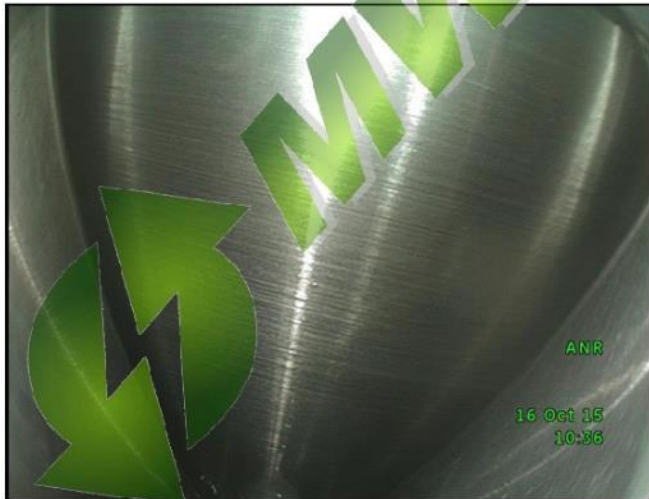
Picture 4 shows the bearing of the third planet wheel. No irregularities.

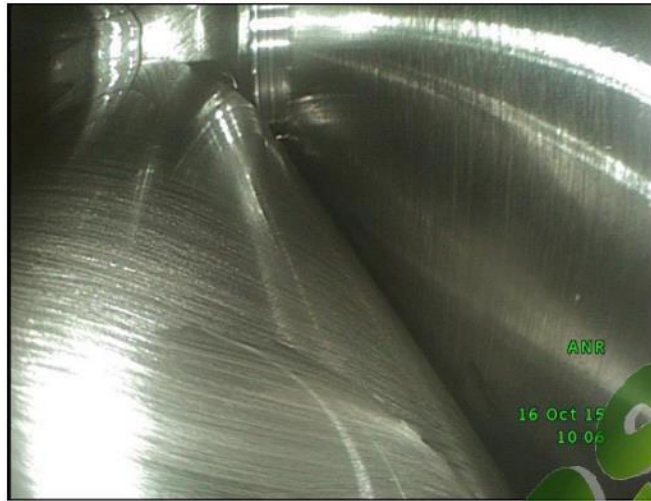
Picture 5 shows bearing position no. 5, the bearing of the planet carrier at generator side. The bearing shows no irregularities.

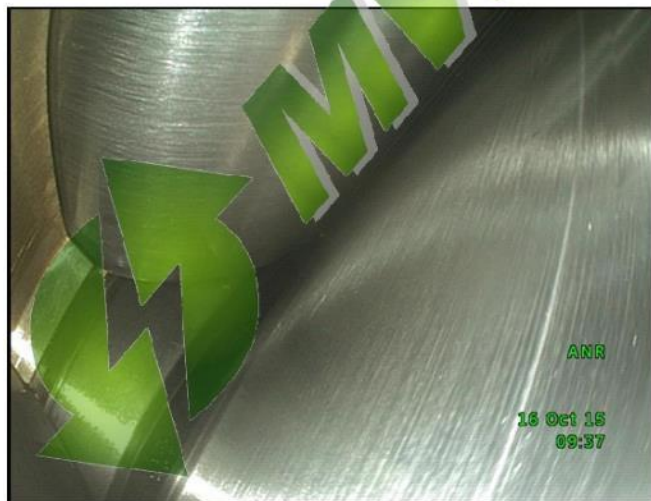
Picture 6 shows bearing position no. 6, the bearing of the low speed shaft at rotor side. The bearing shows no irregularities.

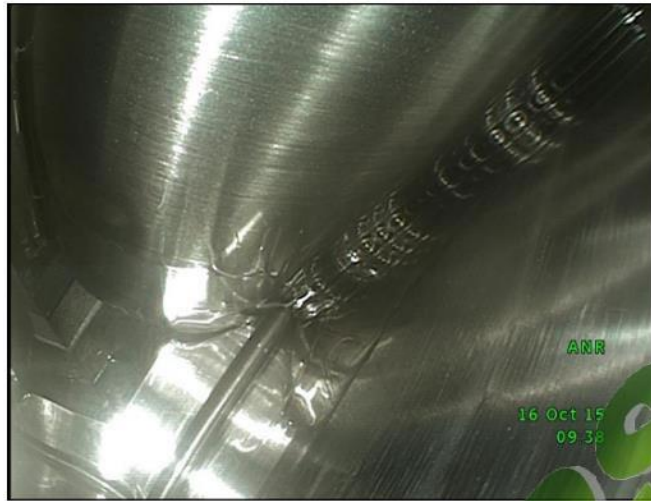
Picture 7 shows bearing position no. 7, the bearing of the low speed shaft at generator side. The bearing shows no irregularities.

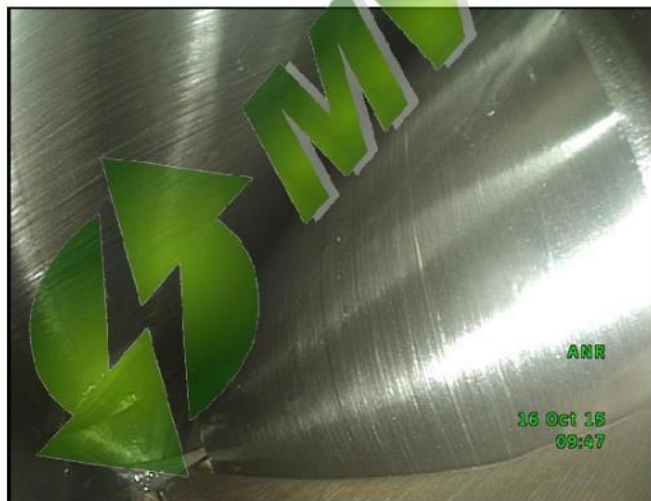
Picture 8 shows bearing position no. 8, the bearing of the intermediate shaft at rotor side. The bearing shows no irregularities.

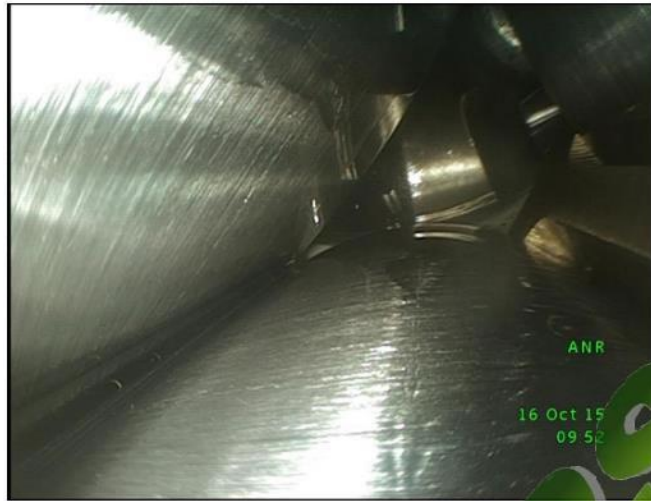
Picture 9 shows bearing position no. 10, the bearing of the high speed shaft at rotor side. The bearing shows no irregularities.

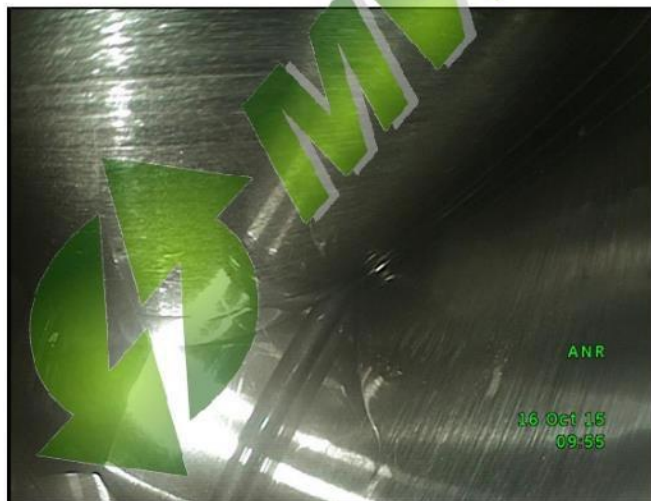
Picture 10 shows bearing position no. 11, the bearing of the high speed shaft at generator side. The bearing shows no irregularities.

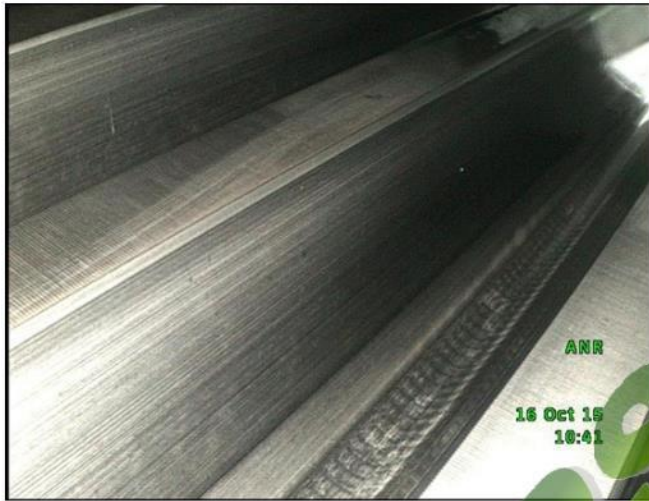
Picture 11 shows the active flank of the ring gear. No irregularities.

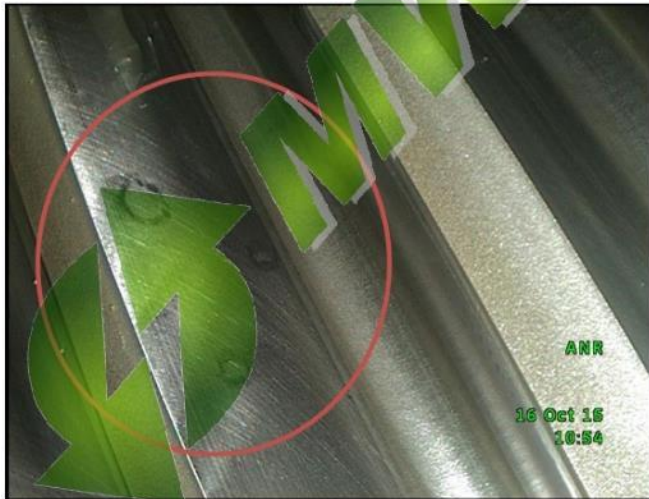
Picture 12 shows one of the planet wheels. One planet wheel shows a few irregularities at the flank.

One planet wheel shows a few irregularities at the flank.

The small irregularities in the planetary stage and the small scratches at the sun pinion were probably generated before the gearbox was revised in 2013. It is likely that the gears have been reused. There is no reason to assume that an active defect is present at this moment. The clean magnet supports this conclusion.

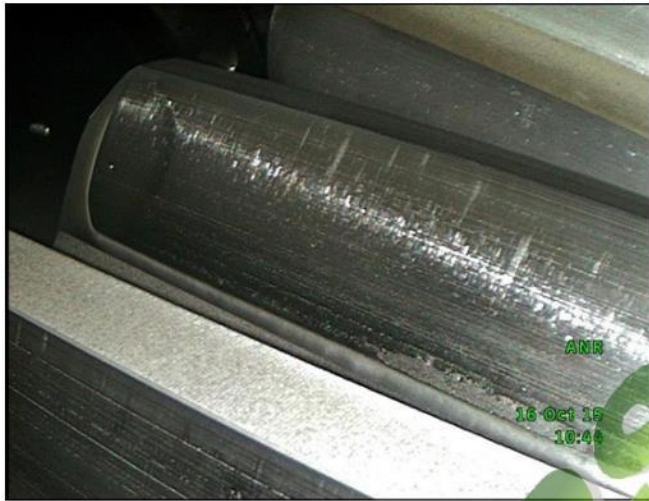
Picture 13 shows the active flanks of the sun pinion. Several scratches visible at the active flank of the sun pinion.

Several scratches visible at the active flank of the sun pinion.

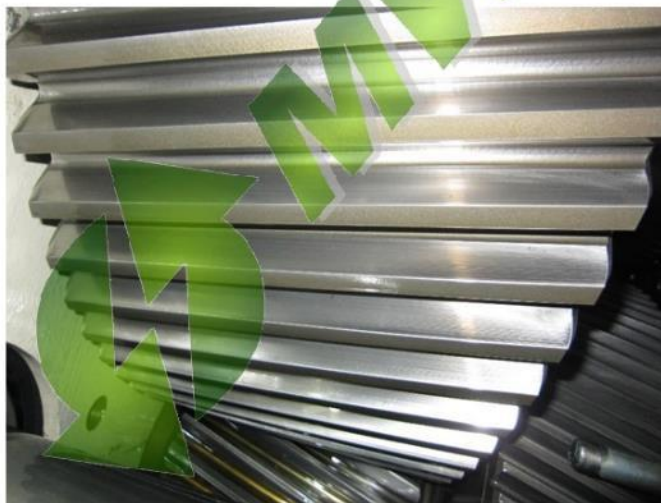
Picture 14 shows the active flanks of the wheel of the low speed shaft in the linear stage. No irregularities.

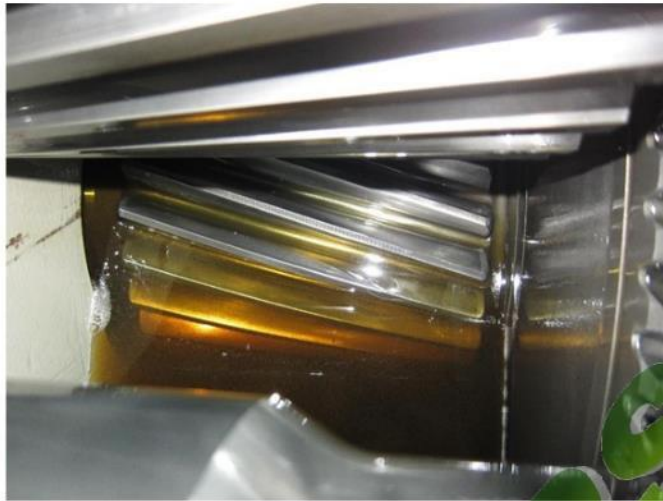
Picture 15 shows the active flanks of the pinion of the intermediate shaft in the linear stage. No irregularities.

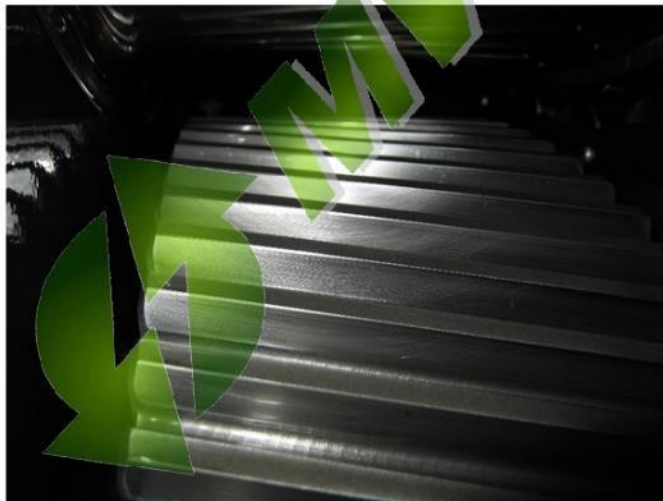
Picture 16 shows the active flanks of the wheel of the intermediate shaft in the linear stage. No irregularities.

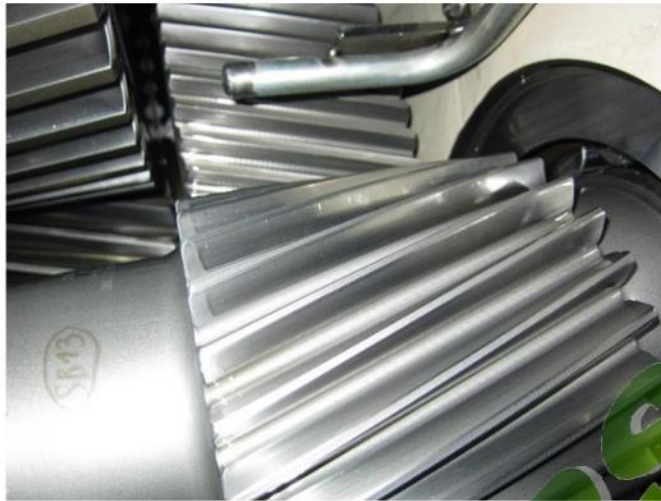
Picture 17 shows the active flanks of the pinion of the high speed shaft in the linear stage. No irregularities.

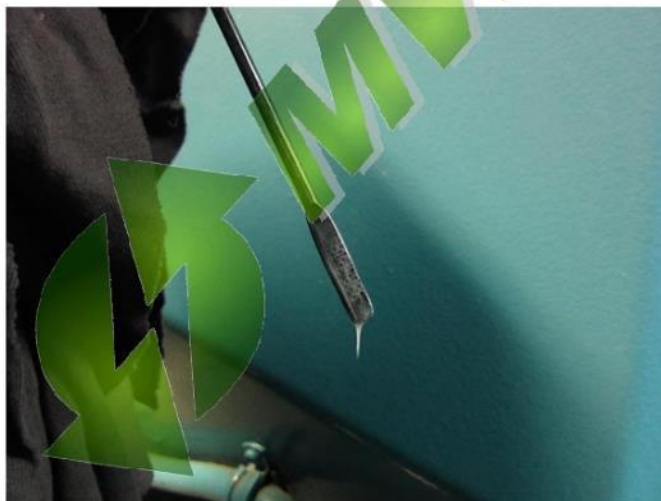
Picture 18 shows the dip stick of the gearbox. The oil level is correct.

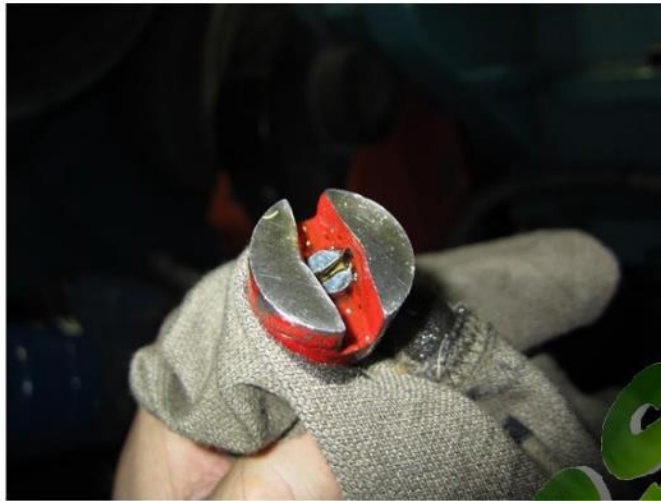
Picture 19

The inside and bottom of the gearbox have been searched with a magnet. The magnet shows no steel particles.
