REPORT TURBINE INSPECTION
SN 15401272, WINDPARK SLUFTER WEST 6

Report No. GE15002015006

REPORT GEARBOX INSPECTION
SN 15401272, WINDPARK SLUFTER WEST 6

Report no. GE15002015016

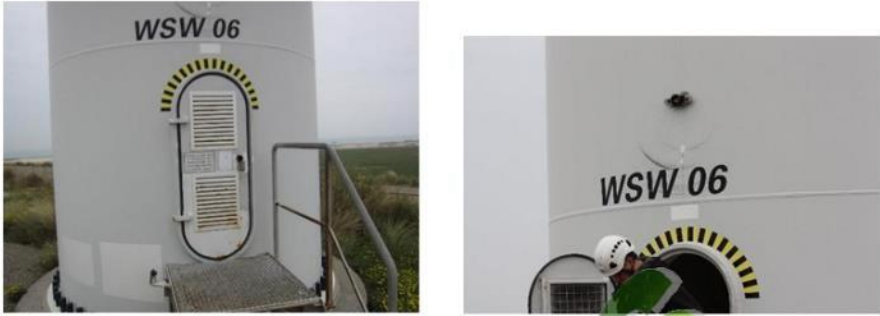
Item	Remark		
1	Tower outside	<p>Light at the outside is broken and has damaged the paint of the tower.</p>

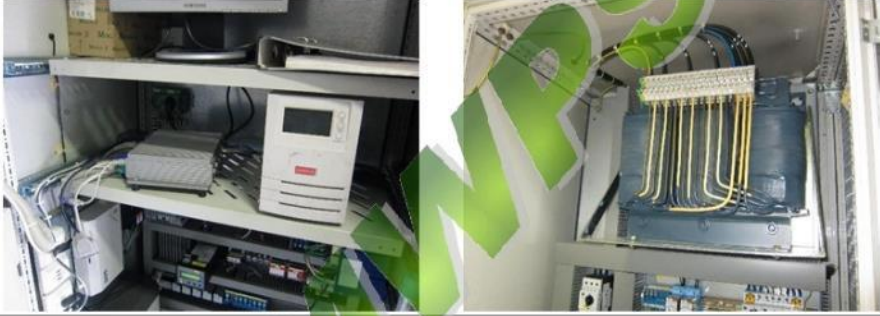
Low</p>
2	Controller overview	<p>UPS is not connected (1st picture).</p>

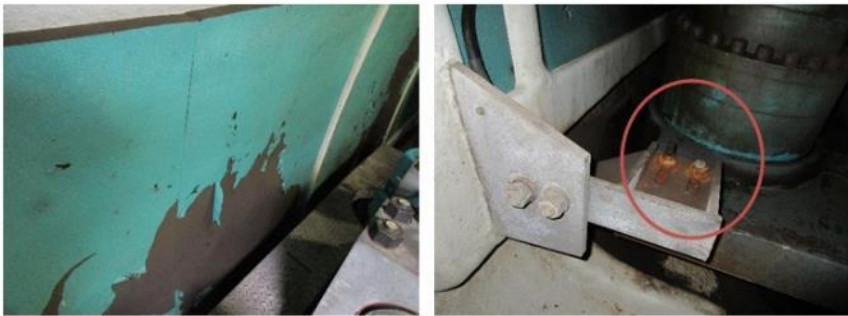
3	Nacelle housing	<p>Parts of the insulation are damaged.</p> <p>Bolt connections of the nacelle frame are corroded (2nd picture).</p>

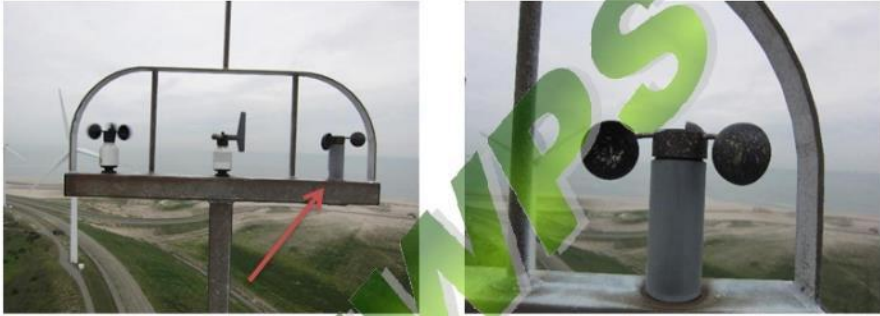
<p>nok</p> <p>Low</p>
4	Weather station	<p>One (redundant) anemometer is damaged.</p>

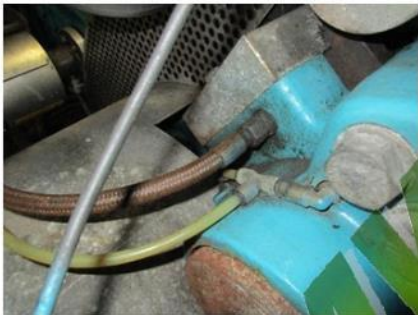
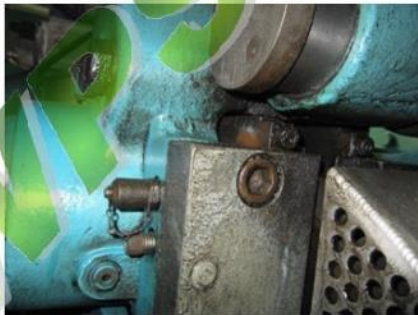
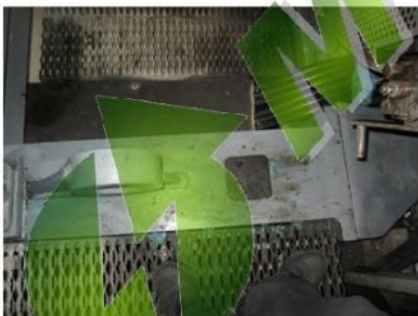
Info
2	Leakage	<p>Hydraulic brake and the area around it are polluted with oil (1st and 2nd picture). The frame under the brake is also polluted (3rd picture).</p>

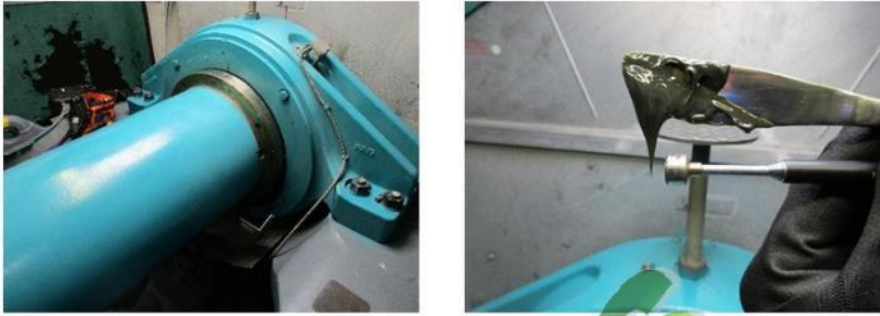
Item	Remark	
1	Main shaft bearings	<p>Grease of the main bearing is not magnetic.</p>

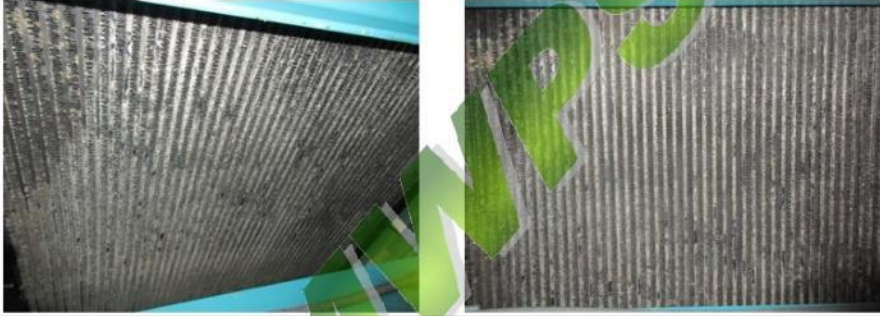
ok
2	Radiators	<p>Parts of the radiator are covered with dust.</p>

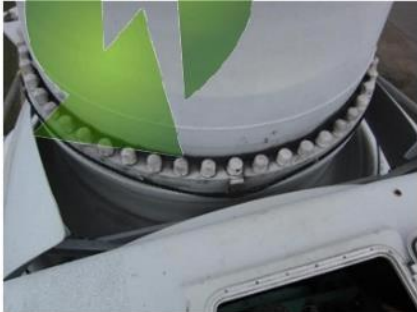
Item	Remark	
1	Blade bearing	Several small cracks are visible at the caps of the blade bearing bolts.

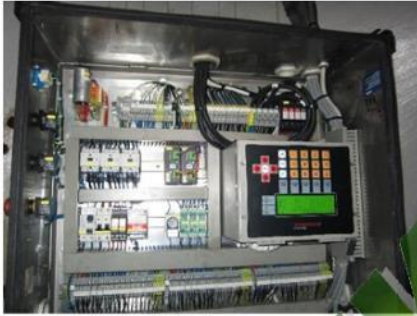
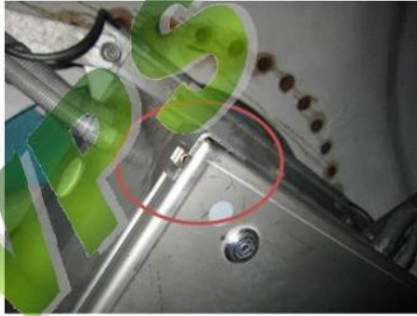
Info
3	Hub cabinet overview	<p>Inside of the cabinet shows no irregularities. One bolt connection of the cover is broken (2nd picture).</p>

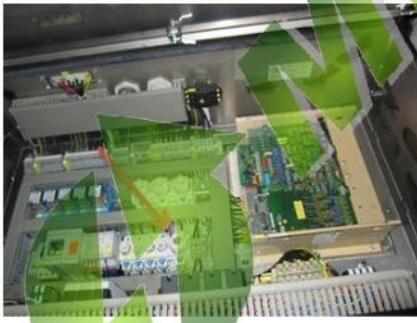
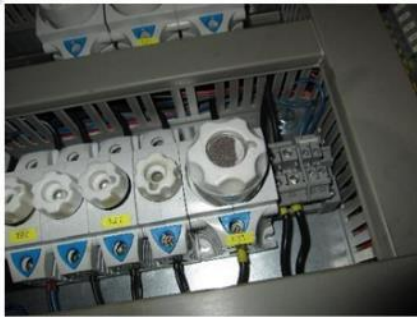
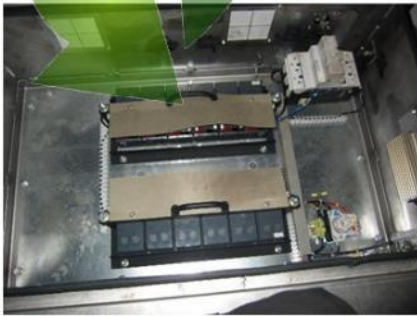
Low
4	Boxes blade 1	<p>Sand is leaking at one fuse of the control box.</p>

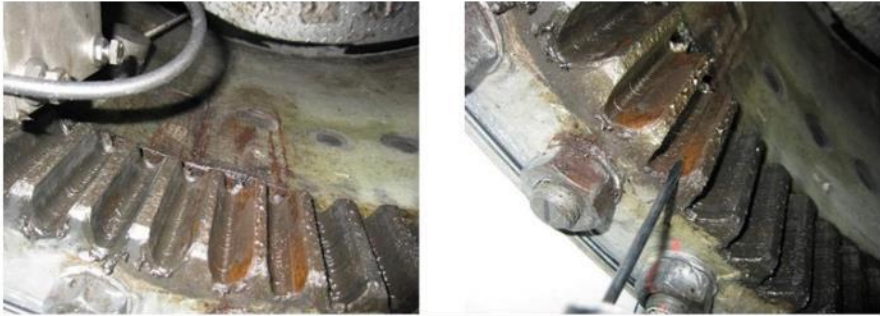
11	Pitch teeth at zero of blade 3	The tooth at zero shows wear.

The wear of the zero-tooth of the pitch ring is serious, but it is possible to solve this problem by assigning another tooth to be the zero-tooth. Dismounting and remounting of the blades is necessary to achieve this. The same thing can be done with the pinions, although replacing the pitch gears (with the pinions) is also an option.

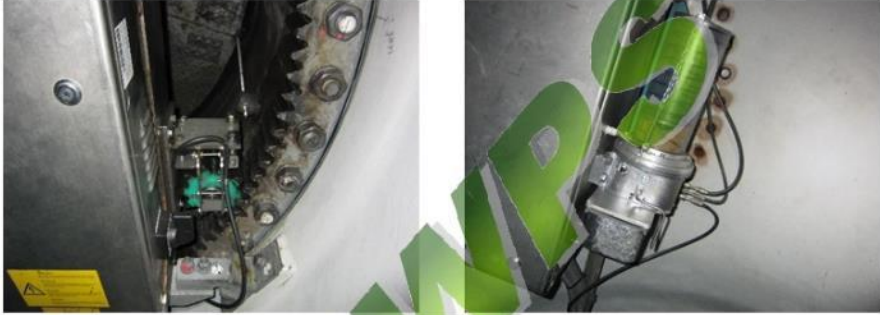
<p style="text-align: center;">nok High</p>
12	Grease system pitch teeth	There is an automatic grease system present in the hub. The system is not operational.

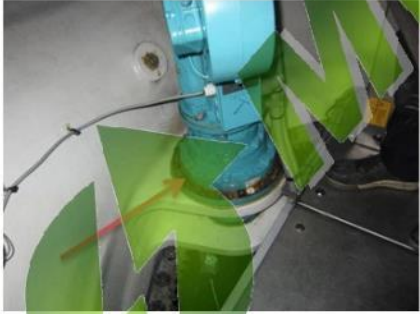
<p style="text-align: center;">nok High</p>
13	Pitch gears	Some corrosion visible at the base of the pitch gears.

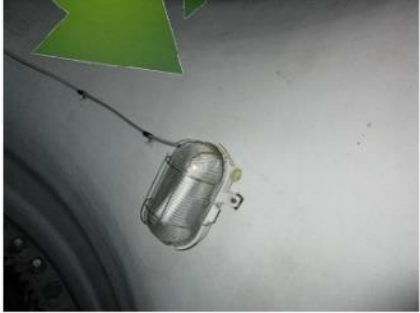
<p style="text-align: center;">nok Low</p>
14	Miscellaneous	The light in the hub is defect.

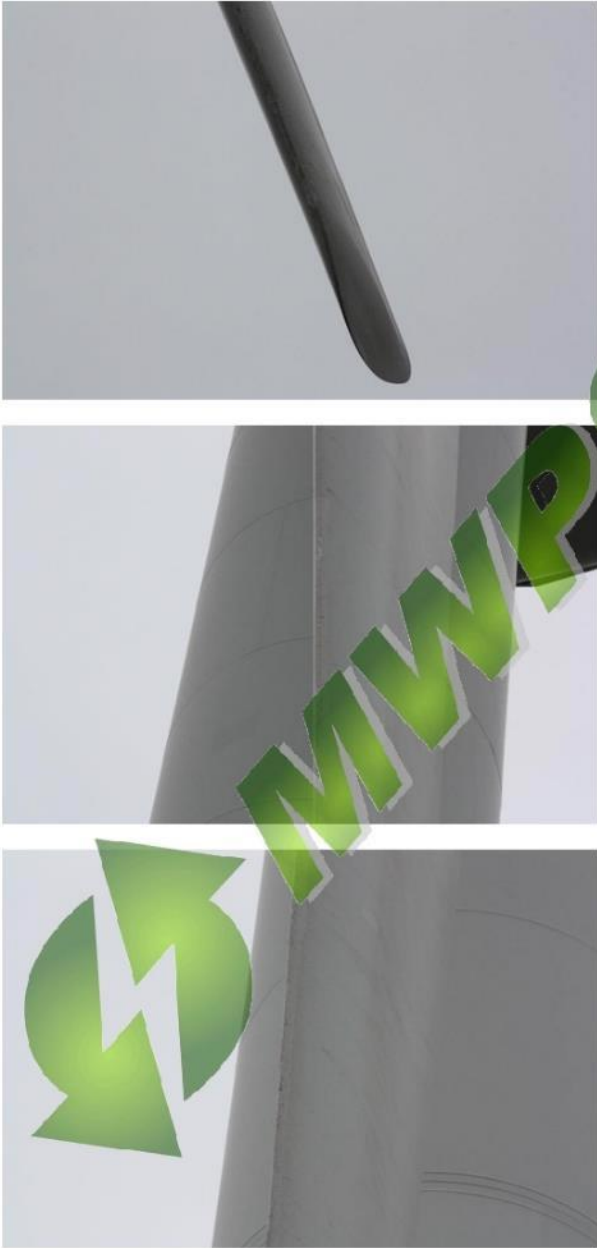
1	Blades	<p>Repaired parts are visible on the leading edges of the blades.</p>

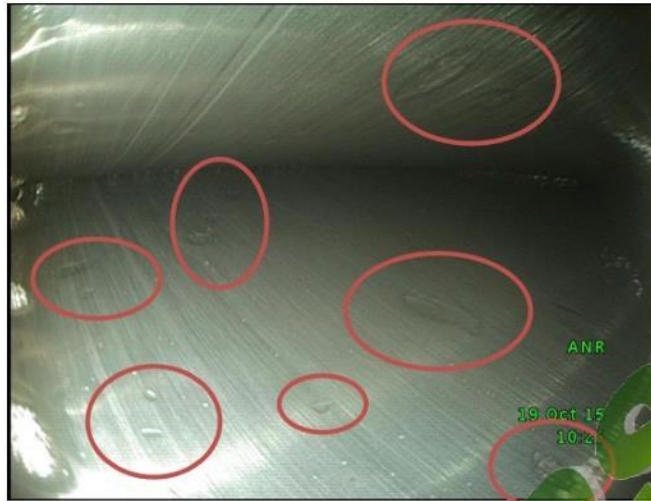
Picture 3 shows the bearing of the second planet wheel. Several significant indentations visible at the raceway.

The bearing of the second planet wheel shows several significant indentations at the raceway.

The indentations at the planet wheel are a strong indication that there is a larger damage present somewhere in the bearing. The damage is probably located at the load bearing part of the inner ring. This part of the inner ring is not accessible for visual inspection.

An inspection interval with a maximum of 6 months is recommended to prevent additional damage at the gears of the gearbox box, caused by the steel particles from the damaged planet bearing.

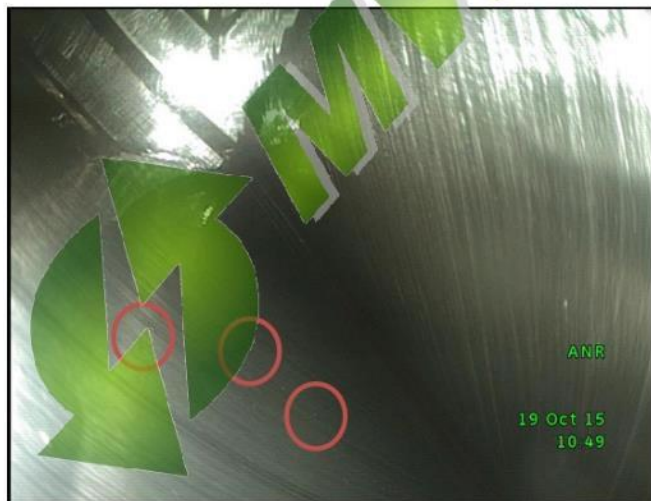
Picture 4 shows the bearing of the third planet wheel. Several very small indentations visible at the raceway.

The bearing of the third planet wheel shows several very small indentations at the raceway.

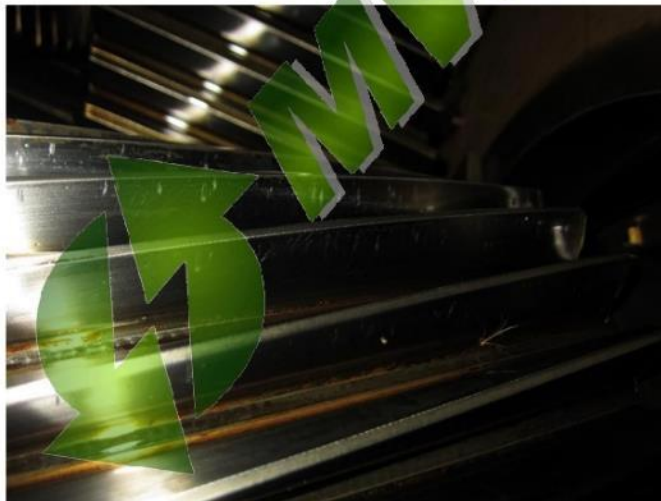
Picture 18 shows the active flanks of the pinion of the high speed shaft in the linear stage. Several scratches visible on the active flank.

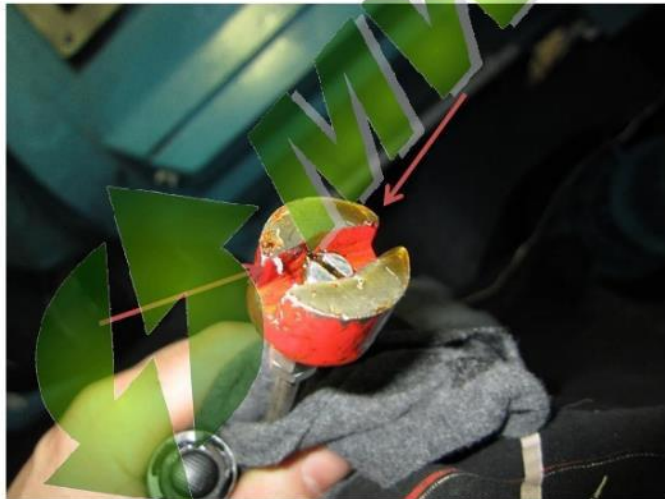
Picture 20

The inside and bottom of the gearbox have been searched with a magnet. Two small steel particles were found.

Two small steel particles were found by using a magnet.
