REPORT TURBINE INSPECTION
SN 15401273, WINDPARK SLUFTER WEST 7

Report No. GE15002015007

REPORT GEARBOX INSPECTION
SN 15401273, WINDPARK SLUFTER WEST 7

Report no. GE15002015017

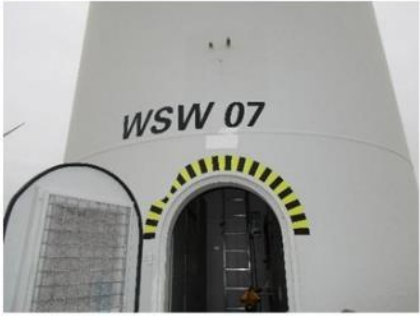
Item	Remark		
1	Tower outside	Light at the outside is broken and has damaged the paint of the tower.

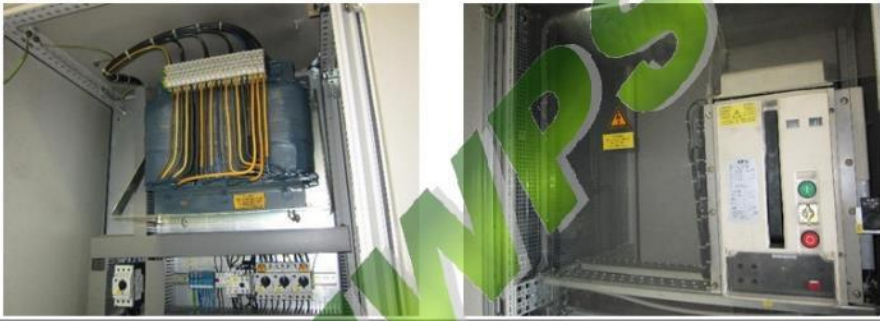
Low </div>
2	Controller overview

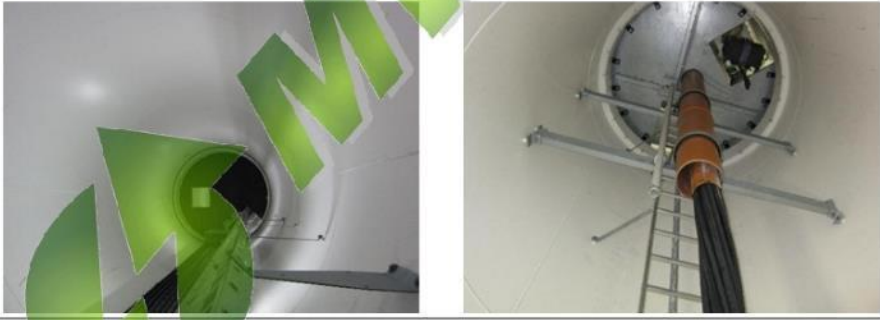
<div style="text-align: right;"> Info </div>
3	Tower inside

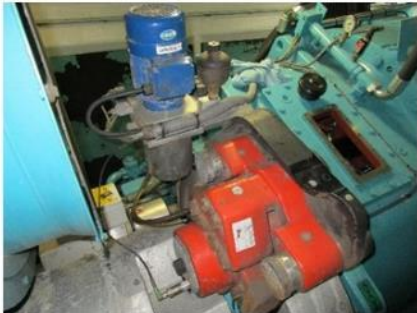
Item	Remark	
1	Overview

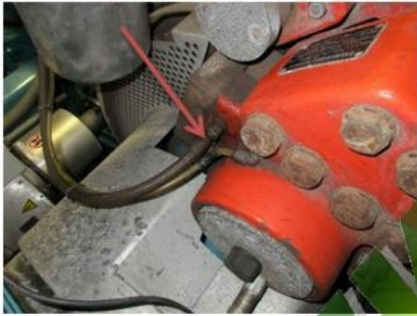
Info
2	Leakage	Leakage at the hydraulic hose of the brake.

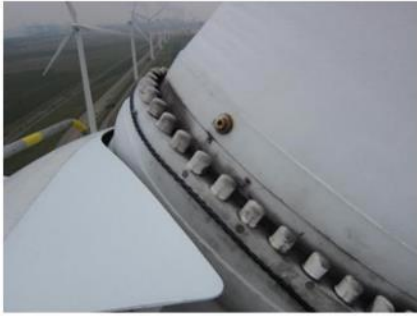
Item	Remark	
1	Blade bearing	<p>Several small cracks are visible at the caps of the blade bearing bolts.</p>

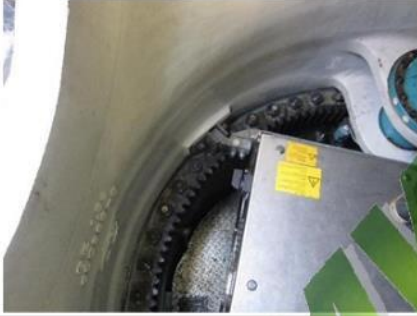
<p>Low</p>
2	Overview inside	<p>In general, the hub is clean and there is no excessive corrosion present.</p>

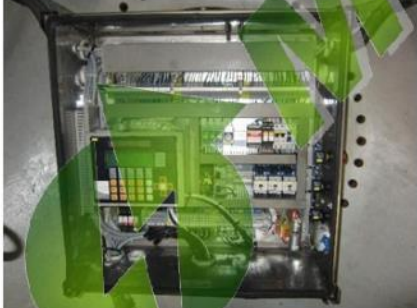
<p><i>Info</i></p>
3	Hub cabinet overview

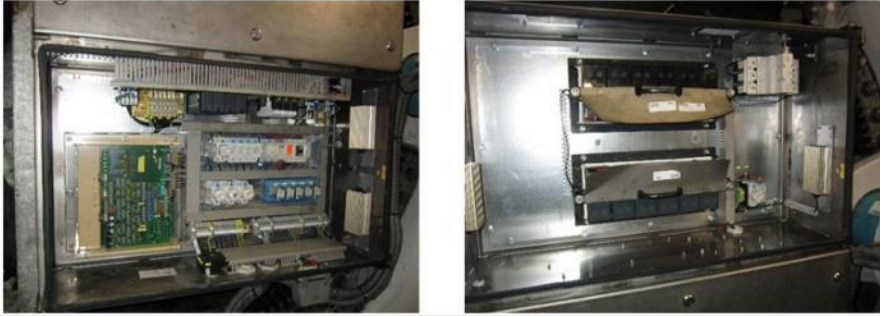
4	Boxes blade 1	Control box and battery box show no irregularities.

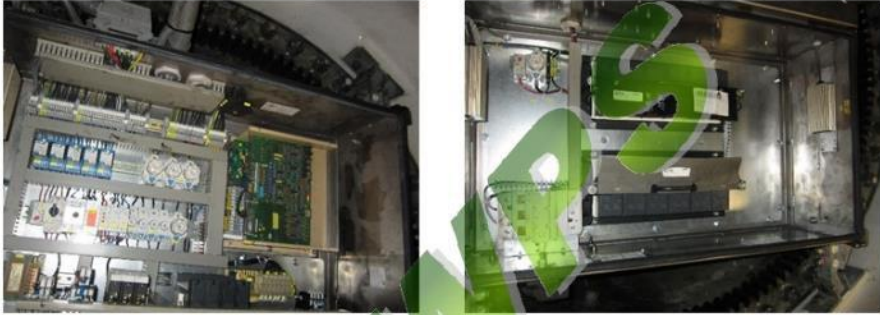
ok
5	Boxes blade 2	Control box and battery box show no irregularities.

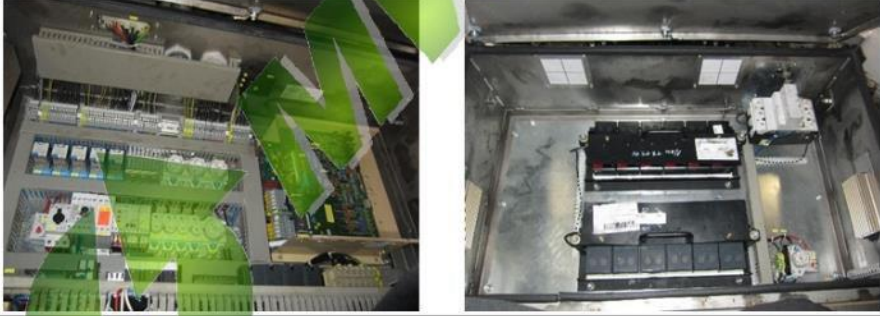
ok
6	Boxes blade 3	Control box and battery box show no irregularities.

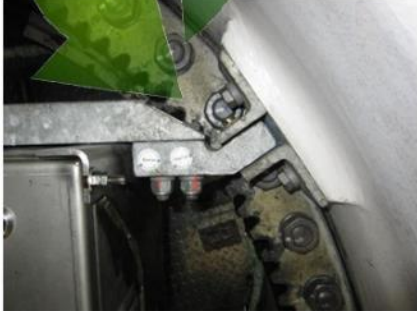
ok
7	Mounting of the electrical boxes	The mounting of the boxes shows no irregularities.

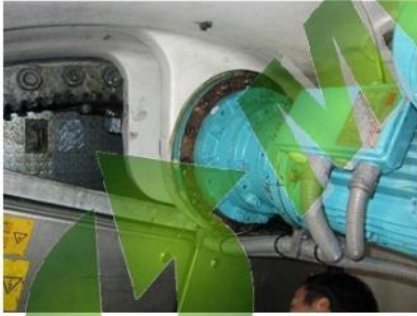
<p>Info</p>
13	Pitch gears	<p>Some corrosion visible at the base of the pitch gears.</p>

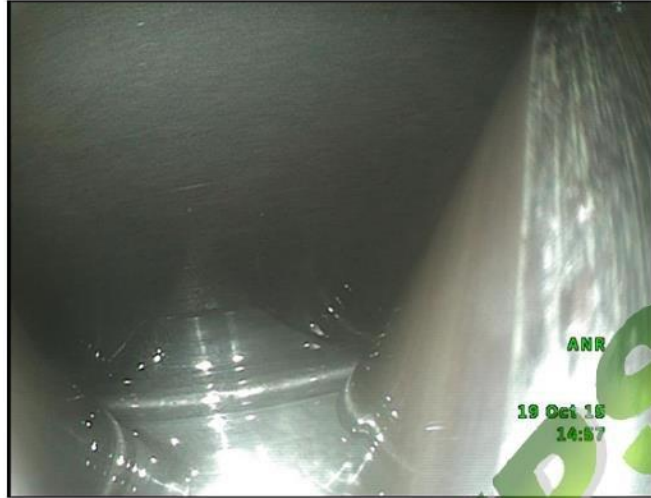
Picture 1 shows bearing position no. 1, the bearing of the planet carrier at rotor side. No irregularities.

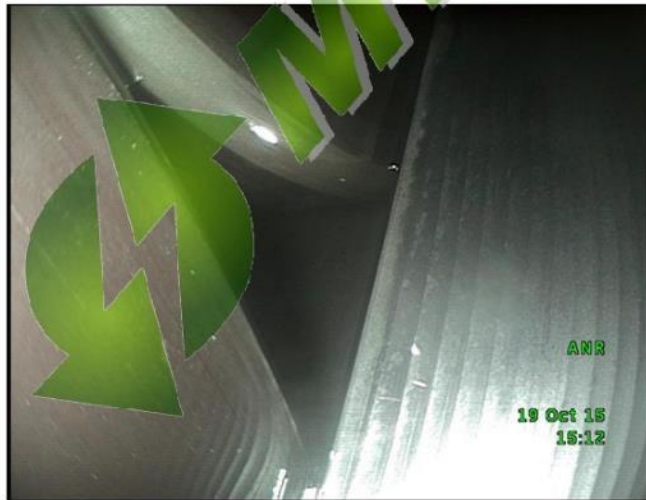
Picture 2 shows the bearing of the first planet wheel. No irregularities.

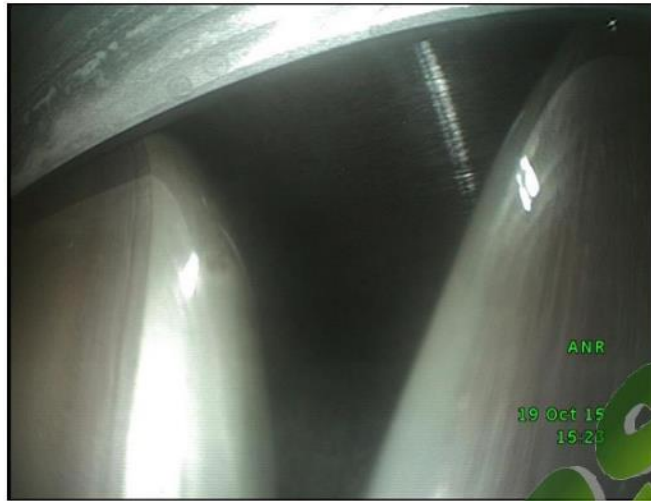
Picture 3 shows the bearing of the second planet wheel. No irregularities.

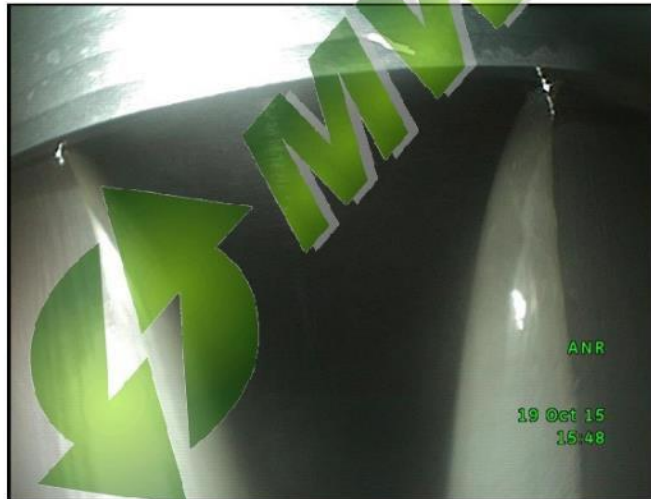
Picture 4 shows the bearing of the third planet wheel. No irregularities.

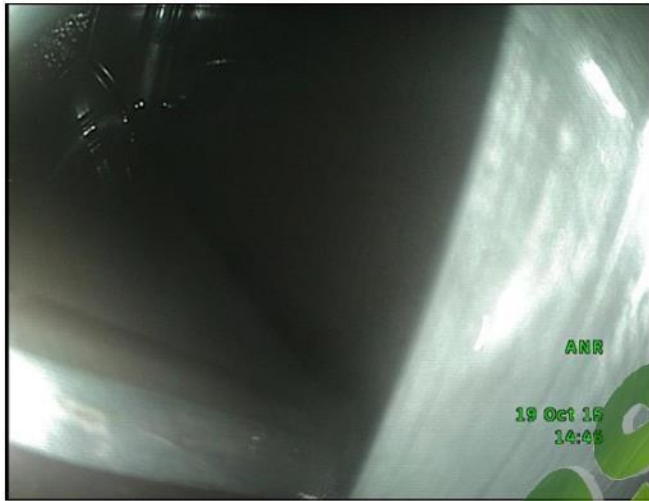
Picture 5 shows bearing position no. 5, the bearing of the planet carrier at generator side. The bearing shows no irregularities.

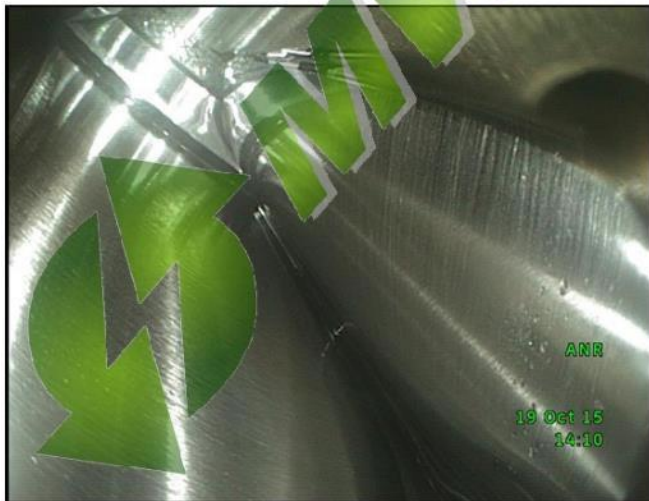
Picture 6 shows bearing position no. 6, the bearing of the low speed shaft at rotor side. The bearing shows no irregularities.

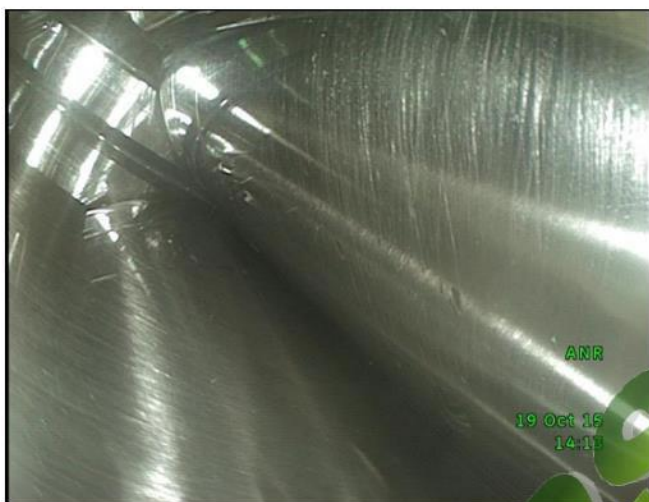
Picture 7 shows bearing position no. 7, the bearing of the low speed shaft at generator side. The bearing shows no irregularities.

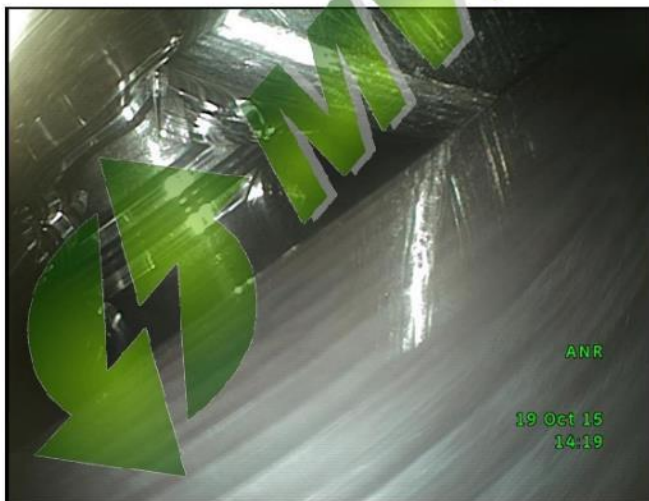
Picture 8 shows bearing position no. 8, the bearing of the intermediate shaft at rotor side. The bearing shows no irregularities.

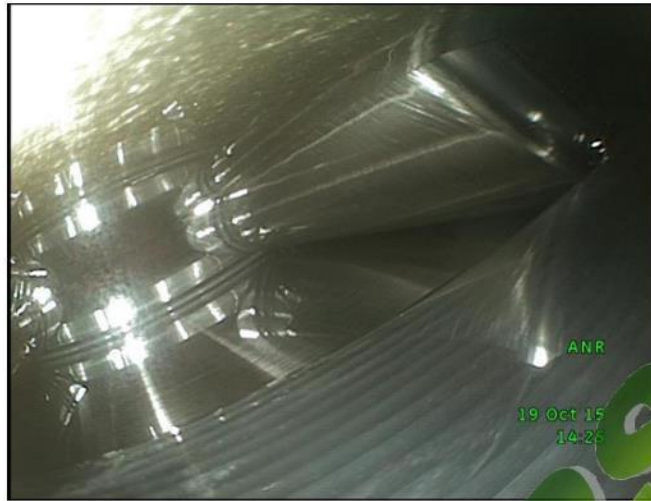
Picture 9 shows bearing position no. 9, the bearing of the intermediate shaft at generator side. The bearing shows no irregularities.

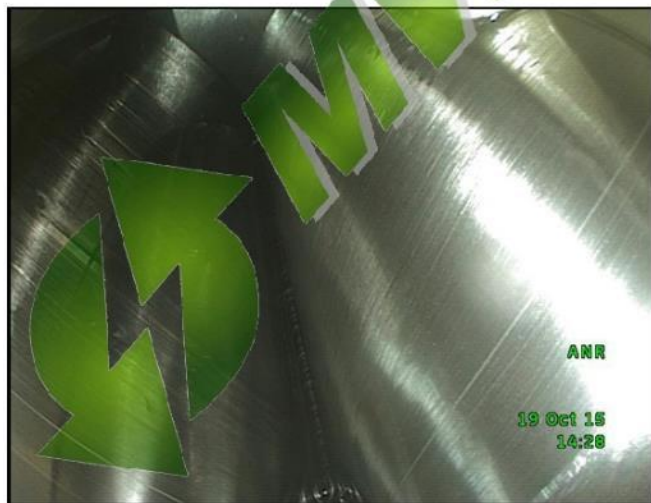
Picture 10 shows bearing position no. 10, the bearing of the high speed shaft at rotor side. The bearing shows no irregularities.

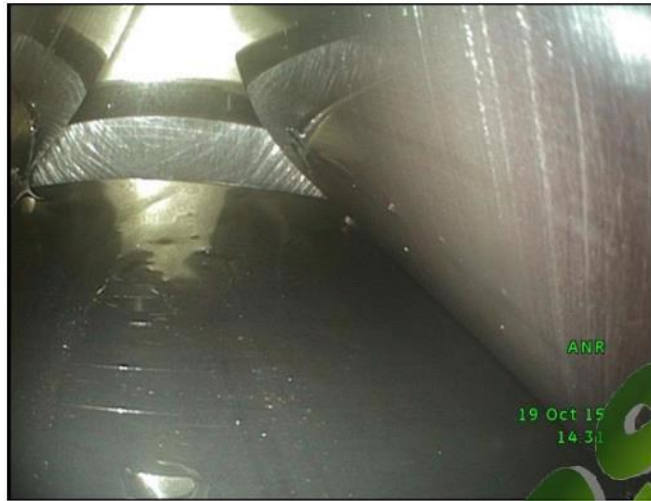
Picture 11 shows bearing position no. 11, the radial bearing of the high speed shaft at generator side. The bearing shows no irregularities.

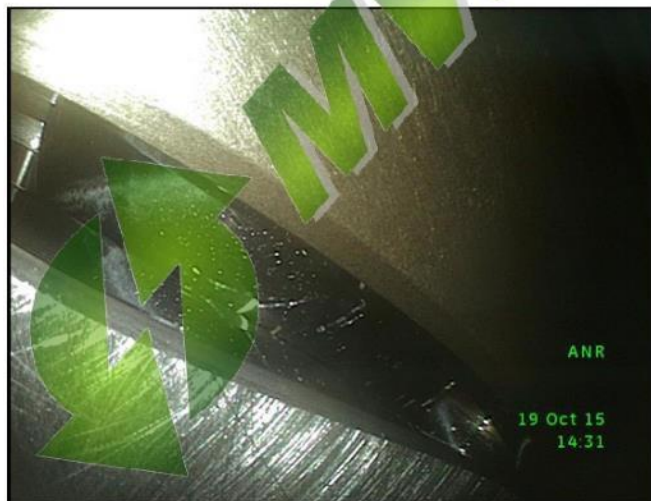
Picture 12 shows bearing position no. 11, the axial bearing of the high speed shaft at generator side. The bearing shows no irregularities.

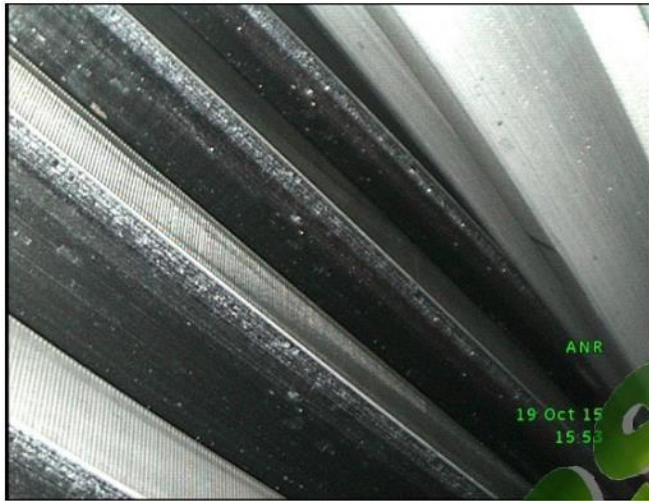
Picture 13 shows the active flank of the ring gear. No irregularities.

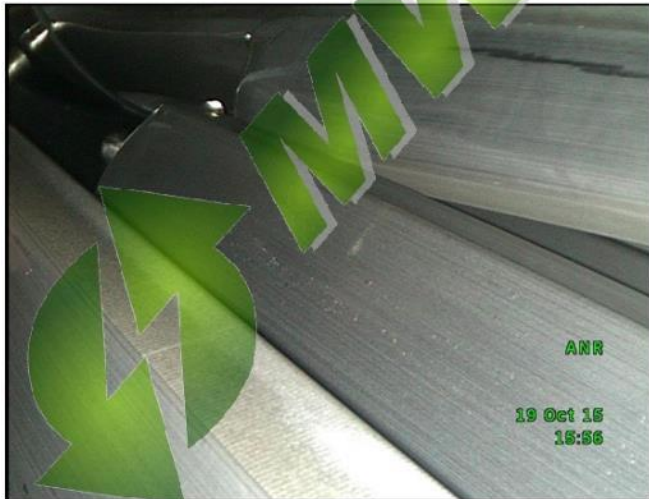
Picture 14 shows one of the planet wheels. None of the planet wheels show irregularities.

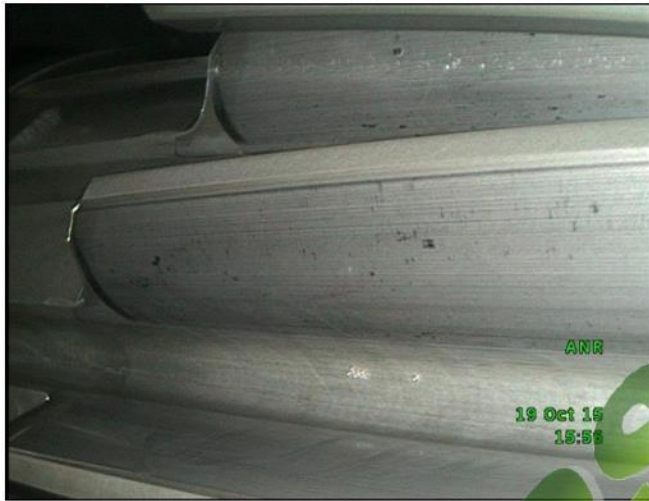
Picture 15 shows the active flanks of the sun pinion. No irregularities.

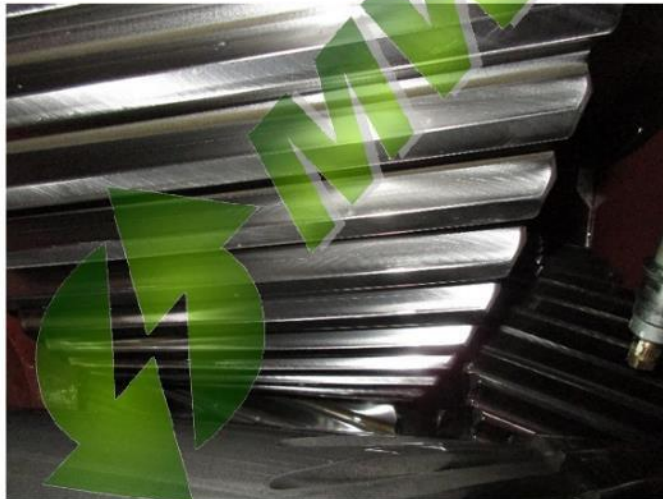
Picture 16 shows the active flanks of the wheel of the low speed shaft in the linear stage. No irregularities.

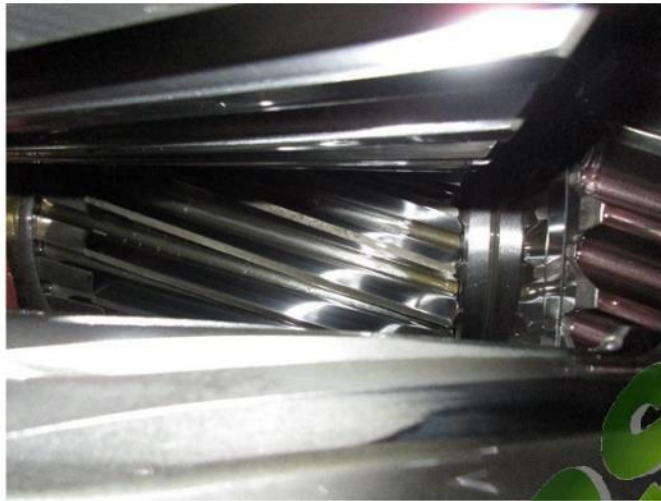
Picture 17 shows the active flanks of the pinion of the intermediate shaft in the linear stage. No irregularities.

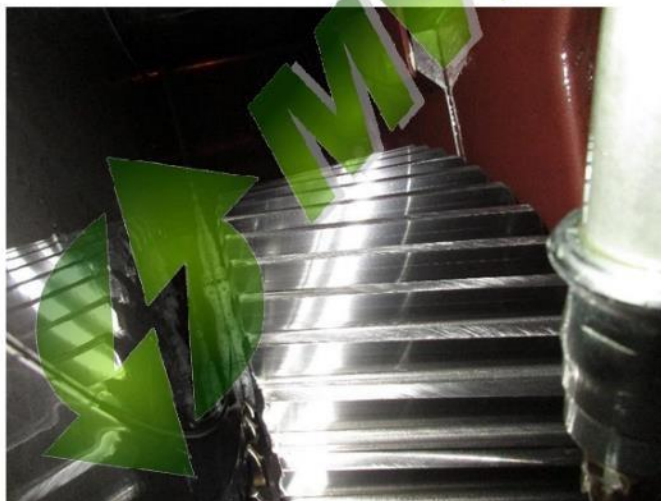
Picture 18 shows the active flanks of the wheel of the intermediate shaft in the linear stage. No irregularities.

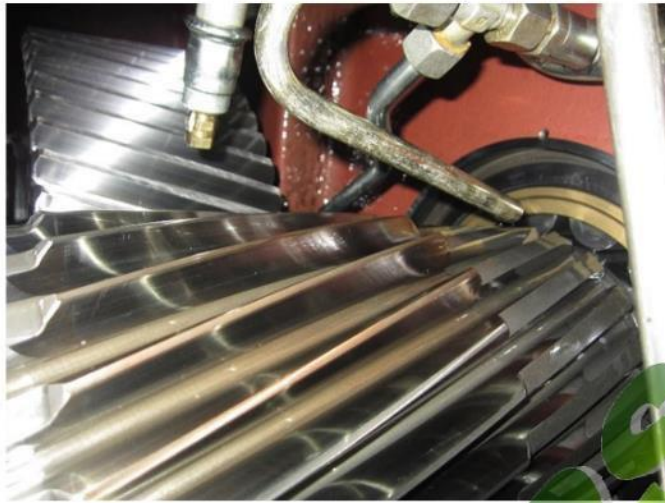
Picture 19 shows the active flanks of the pinion of the high speed shaft in the linear stage. No irregularities.

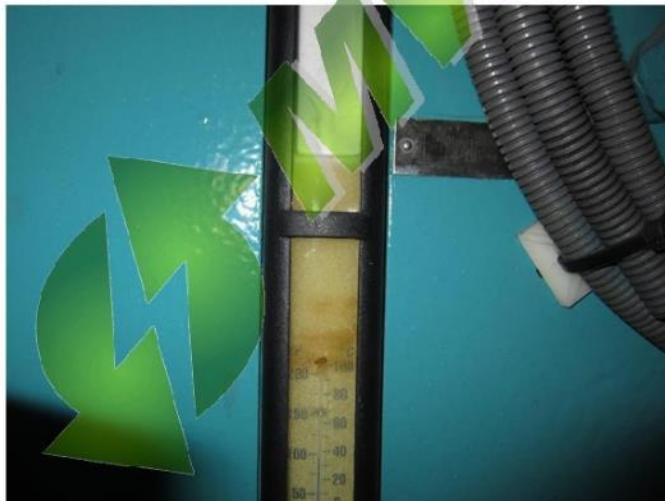
Picture 20 shows the oil level of the gearbox. The oil level is correct.

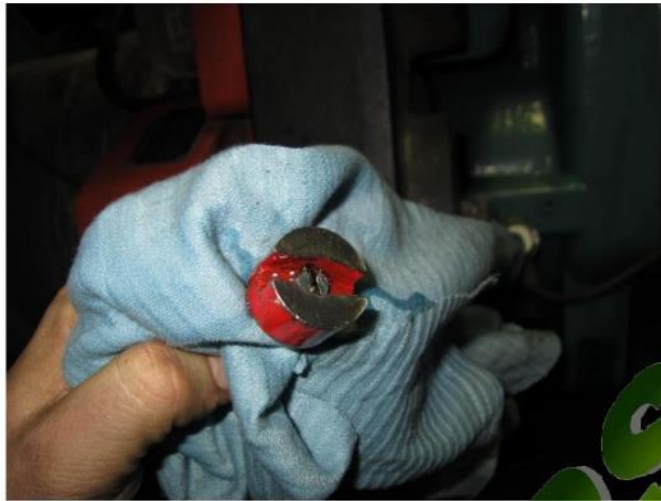
Picture 21

The inside and bottom of the gearbox have been searched with a magnet. The magnet shows no steel particles.
