REPORT TURBINE INSPECTION  
SN 15401274, WINDPARK SLUFTER WEST 8

Report No. GE15002015008

REPORT GEARBOX INSPECTION  
SN 15401274, WINDPARK SLUFTER WEST 8

Report no. GE15002015018

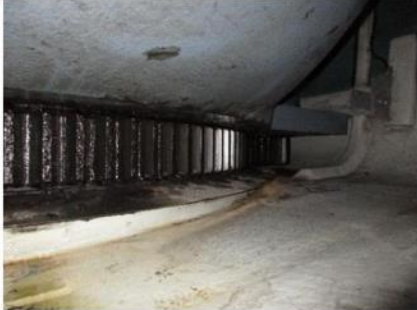
Item	Remark	
1	Yaw section		ok
2	Yaw ring teeth	Yaw ring shows no irregularities.

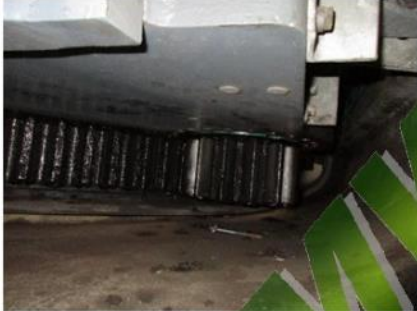
ok
3	Yaw pinions	Yaw pinions show no irregularities.

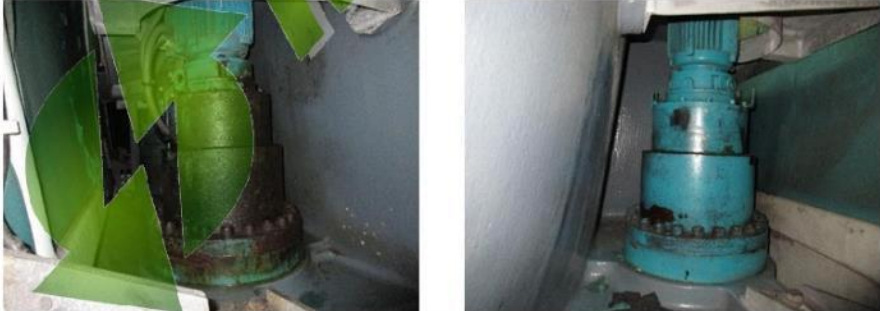
ok
4	Yaw gears	Paint work of the gears is not acceptable.

<div style="color: red; font-weight: bold;">nok</div> Low

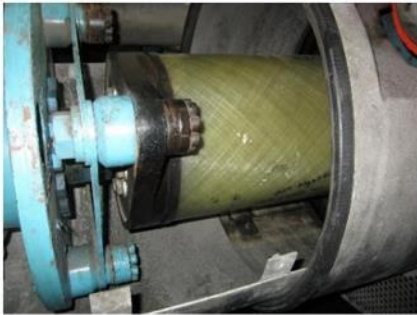
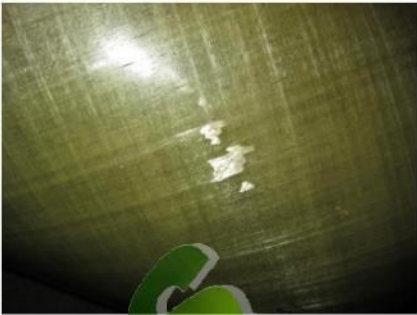
Item	Remark	
1	Coupling	<p>Minor damage at the surface of the composite tube. It looks like handling damage and it is considered to be acceptable.</p> <div style="display: flex; justify-content: space-around;">

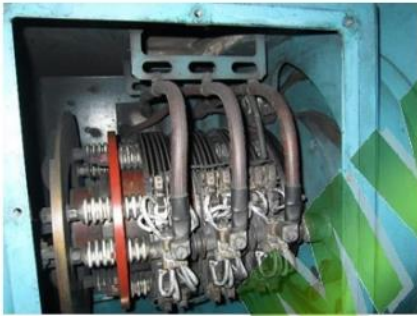
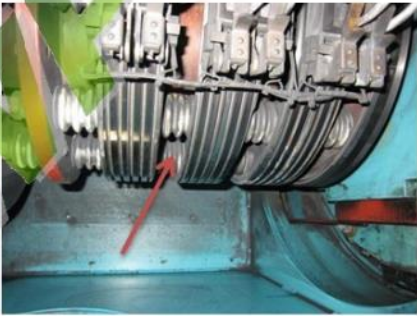
</div>	Info
2	Paint / Corrosion		ok
3	Slip ring	<p>The insulating parts between the phases are covered with black carbon dust.</p> <div style="display: flex; justify-content: space-around;">

</div>	<div style="text-align: center;"> <span style="color: red; font-weight: bold;">nok</span>              High         </div>
4	Miscellaneous		ok

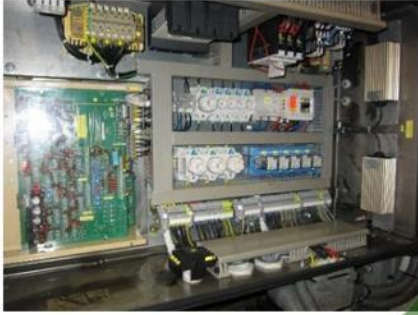
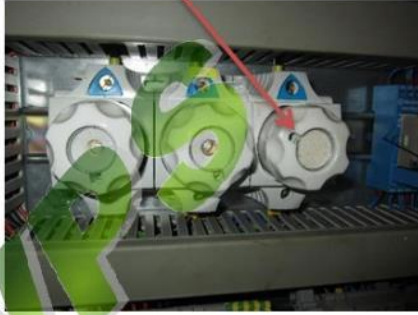
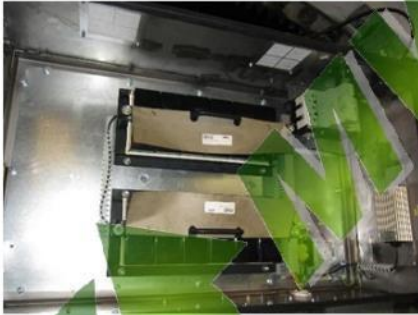
5	Boxes blade B	<p>Sand is leaking at one fuse of the control box.</p>

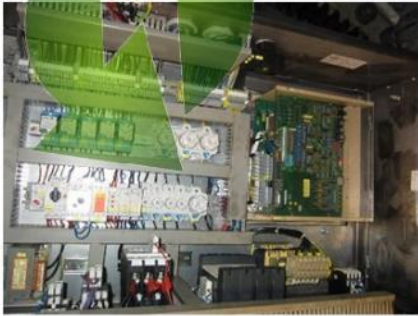
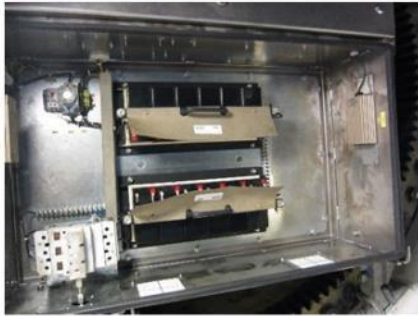
<p><b>ok</b></p> <p>Low</p>
6	Boxes blade 3	<p>Control box and battery box show no irregularities.</p>

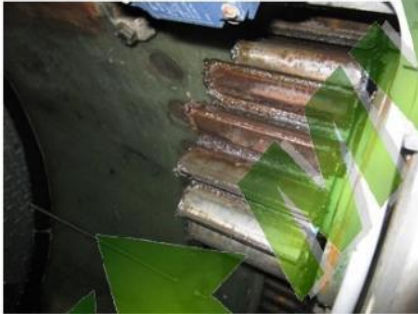
8	Pinions of pitch gears	Wear on one tooth of the pinions of the pitch gears.

High
9	Pitch teeth at zero of blade 1	The tooth at zero shows wear.

The wear of the zero-tooth of the pitch ring is serious, but it is possible to solve this problem by assigning another tooth to be the zero-tooth. Dismounting and remounting of the blades is necessary to achieve this. The same thing can be done with the pinions, although replacing the pitch gears (with the pinions) is also an option.

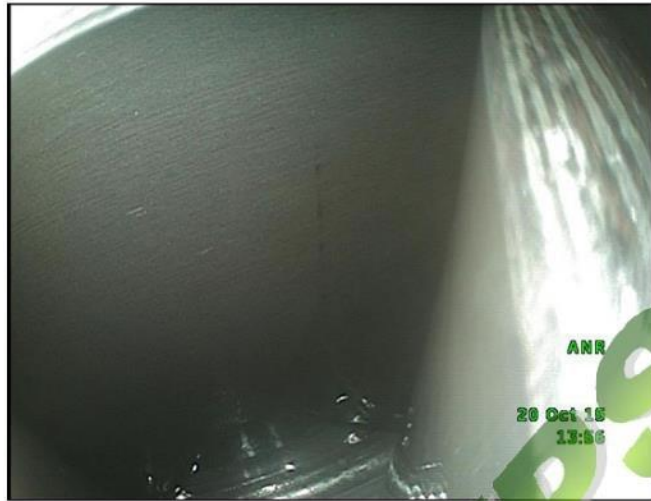
Picture 1 shows bearing position no. 1, the bearing of the planet carrier at rotor side. No irregularities.

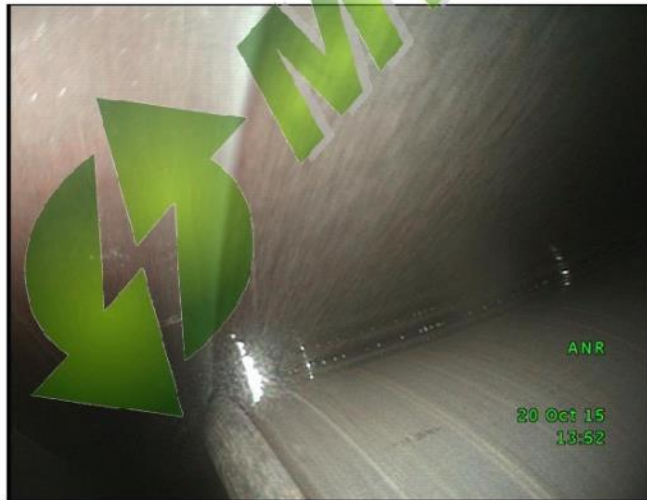
Picture 2 shows the bearing of the first planet wheel. No irregularities.

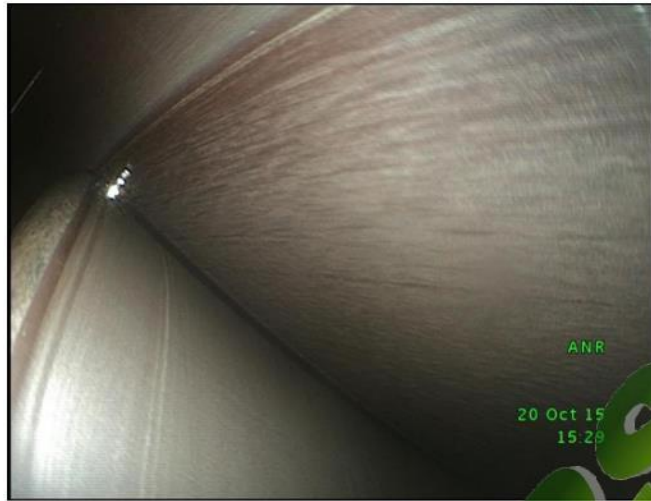
**Picture 3**

Picture 3 shows the bearing of the second planet wheel. No irregularities.

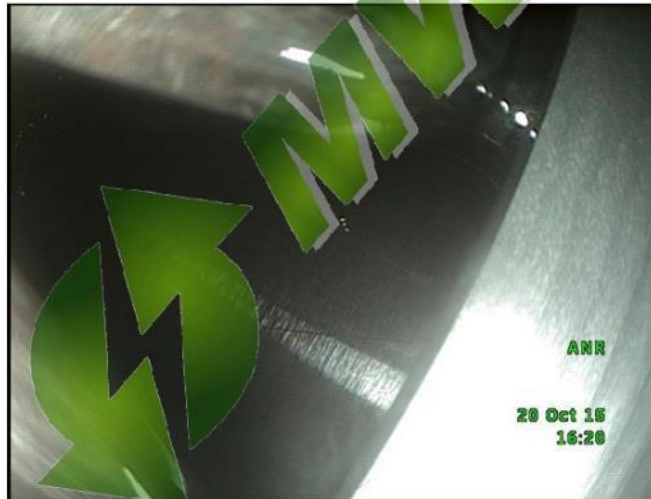
**Picture 4**

Picture 4 shows the bearing of the third planet wheel. No irregularities.

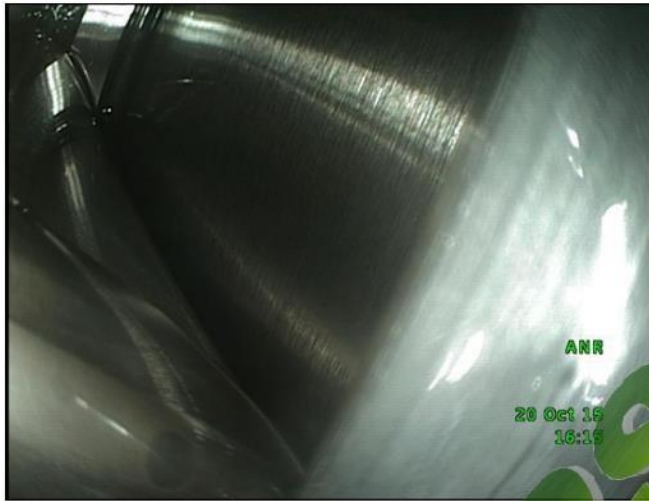
**Picture 5**

Picture 5 shows bearing position no. 5, the bearing of the planet carrier at generator side. The bearing shows no irregularities.

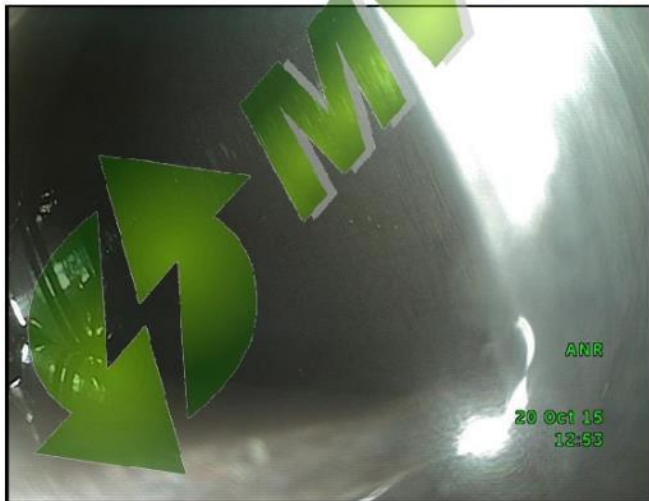
**Picture 6**

Picture 6 shows bearing position no. 6, the bearing of the low speed shaft at rotor side. The bearing shows no irregularities.

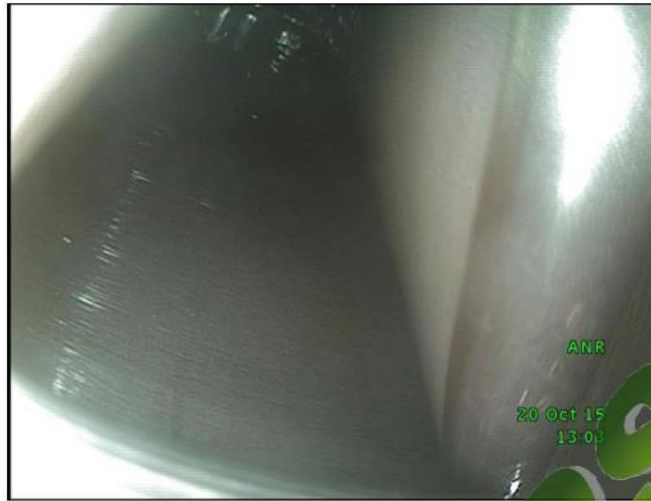
**Picture 7**

Picture 7 shows bearing position no. 7, the bearing of the low speed shaft at generator side. The bearing shows no irregularities.

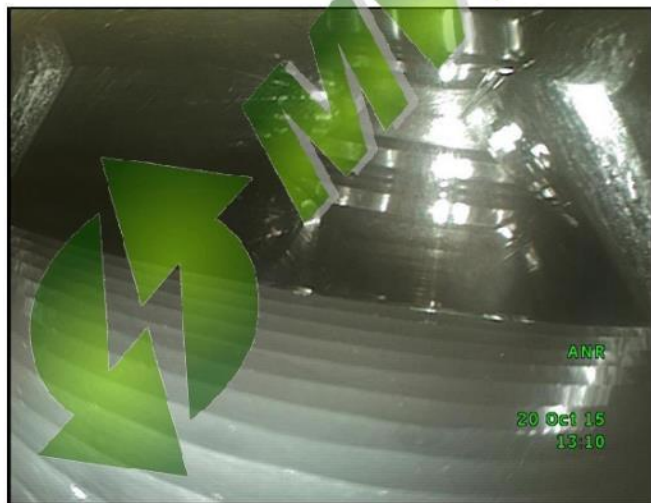
**Picture 8**

Picture 8 shows bearing position no. 8, the bearing of the intermediate shaft at rotor side. The bearing shows no irregularities.

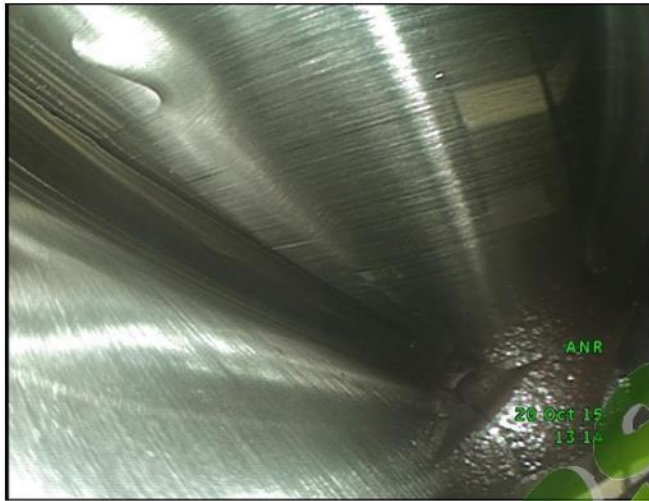
**Picture 9**

Picture 9 shows bearing position no. 9, the bearing of the intermediate shaft at generator side. The bearing shows no irregularities.

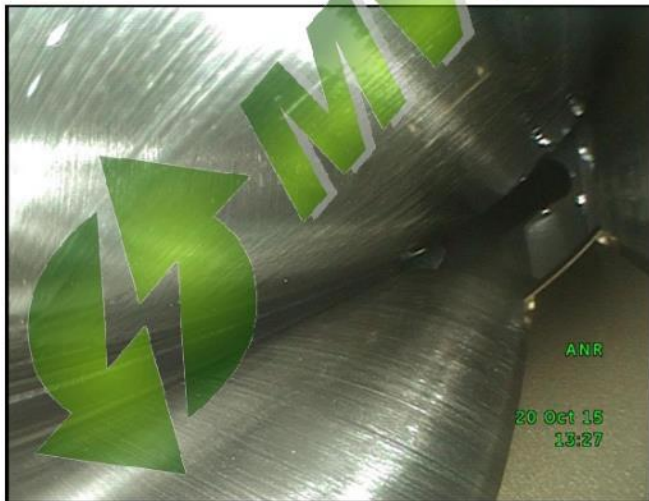
**Picture 10**

Picture 10 shows bearing position no. 10, the bearing of the high speed shaft at rotor side. The bearing shows no irregularities.

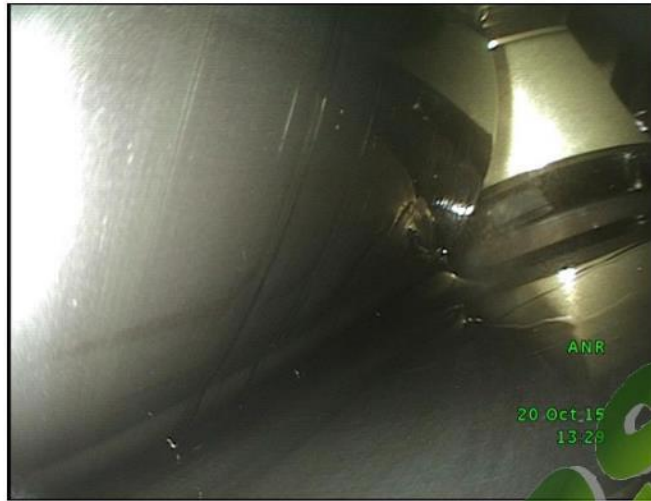
**Picture 11**

Picture 11 shows bearing position no. 11, the radial bearing of the high speed shaft at generator side. The bearing shows no irregularities.

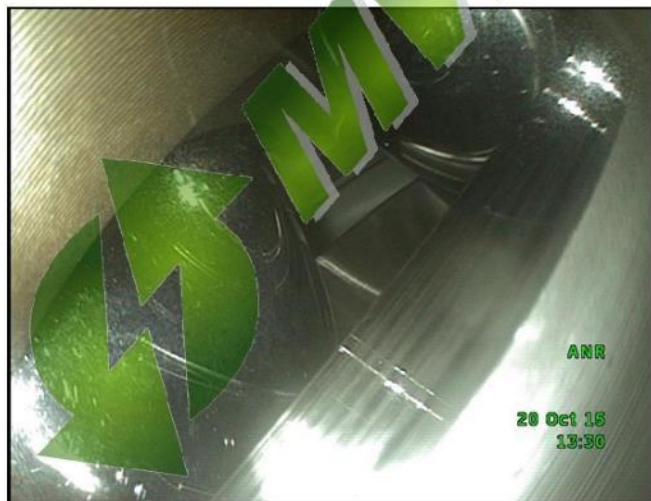
**Picture 12**

Picture 12 shows bearing position no. 11, the axial bearing of the high speed shaft at generator side. The bearing shows no irregularities.

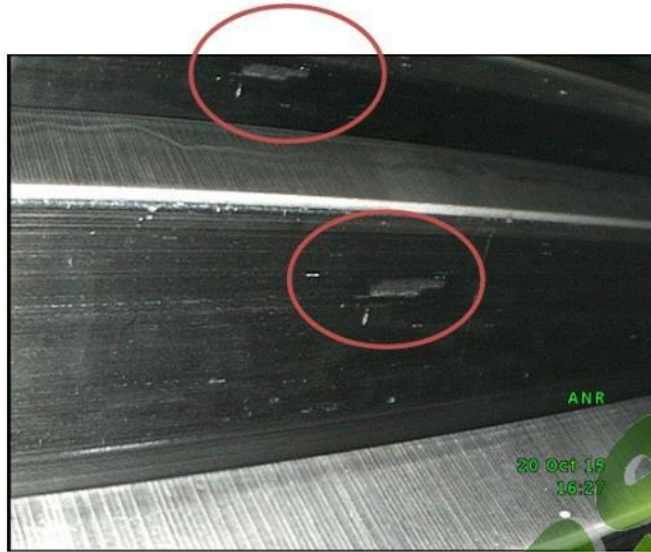
**Picture 13**

Picture 13 shows the active flank of the ring gear. Small repeating irregularity visible at the flanks.

The active flank of the ring gear shows a small repeating irregularity at each flank.

The small irregularities at the flanks of the ring gear were probably generated before the gearbox was revised in 2013. It is likely that the gear has been re-used. There is no reason to assume that an active defect is present at this moment. The clean magnet supports this conclusion.

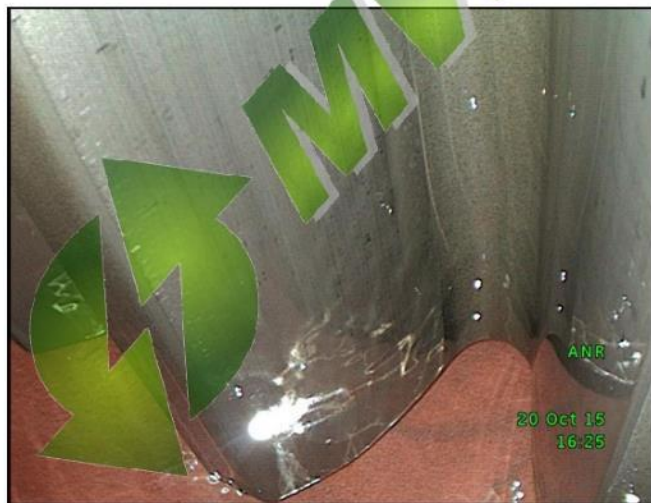
**Picture 14**

Picture 14 shows one of the planet wheels. None of the planet wheels show irregularities.

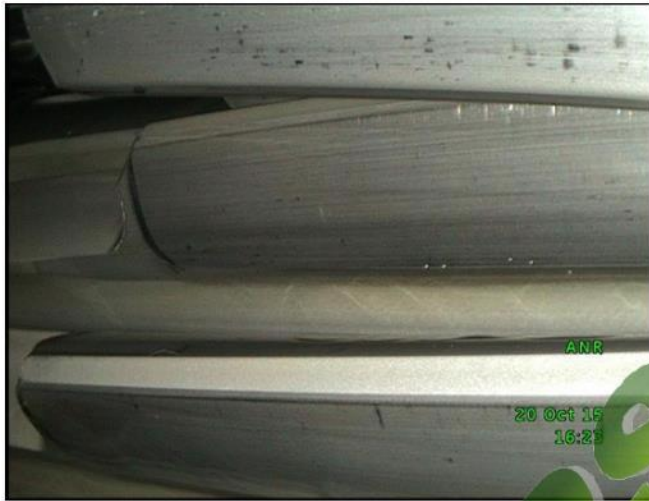
**Picture 15**

Picture 15 shows the active flanks of the sun pinion. No irregularities.

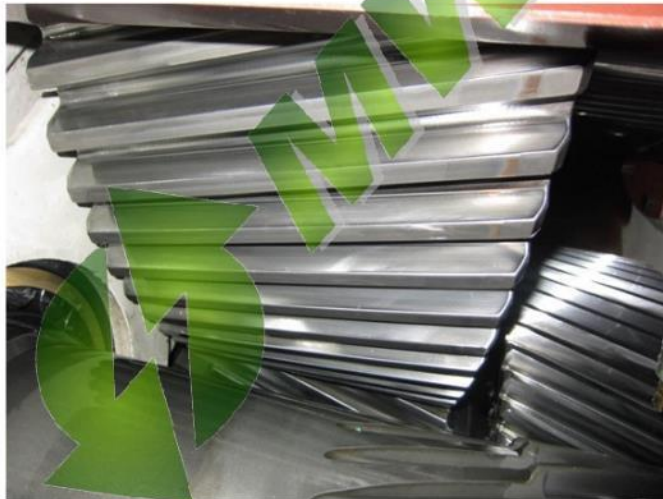
**Picture 16**

Picture 16 shows the active flanks of the wheel of the low speed shaft in the linear stage. No irregularities.

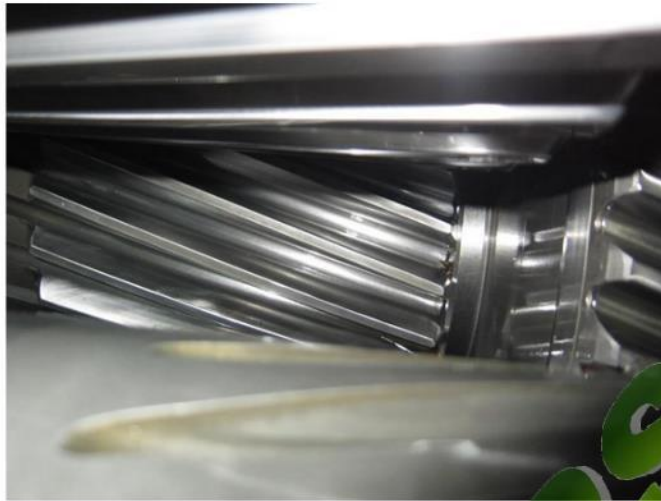
**Picture 17**

Picture 17 shows the active flanks of the pinion of the intermediate shaft in the linear stage. No irregularities.

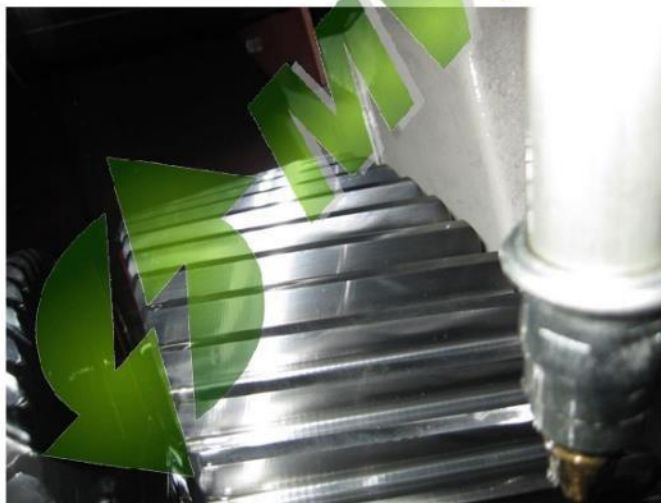
**Picture 18**

Picture 18 shows the active flanks of the wheel of the intermediate shaft in the linear stage. No irregularities.

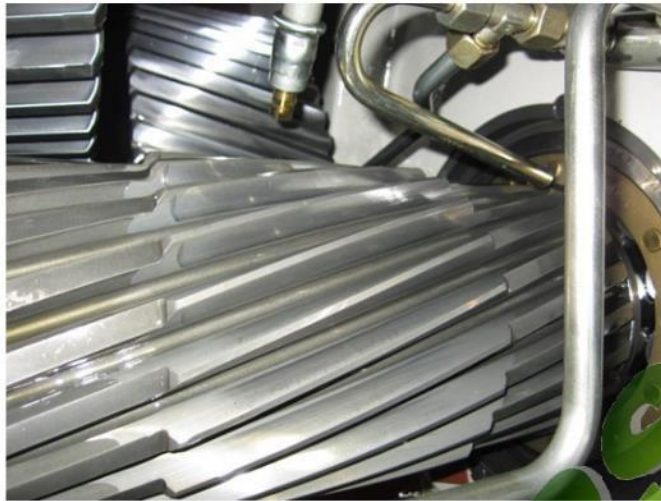
Picture 19 shows the active flanks of the pinion of the high speed shaft in the linear stage. No irregularities.

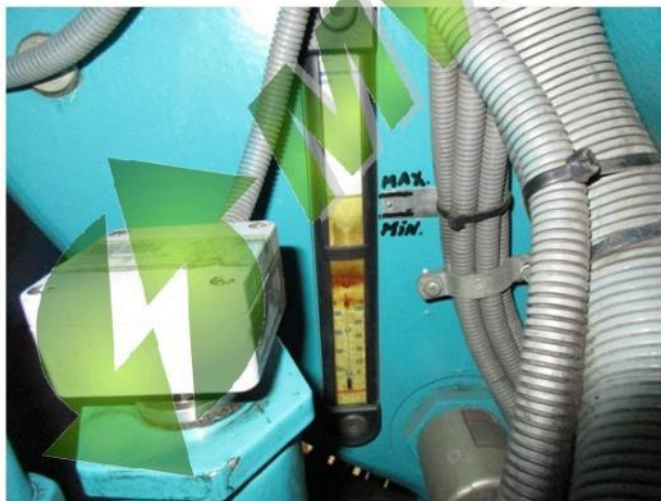
Picture 20 shows the oil level of the gearbox. The oil level is correct.

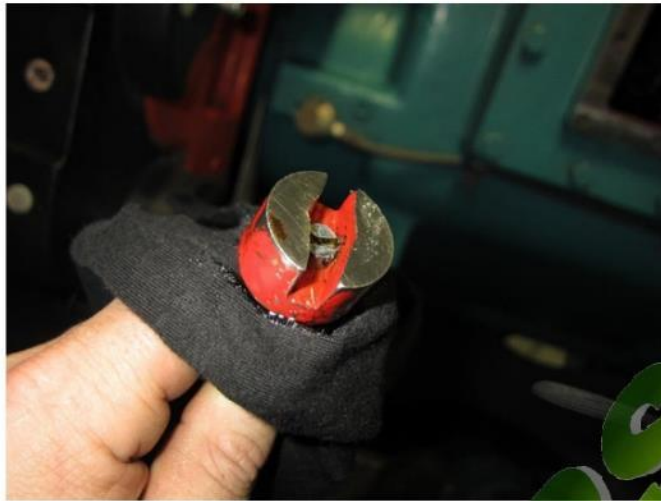
Picture 21

The inside and bottom of the gearbox have been searched with a magnet. The magnet shows no steel particles.
