REPORT TURBINE INSPECTION
SN 15401275, WINDPARK SLUFTER WEST 9

Report No. GE15002015009

REPORT GEARBOX INSPECTION
SN 15401275, WINDPARK SLUFTER WEST 9

Report no. GE15002015019

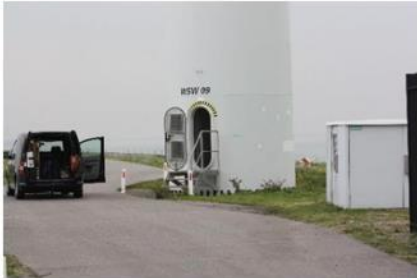
| | Item | Remark | |
|---|---|---|--|
| 1 | Tower outside | Light at the outside is broken and has damaged the paint of the tower. | Low |

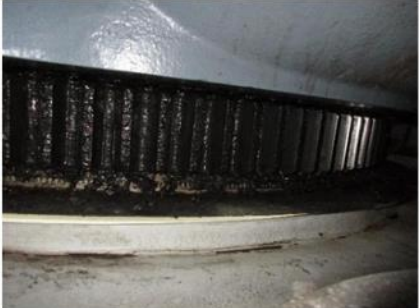
| | Item | Remark | |
|---|---|--|--|
| 2 | Yaw ring teeth | Yaw ring shows no irregularities. | ok |

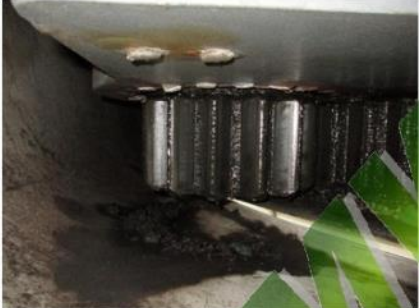
| | Item | Remark | |
|---|---|--|--|
| 3 | Yaw pinions | Yaw pinions show no irregularities. | ok |

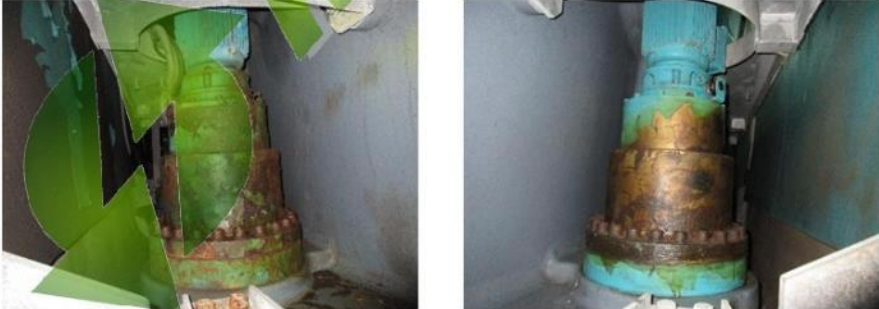
| | Item | Remark | |
|---|---|--|--|
| 4 | Yaw gears | Paint work of the gears is not acceptable. | <div style="color: red; font-weight: bold;">nok</div> Low |

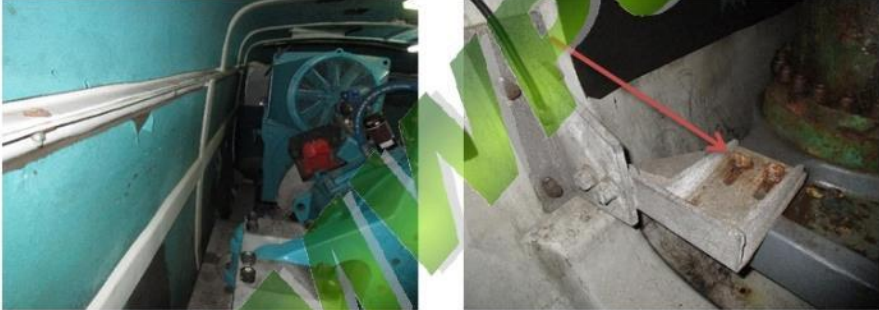
| | Item | Remark | |
|---|---|---|---|
| 3 | Nacelle housing | <p>Parts of the insulation are damaged. Bolts of the nacelle frame are corroded (2nd picture).</p> | <div style="text-align: center;"> Low </div> |

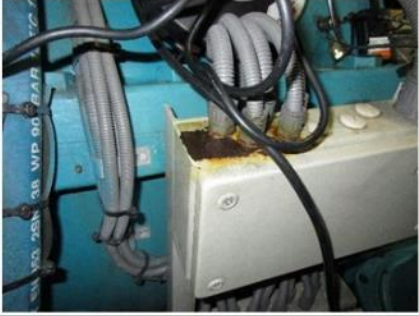
| 6 | Miscellaneous | Corrosion at the housing of the GX2-box. | | nok Low |

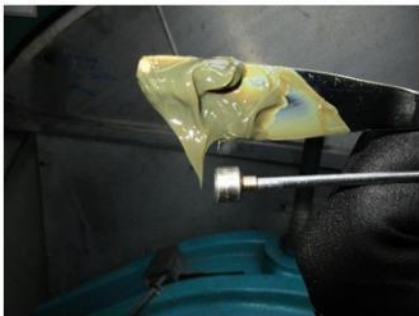
| Item | Remark | |
|---|--|---|
| 1 | Main shaft bearings Grease of the main bearing is not magnetic. | ok |

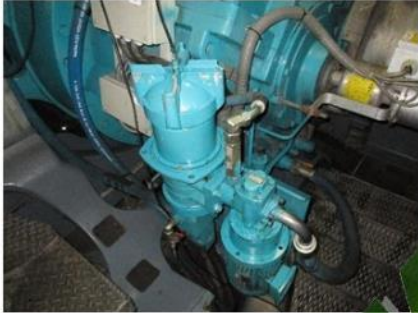
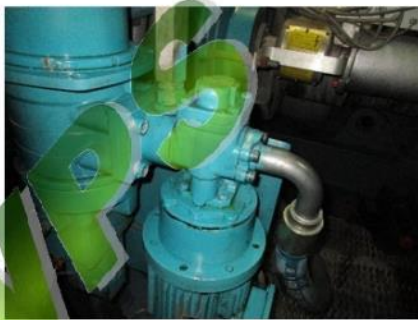
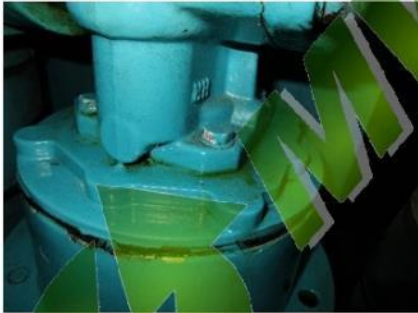
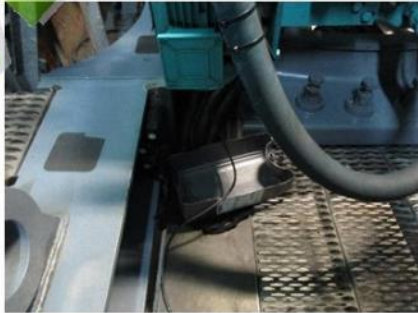
| 4 | Gear oil system | Oil leakage present at the gear oil system. | not ok <i>High</i> |

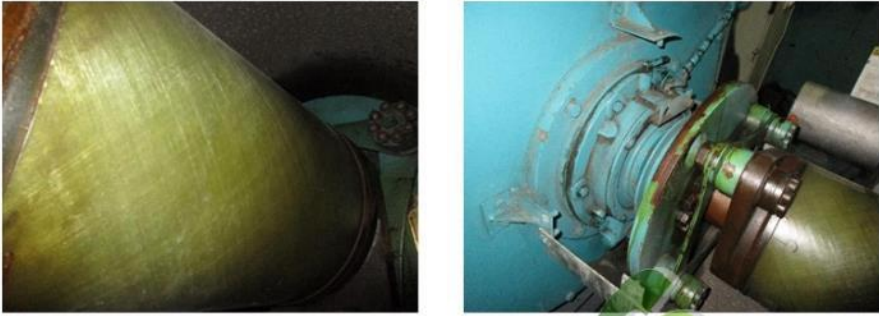
| | Item | Remark | |
|---|---|---|---|
| 1 | Coupling | <p>The coupling shows no irregularities.</p> | ok |

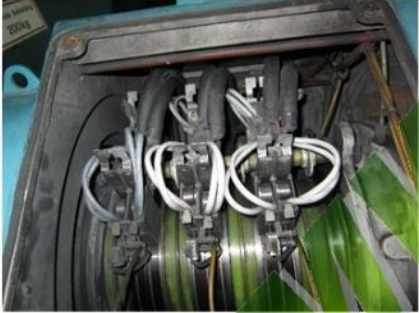
| | Item | Remark | |
|---|---|---|---|
| 3 | Slip ring | <p>The slip ring shows no visual irregularities.</p> | Info |

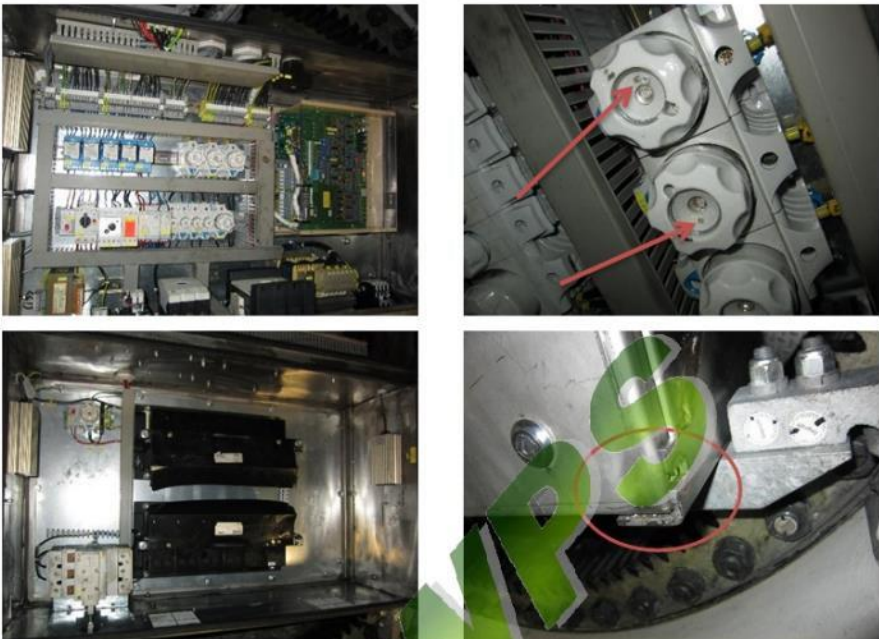
| 5 | Boxes blade 2 | <p>Small loose parts of the fuses are visible behind the glass cover (2nd picture). Bolt connection of the cover of the battery box is broken (4th picture).</p> | <p>NO Low</p> |

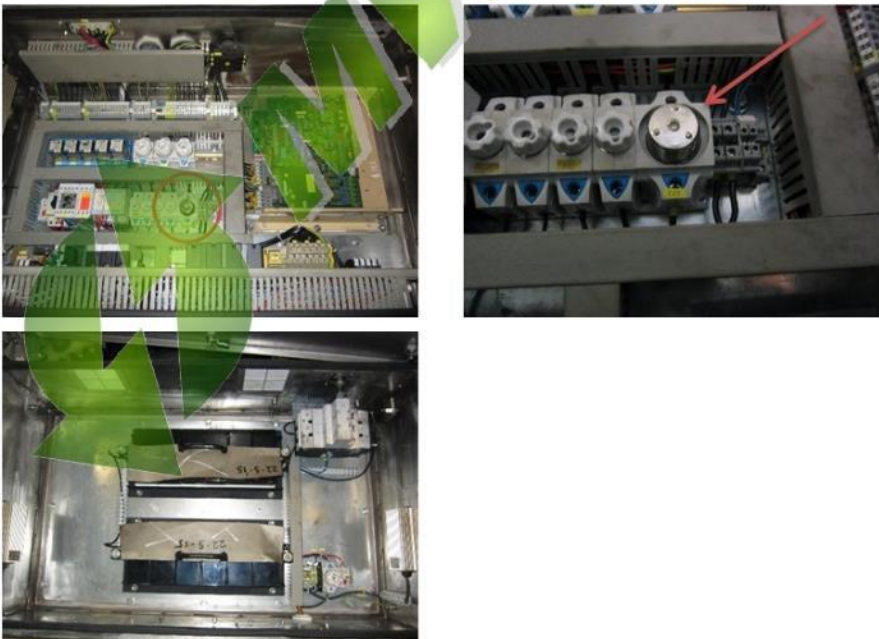
| 6 | Boxes blade 3 | <p>Cover of the fuse is missing (1st and 2nd picture).</p> | <p>NO High</p> |

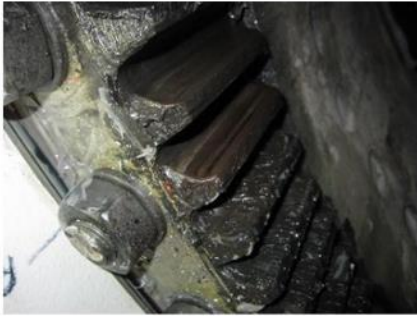
| 11 | Pitch teeth at zero of blade 2 | <p>The tooth at zero shows wear.</p> | <p>nok High</p> |

The wear of the zero-tooth of the pitch ring is serious, but it is possible to solve this problem by assigning another tooth to be the zero-tooth. Dismounting and remounting of the blades is necessary to achieve this. The same thing can be done with the pinions, although replacing the pitch gears (with the pinions) is also an option.

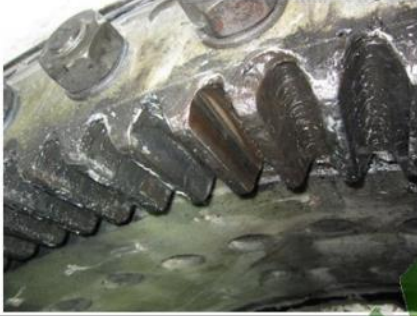
| 12 | Pitch teeth at zero of blade 3 | <p>The tooth at zero shows wear.</p> | <p>nok High</p> |

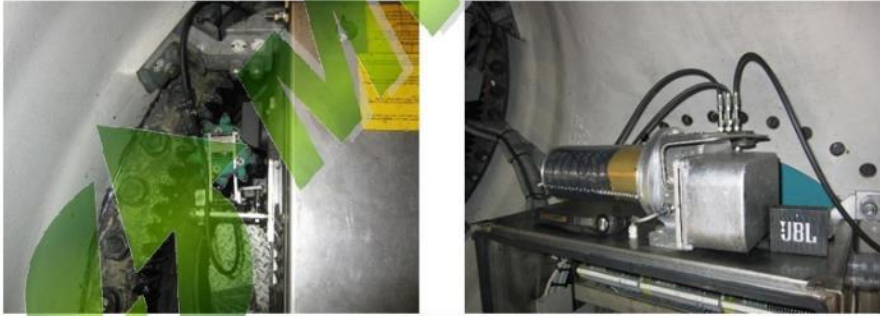
| 13 | Grease system pitch teeth | <p>There is an automatic grease system present in the hub. The system is not operational.</p> | <p>nok High</p> |

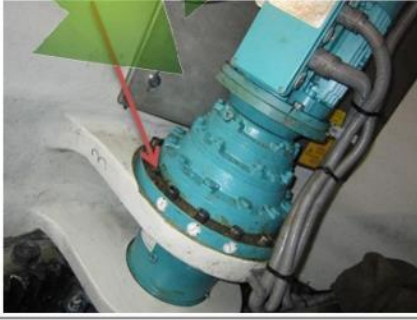
| 14 | Pitch gears | <p>Some corrosion visible at the base of the pitch gears.</p> | <p>nok Low</p> |

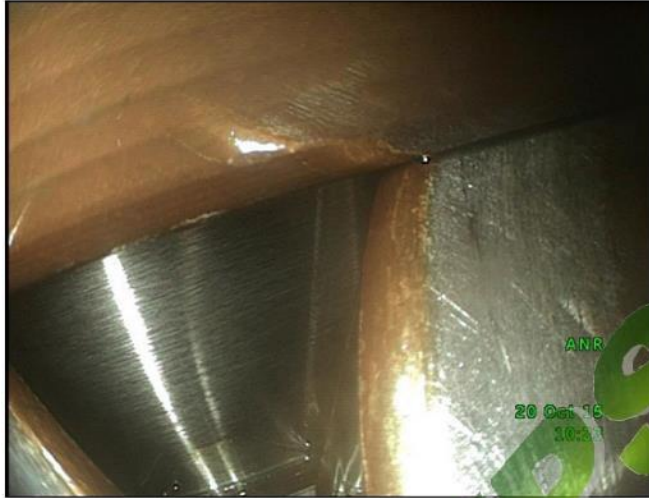
Picture 1 shows bearing position no. 1, the bearing of the planet carrier at rotor side. No irregularities.

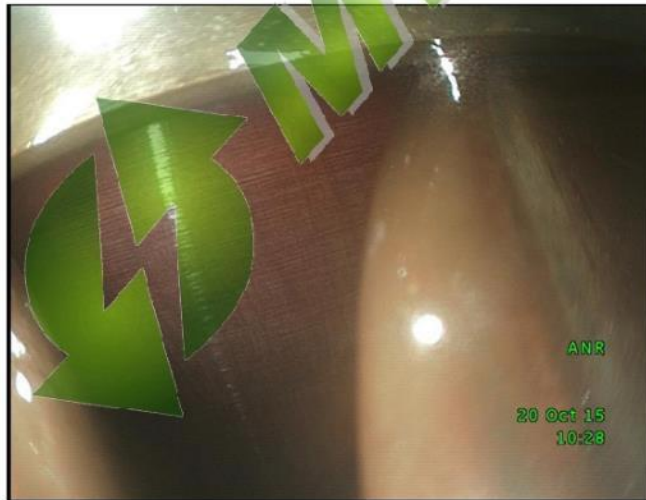
Picture 2 shows the bearing of the first planet wheel. No irregularities.

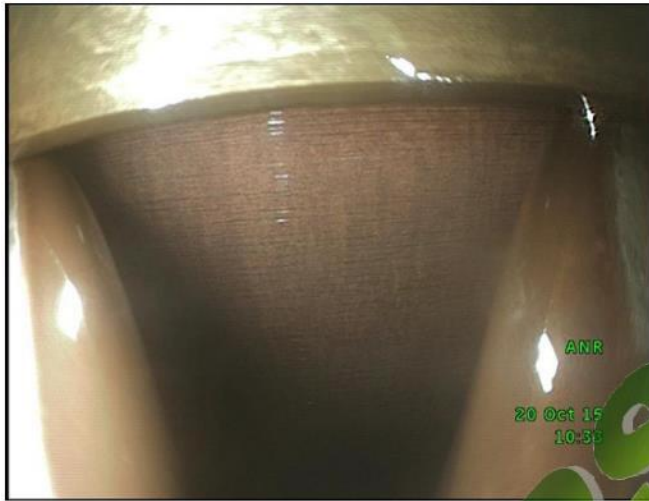
Picture 3 shows the bearing of the second planet wheel. No irregularities.

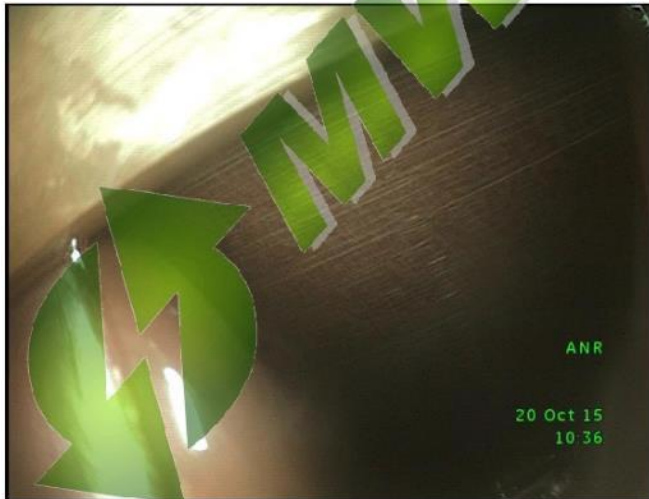
Picture 4 shows the bearing of the third planet wheel. No irregularities.

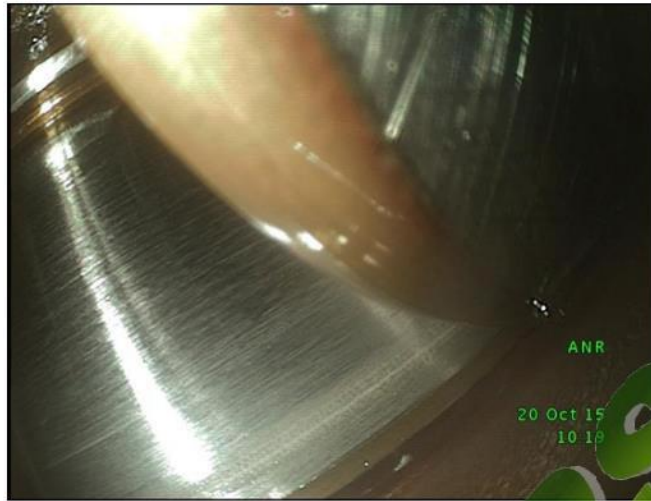
Picture 5 shows bearing position no. 5, the bearing of the planet carrier at generator side. The bearing shows no irregularities.

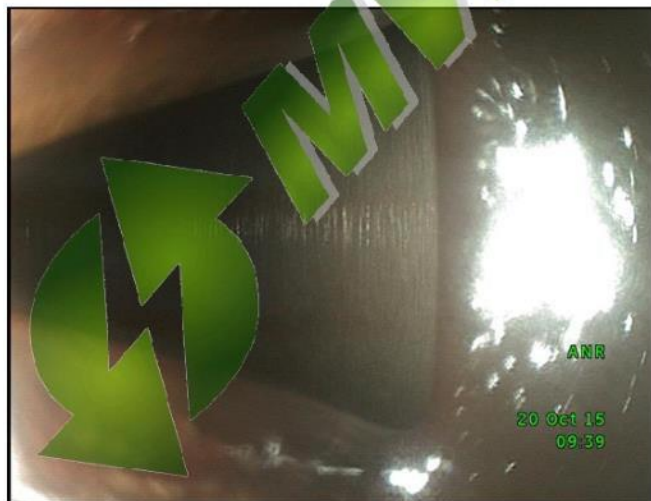
Picture 6 shows bearing position no. 6, the bearing of the low speed shaft at rotor side. The bearing shows no irregularities.

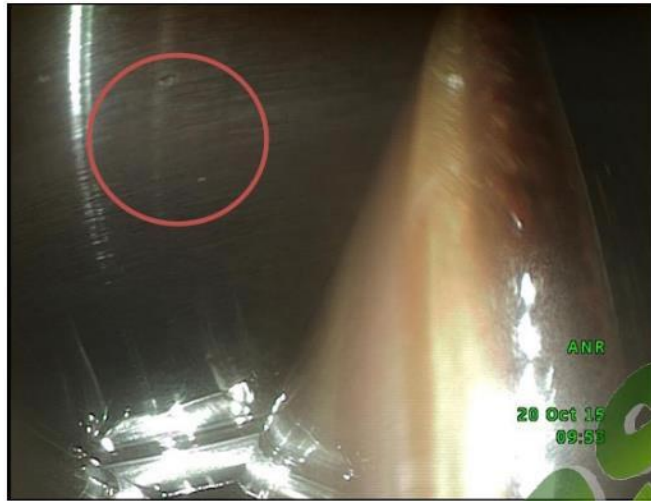
Picture 7 shows bearing position no. 7, the bearing of the low speed shaft at generator side. Two very small indentations visible at the raceway.

The bearing of the low speed shaft at generator side shows two very small indentations at the raceway.

The small indentations on the bearing of the low speed shaft have probably been caused by particles from the damaged high speed bearings in 2014.

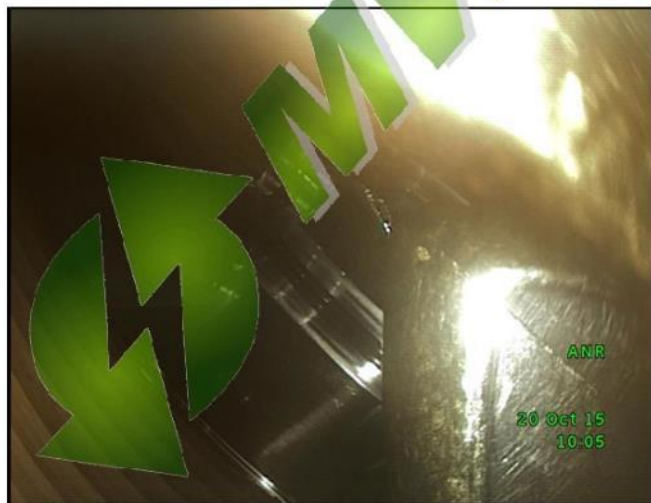
Picture 8 shows bearing position no. 8, the bearing of the intermediate shaft at rotor side. The bearing shows no irregularities.

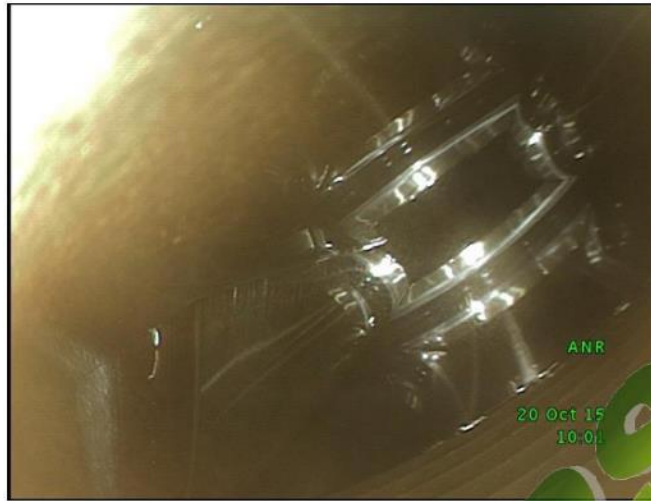
Picture 9 shows bearing position no. 9, the bearing of the intermediate shaft at generator side. The bearing shows no irregularities.

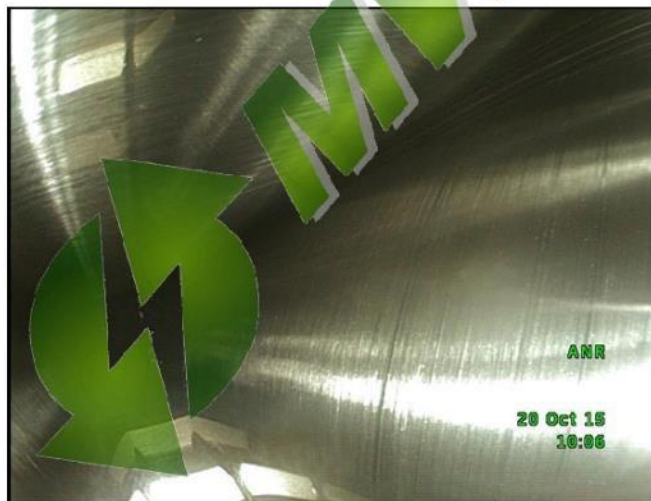
Picture 10 shows bearing position no. 10, the bearing of the high speed shaft at rotor side. The bearing shows no irregularities.

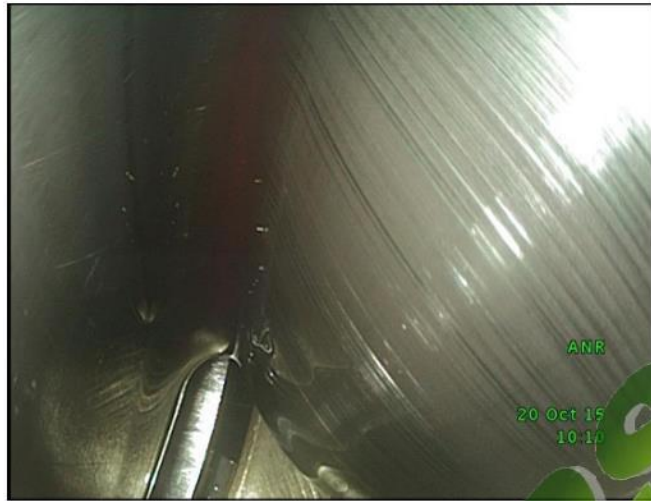
Picture 11 shows bearing position no. 11, the radial bearing of the high speed shaft at generator side. The bearing shows no irregularities.

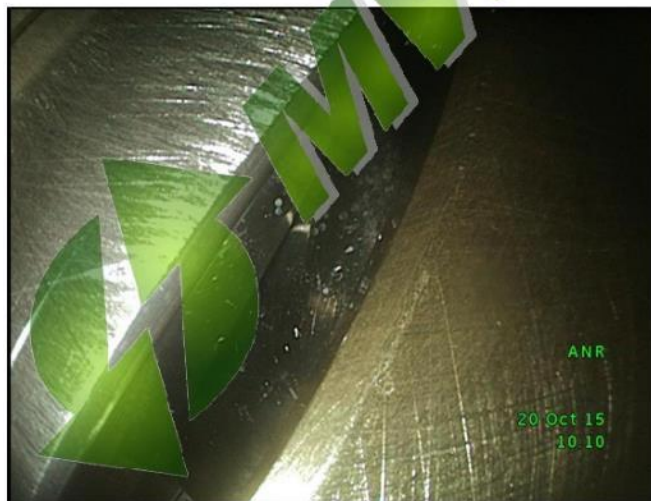
Picture 12 shows bearing position no. 11, the axial bearing of the high speed shaft at generator side. The bearing shows no irregularities.

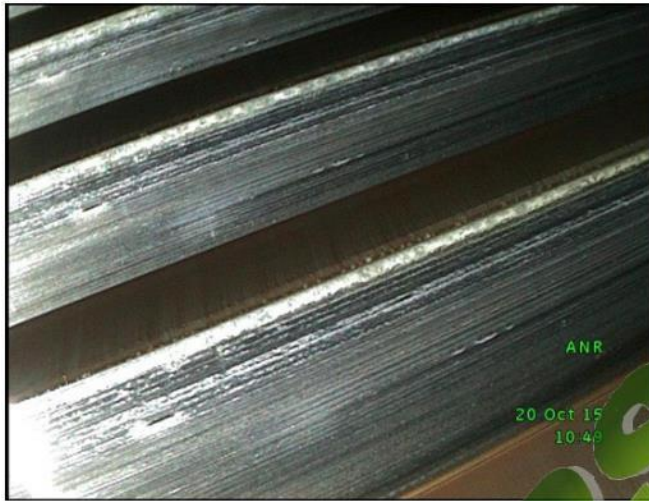
Picture 13 shows the active flank of the ring gear. No irregularities.

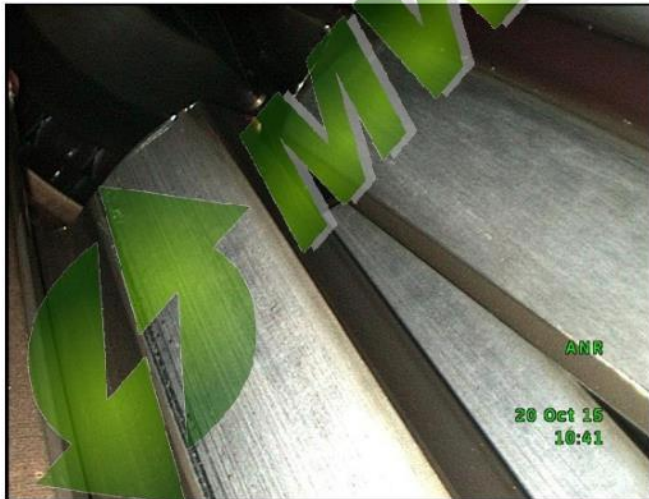
Picture 14 shows one of the planet wheels. None of the planet wheels show irregularities.

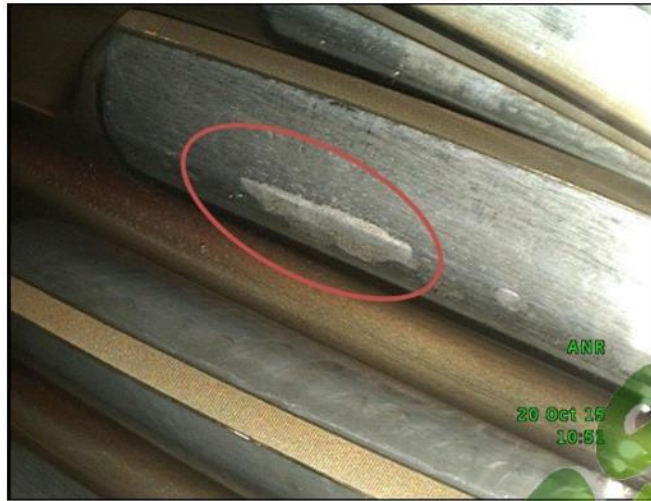
Picture 15 shows the active flanks of the sun pinion. Stabilized micropitting visible at the flank.

The active flanks of the sun pinion show stabilized micropitting.

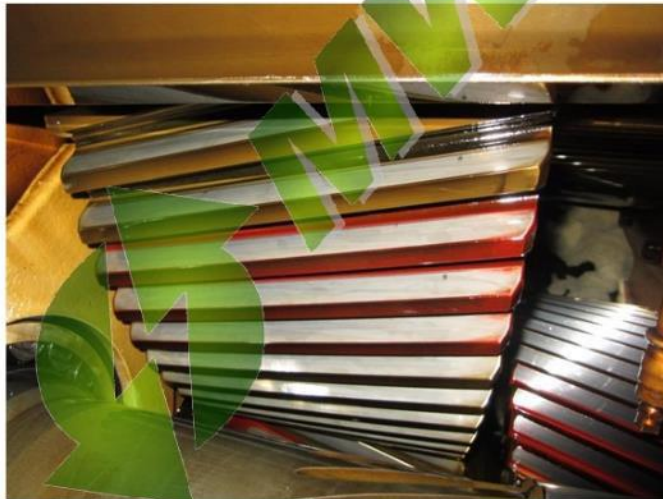
Picture 16 shows the active flanks of the wheel of the low speed shaft in the linear stage. No irregularities.

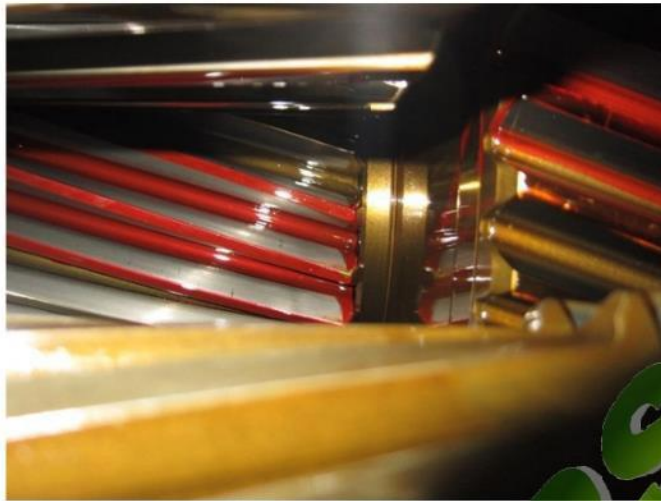
Picture 17 shows the active flanks of the pinion of the intermediate shaft in the linear stage. No irregularities.

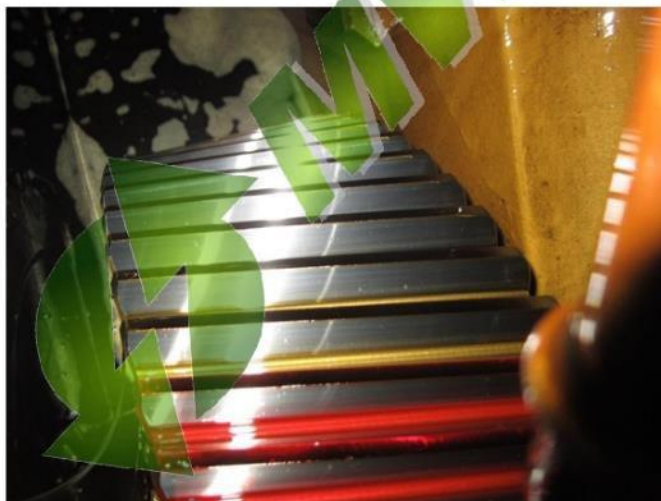
Picture 18 shows the active flanks of the wheel of the intermediate shaft in the linear stage. No irregularities.

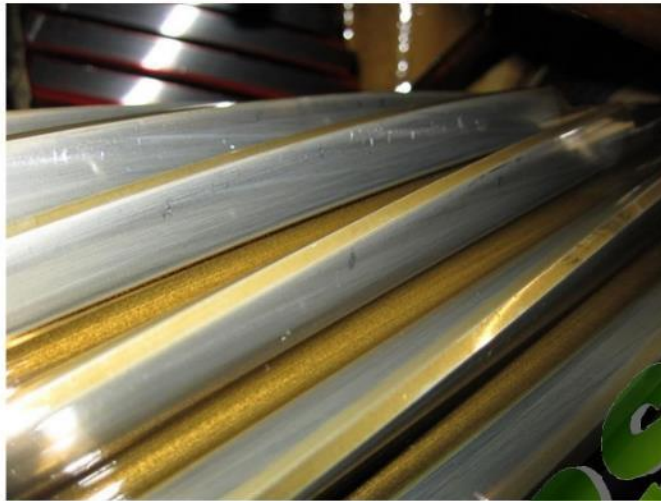
Picture 19 shows the active flanks of the pinion of the high speed shaft in the linear stage. No irregularities.

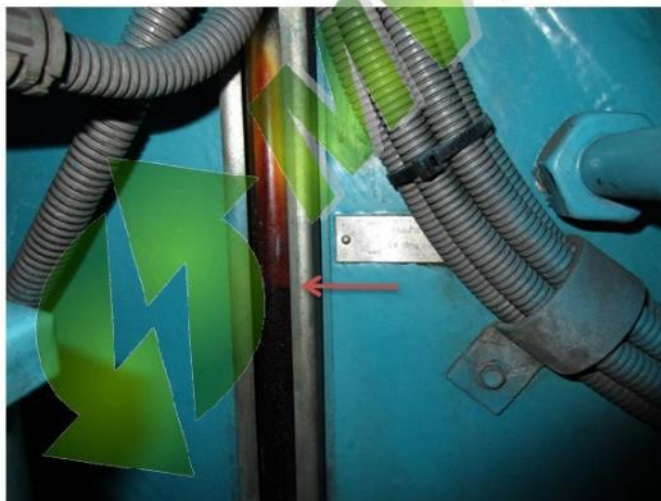
Picture 20 shows the oil level of the gearbox. The oil level is a bit too low.

The oil level is a bit too low and no steel particles were found in the gearbox.

The oil level is a bit too low and it is recommended to fill up the gearbox at the next maintenance.

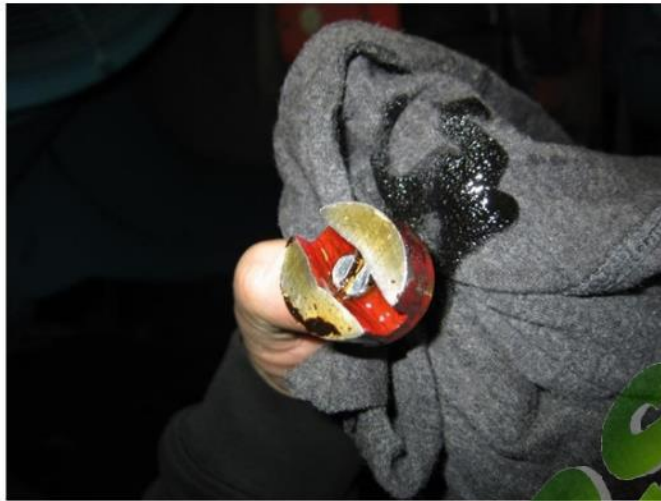
Picture 21

The inside and bottom of the gearbox have been searched with a magnet. The magnet shows no steel particles.
