REPORT TURBINE INSPECTION
SN 15401273, WINDPARK SLUFTER WEST 7

Report No. GE15002015007

REPORT GEARBOX INSPECTION
SN 15401273, WINDPARK SLUFTER WEST 7

Report no. GE15002015017

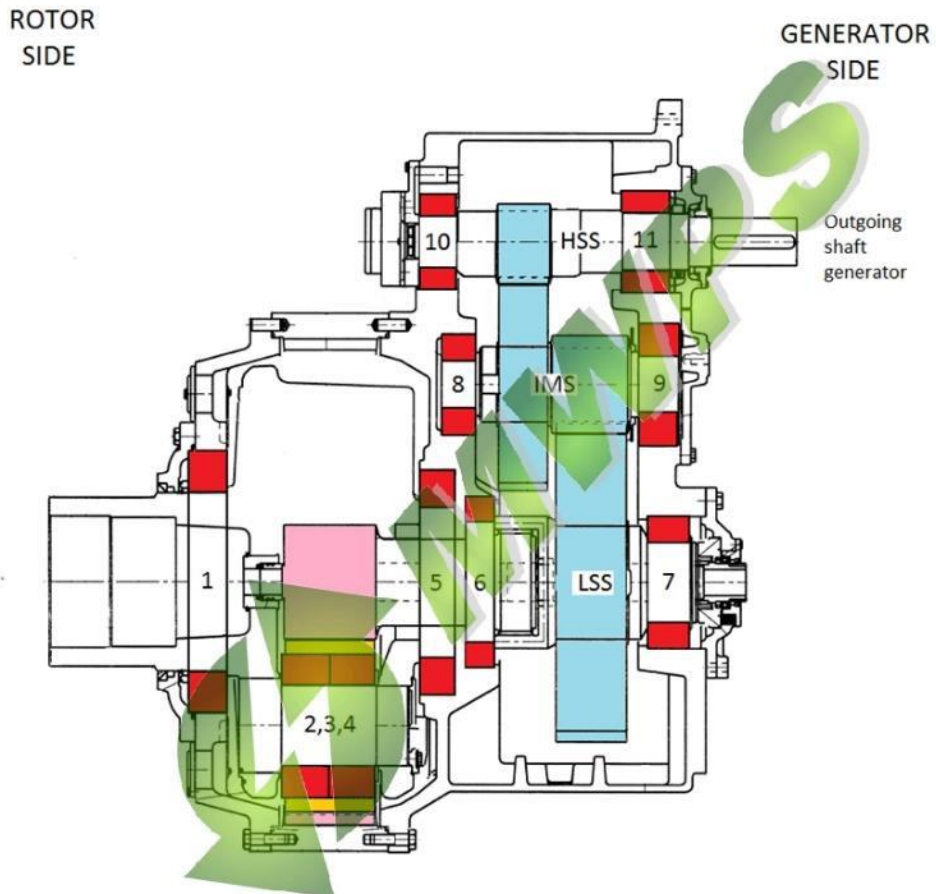
The next drawing shows a cross-section of a planetary gearbox with two linear stages with corresponding bearing positions. The drawing should be used as a reference for the bearing position only.
